February 29, 2024 R1

**PROPERTY:** MESQUITE GROVES ESTATES  
CHANDLER, ARIZONA

**SERVICE:** FULL RESERVE FUND ANALYSIS

**ATTACHMENT:** 23-0446 – FINAL REPORT

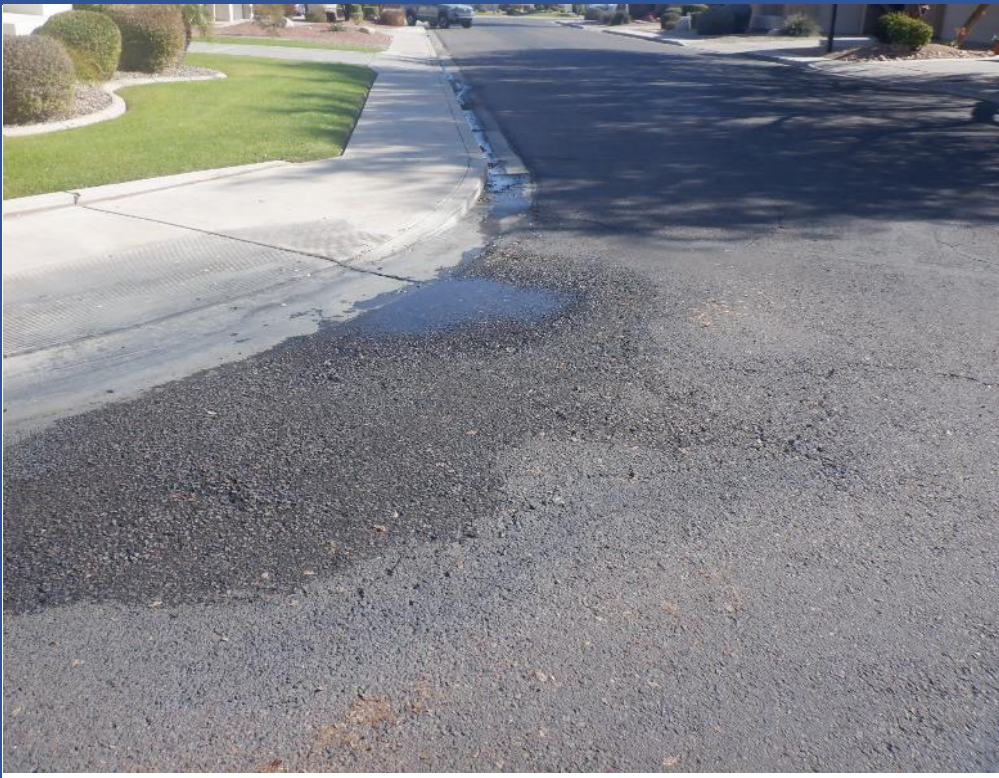
91

Asphalt near Aquarius and Rincon (standing water deteriorating asphalt)

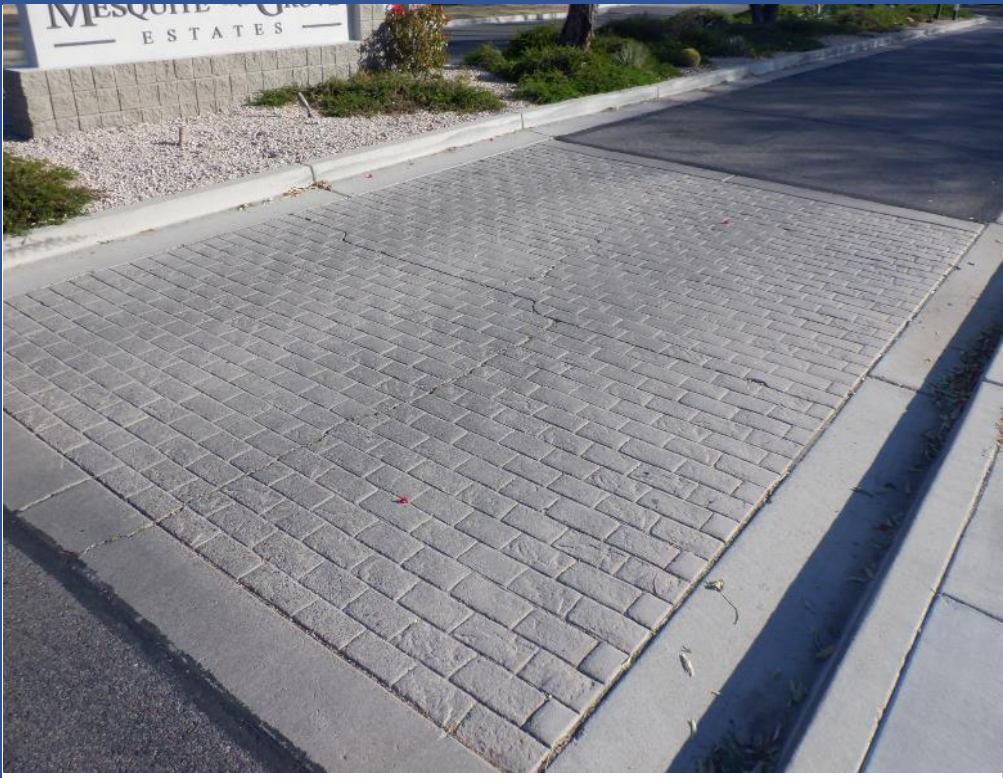
**D1**

The stamped asphalt at the entrance off of South Gilbert Road is in good to fair condition with some significant cracks in the asphalt. This should be repaired and maintained in the same fashion as the other asphalt roads in the community.

Deficiency - Cracks in stamped asphalt at Gilbert Road entrance

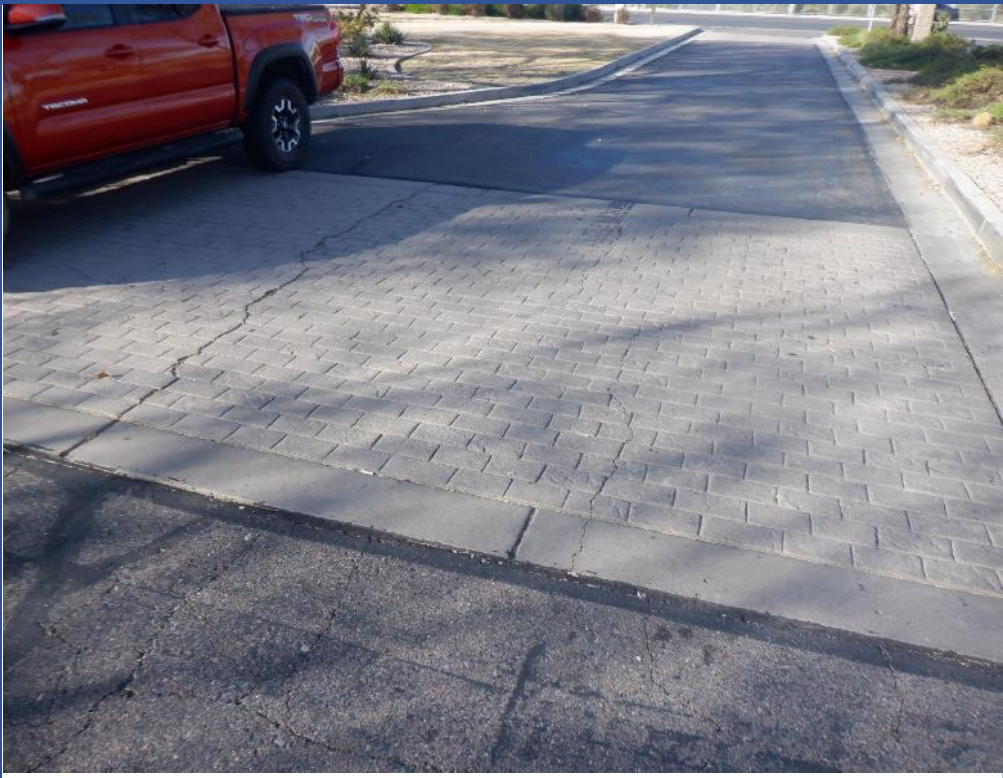
Deficiency - Cracks in stamped asphalt at Gilbert Road entrance

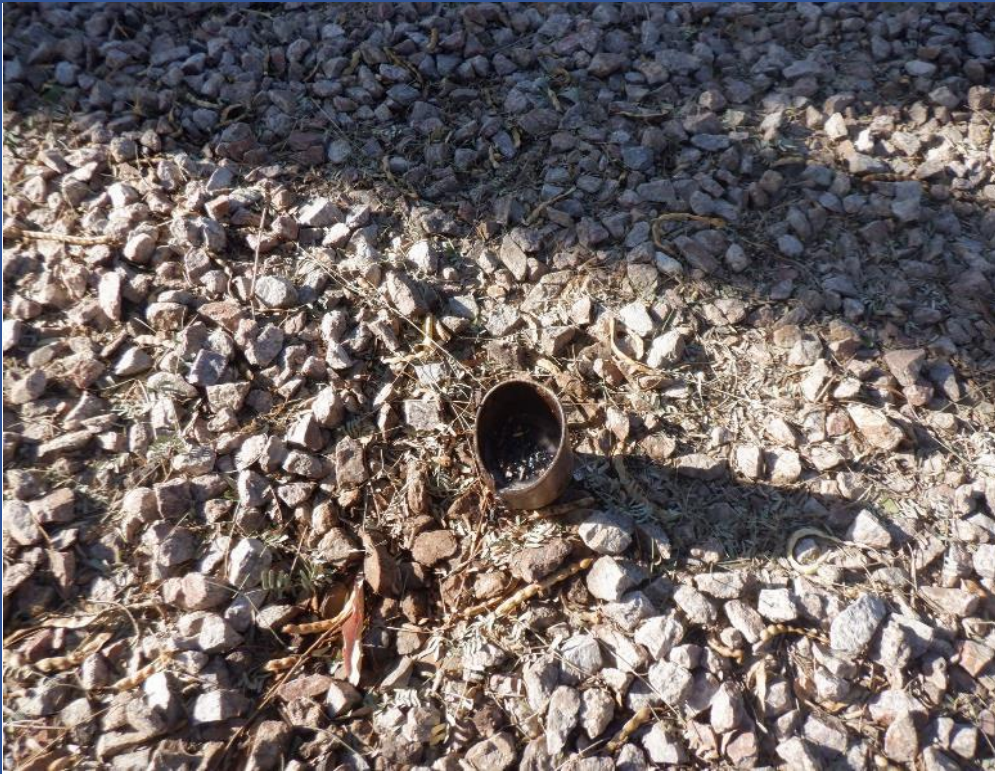
D3

Deficiency - Corroded and damaged landscape lighting

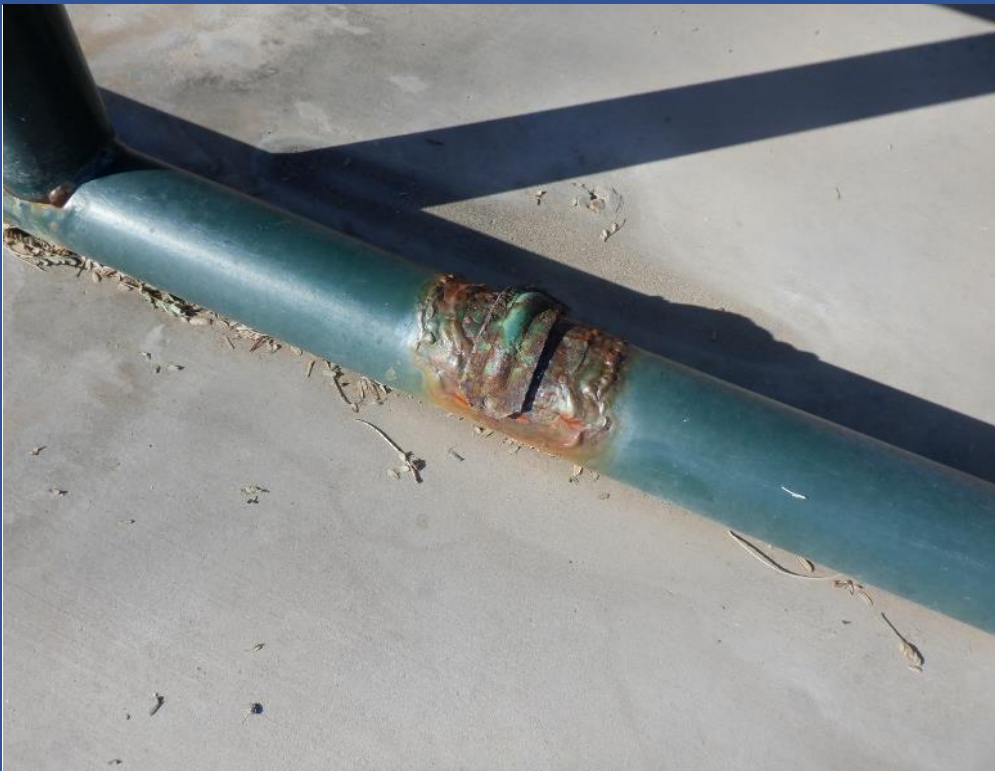
Deficiency - Corroded picnic table in Tract I

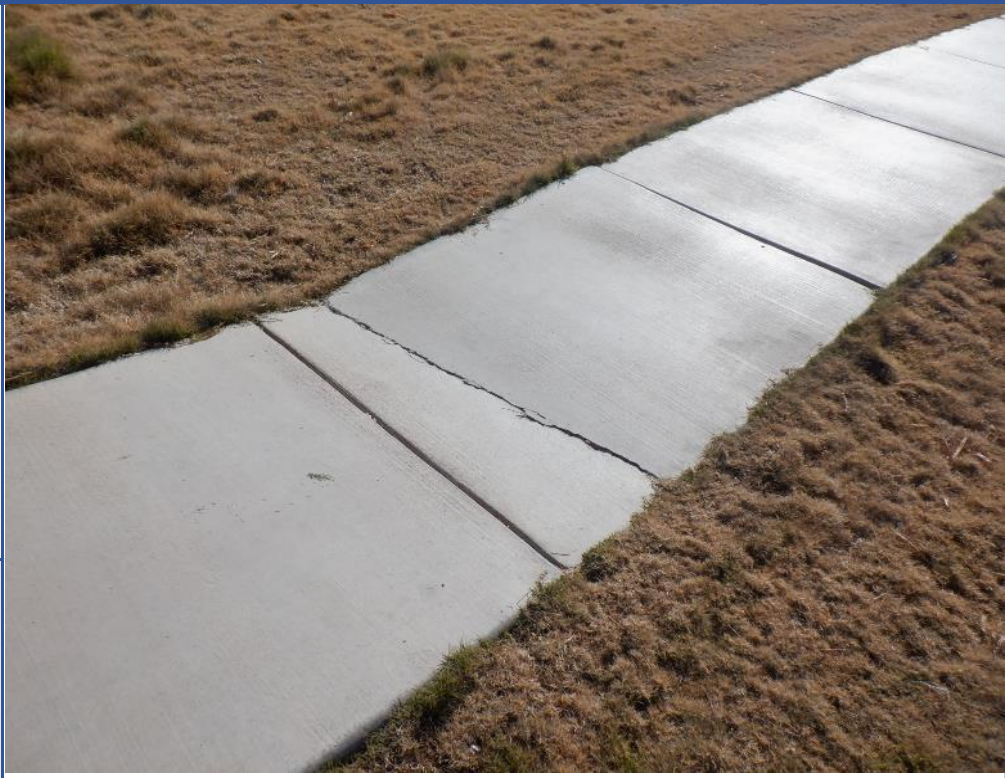
**D5**

Deficiency - Cracked and depressed concreted sidewalk in Tract I

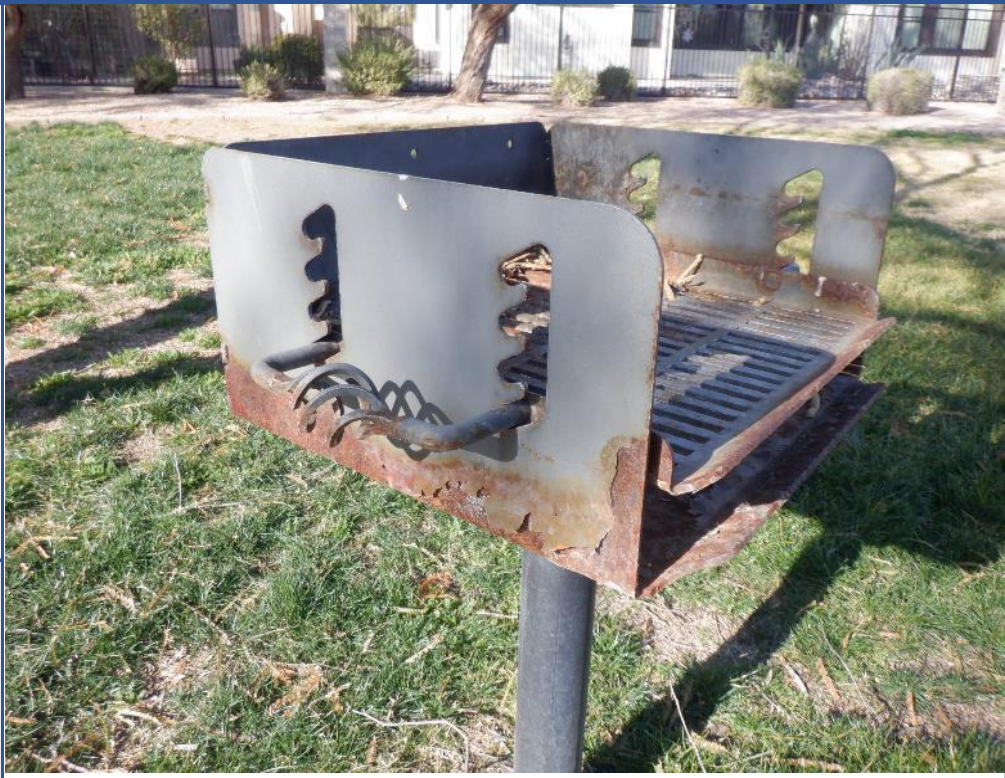
Deficiency - Corroded BBQ in Tract I

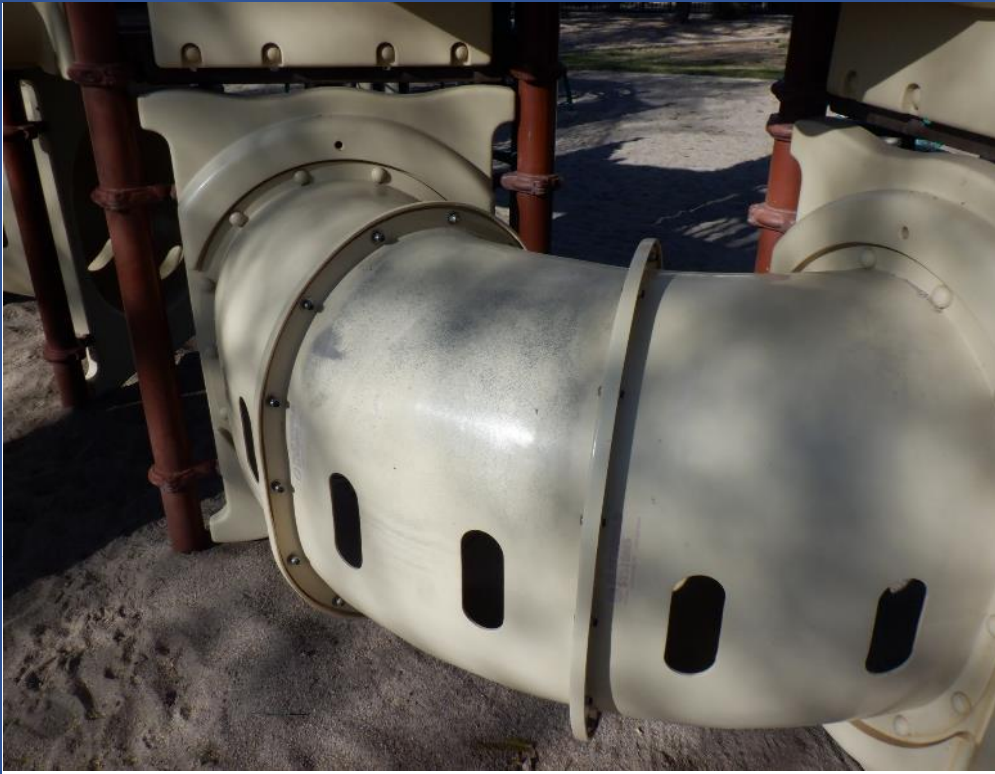
D7

Deficiency - Aging  
playground set

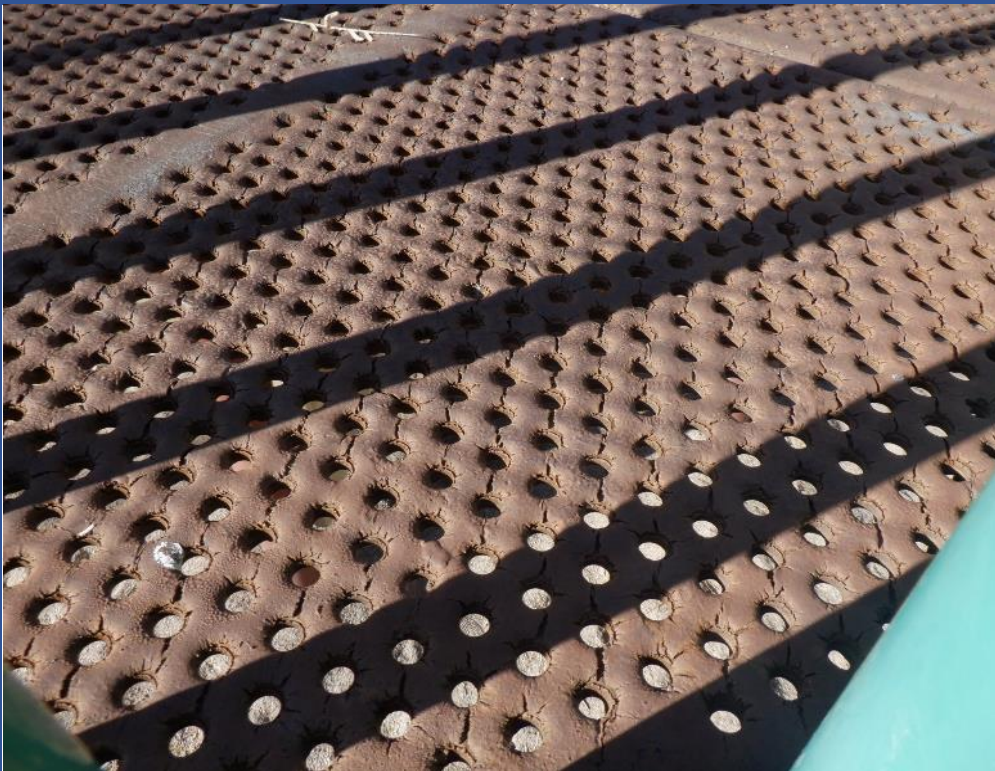
Deficiency - Corroded  
platform on playground  
set

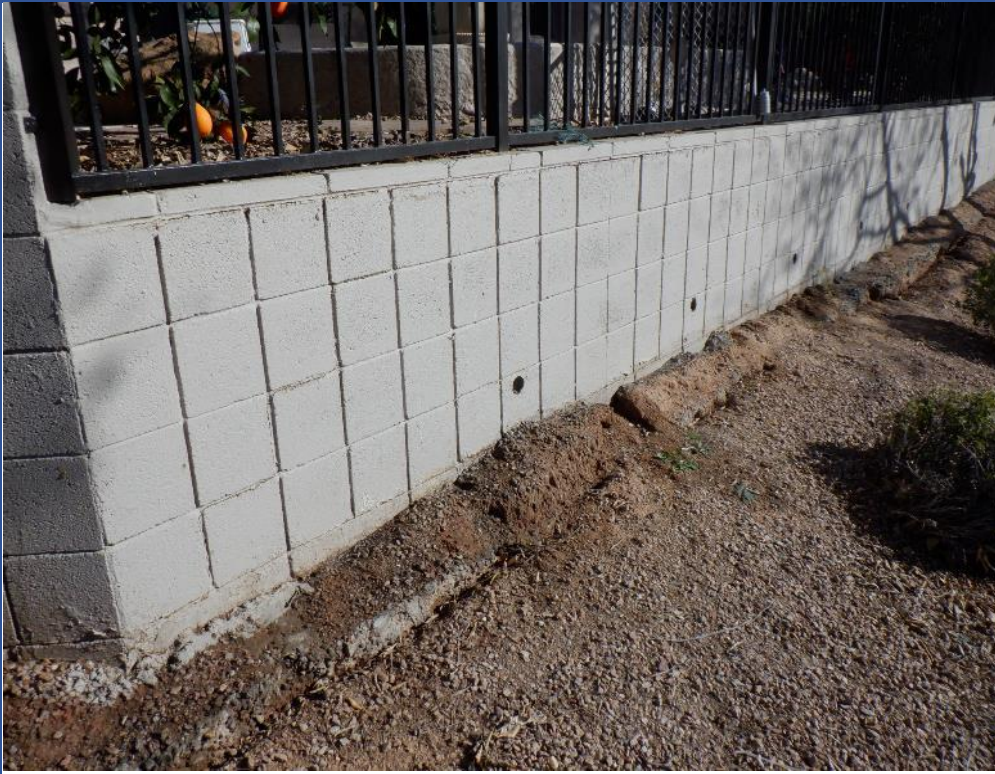
D9

The network of perimeter block walls and view fences throughout the property is in good to fair general condition. We noted a number of locates where significant erosion has exposed the wall footing/foundation – this should be inspected by a licensed engineering firm and then repaired by a qualified contractor using repair designs prepared and stamped by a licensed engineering firm.

Deficiency - Block wall exposed footing due to erosion

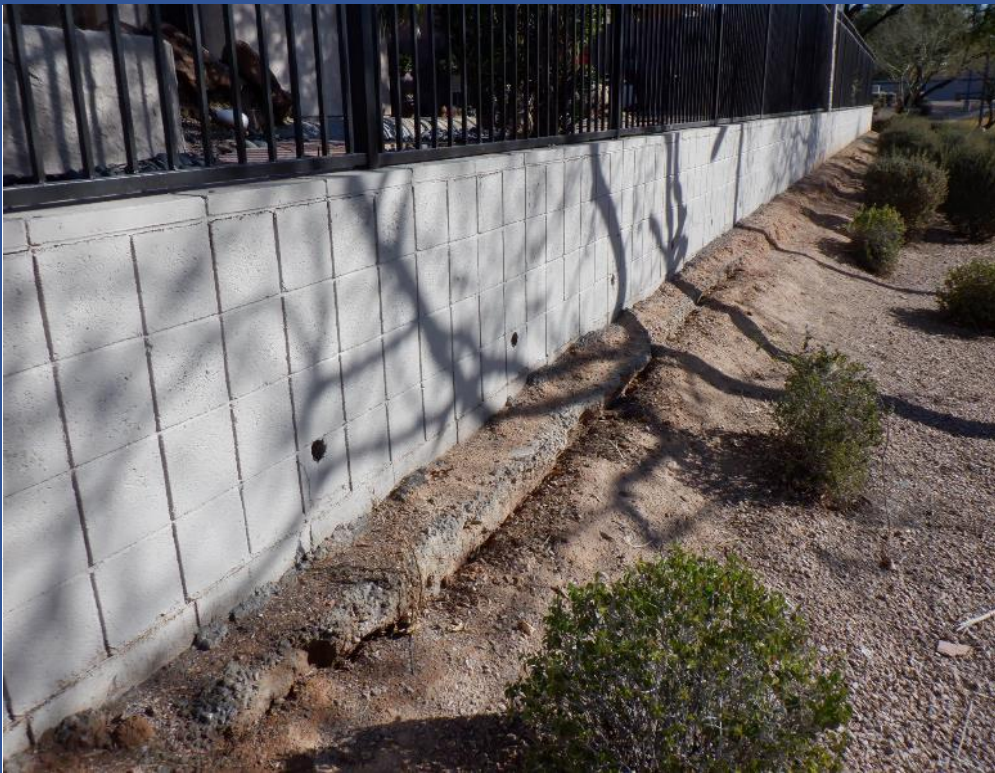
Deficiency - Block wall exposed footing due to erosion

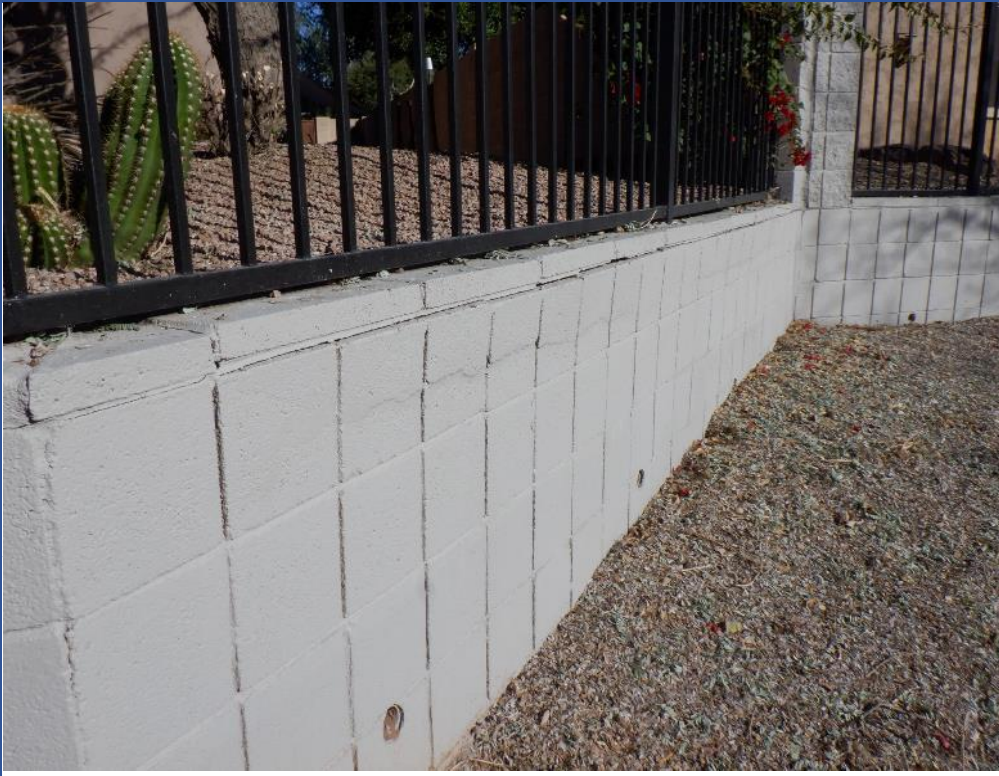
**D11**

Deficiency -  
Deteriorating block wall  
(top)

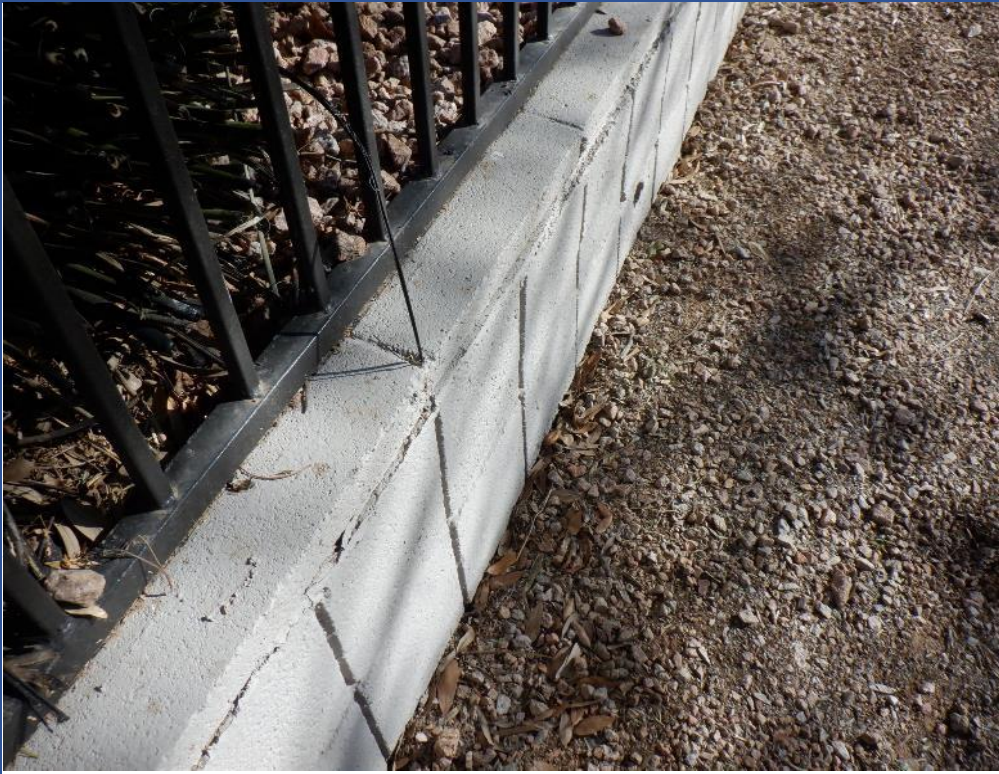
**D12**

Deficiency -  
Deteriorating block wall  
(top)

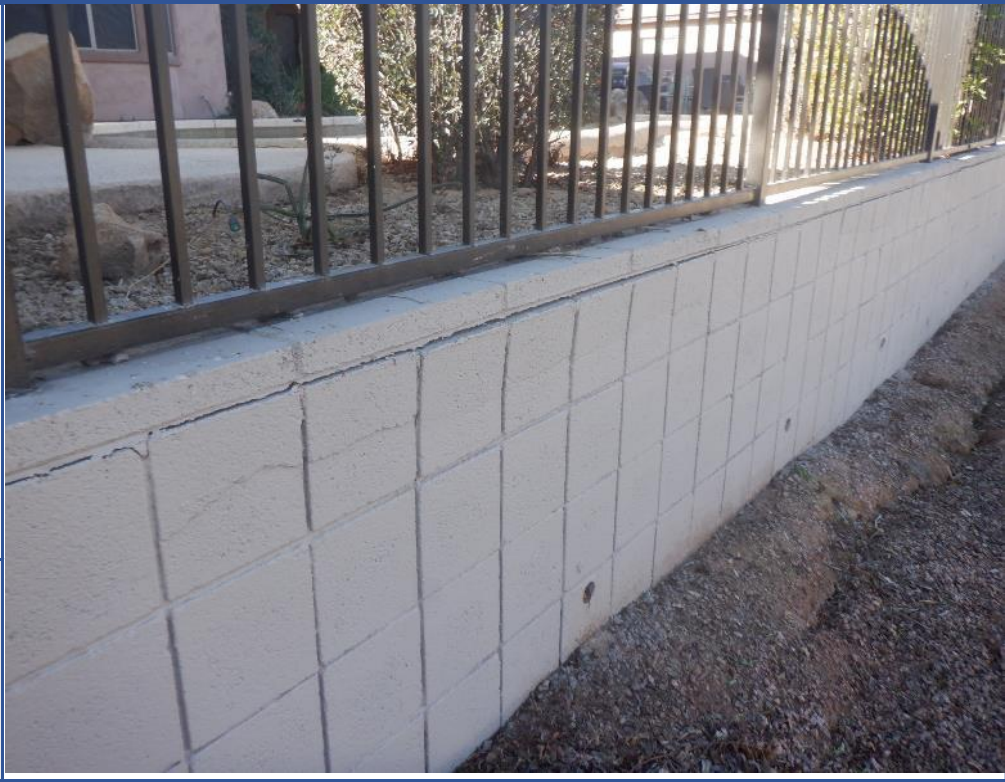
**D13**

Deficiency -  
Deteriorating block wall  
(top)

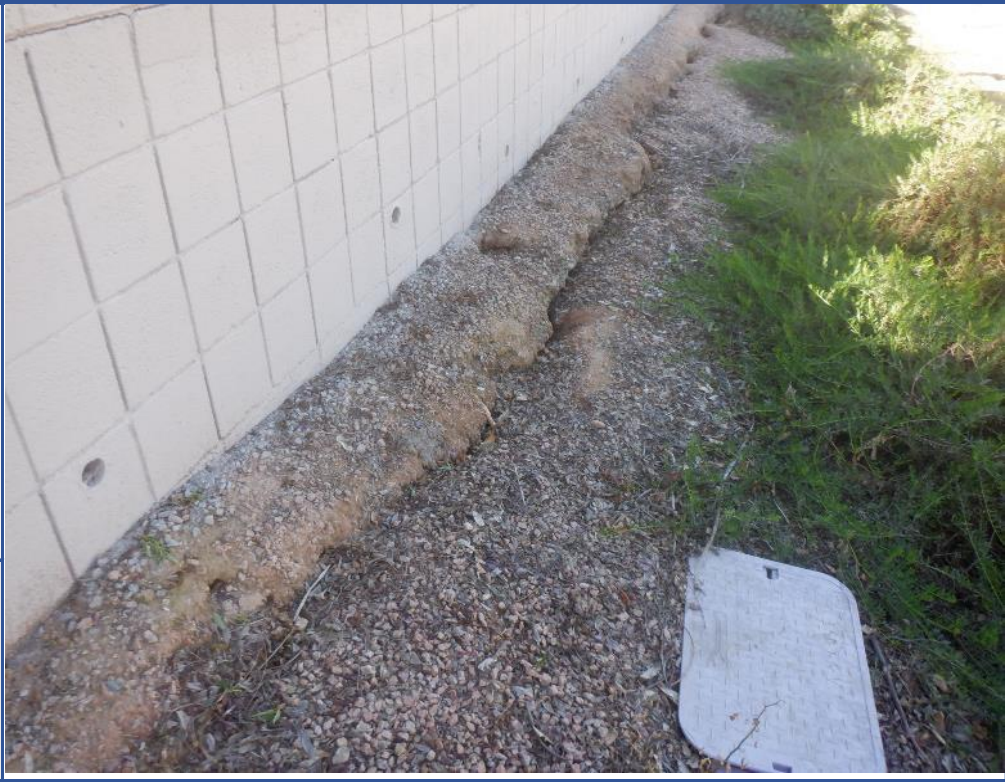
**D14**

Deficiency - Block wall  
exposed footing due to  
erosion

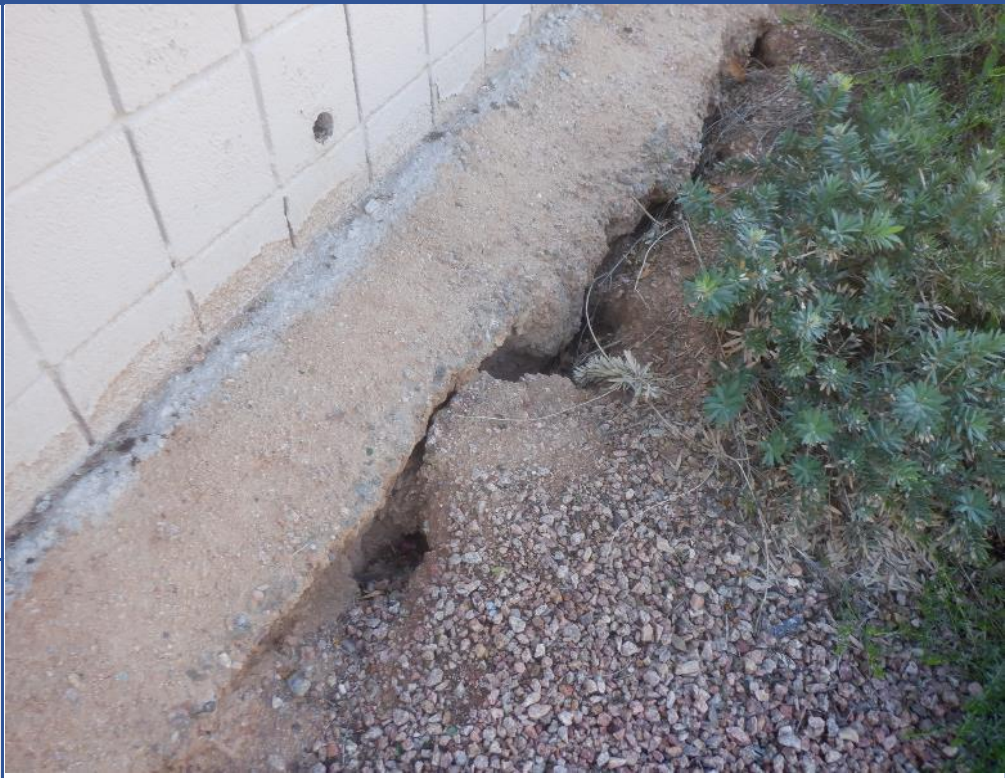
**D15**

Deficiency - Block wall exposed footing due to erosion

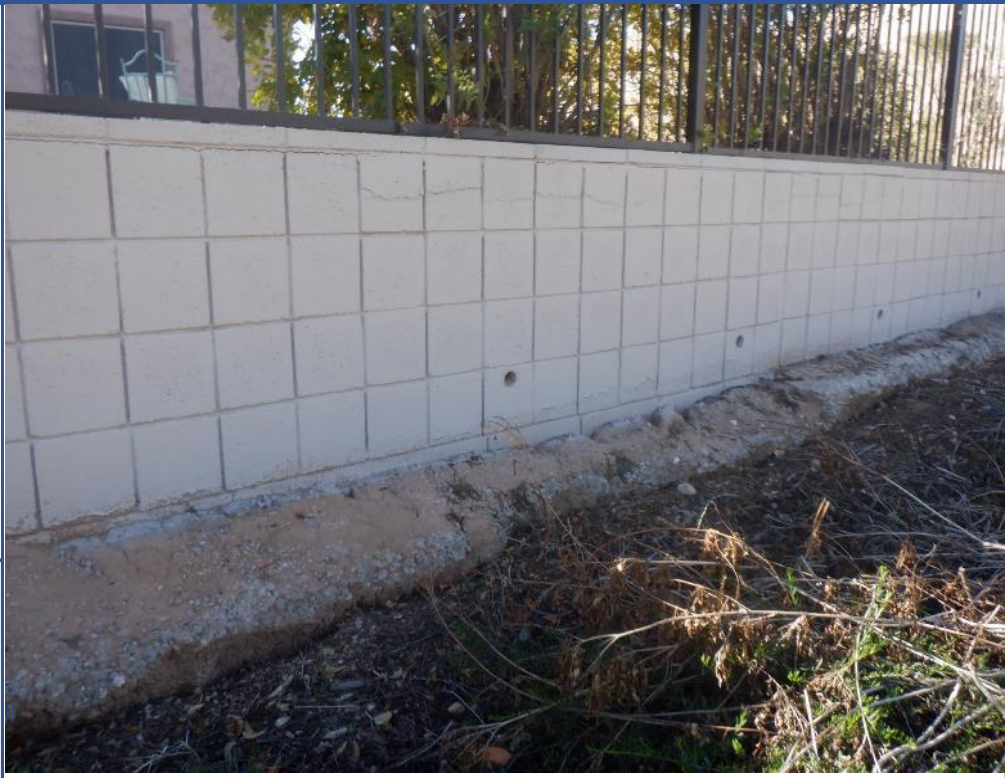
Deficiency - Block wall exposed footing due to erosion

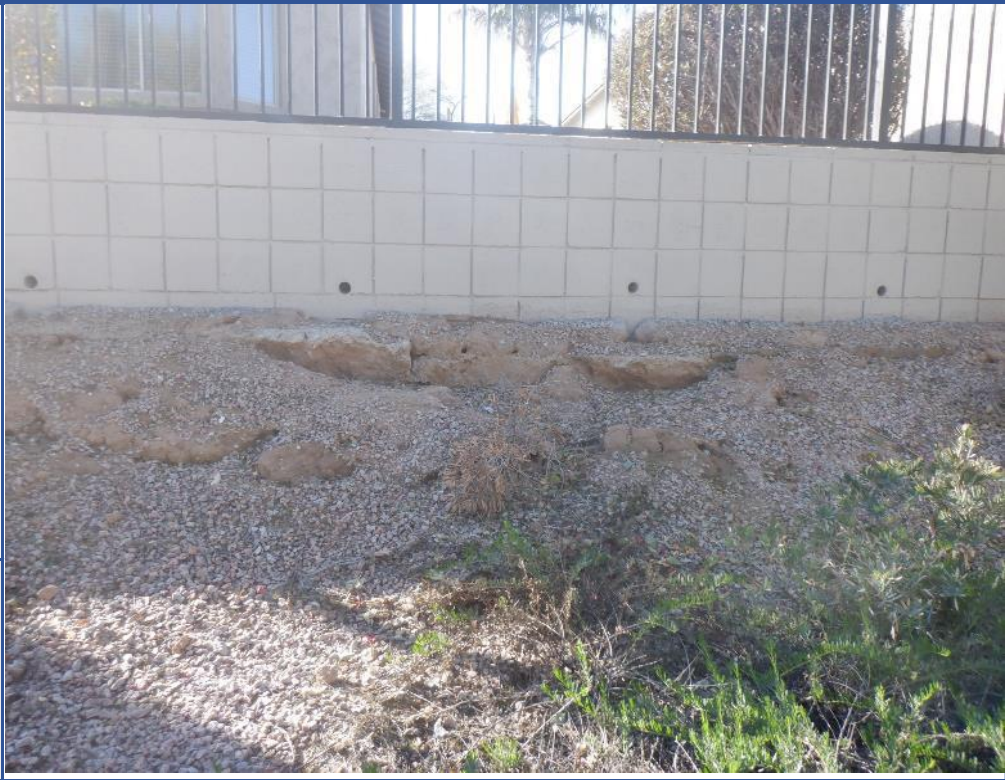
**D17**

Deficiency - Block wall exposed footing due to erosion

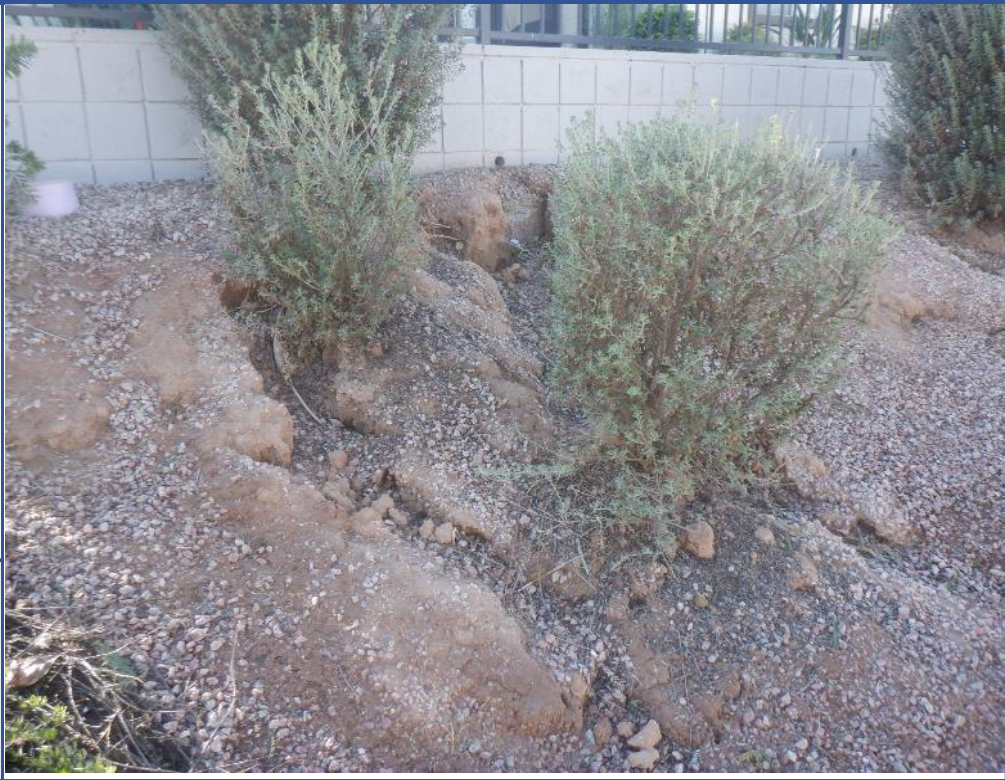
Deficiency - Significant erosion adjacent to block walls

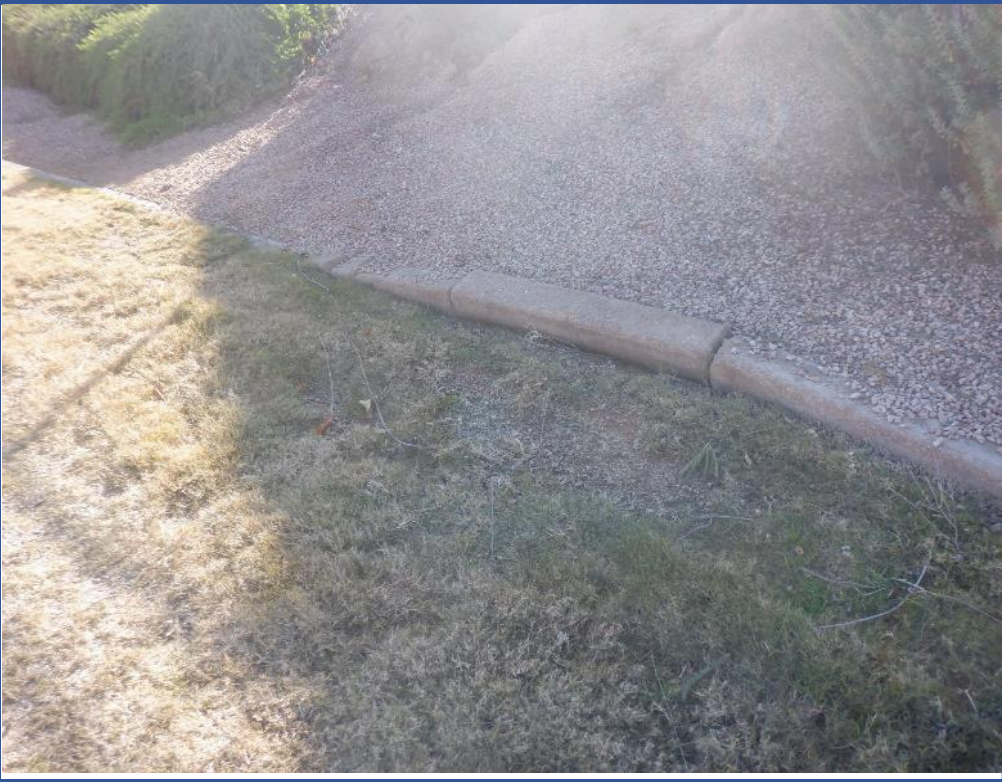
**D19**

Deficiency - Damaged landscape curbing

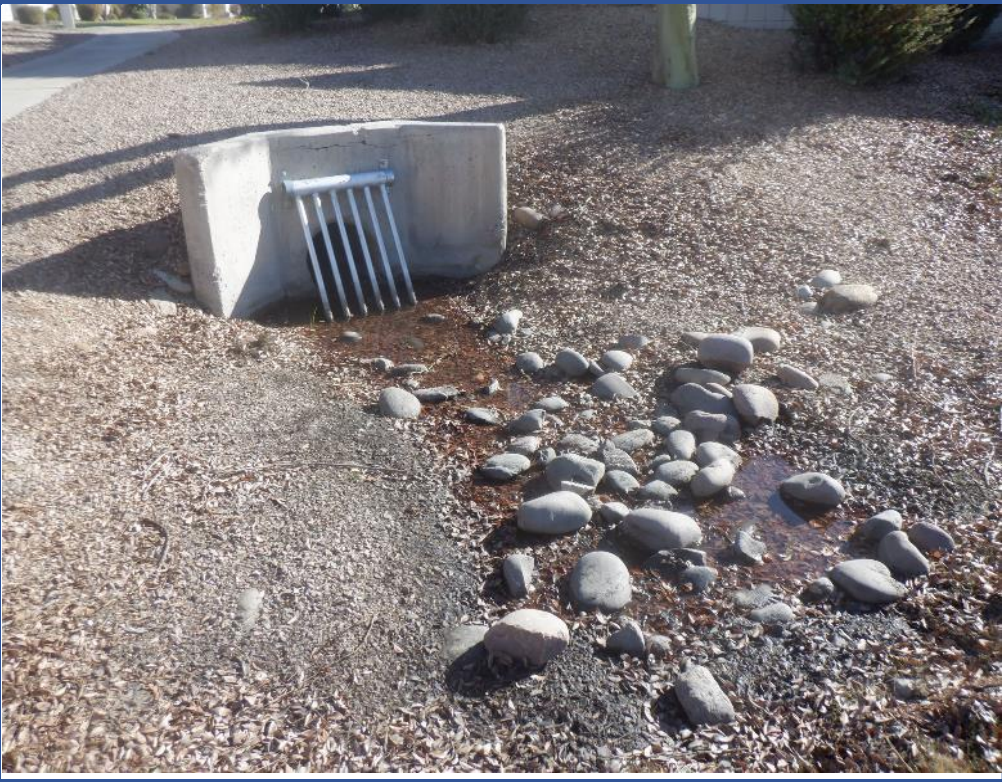
**D20**

Deficiency - Drainage culvert not draining

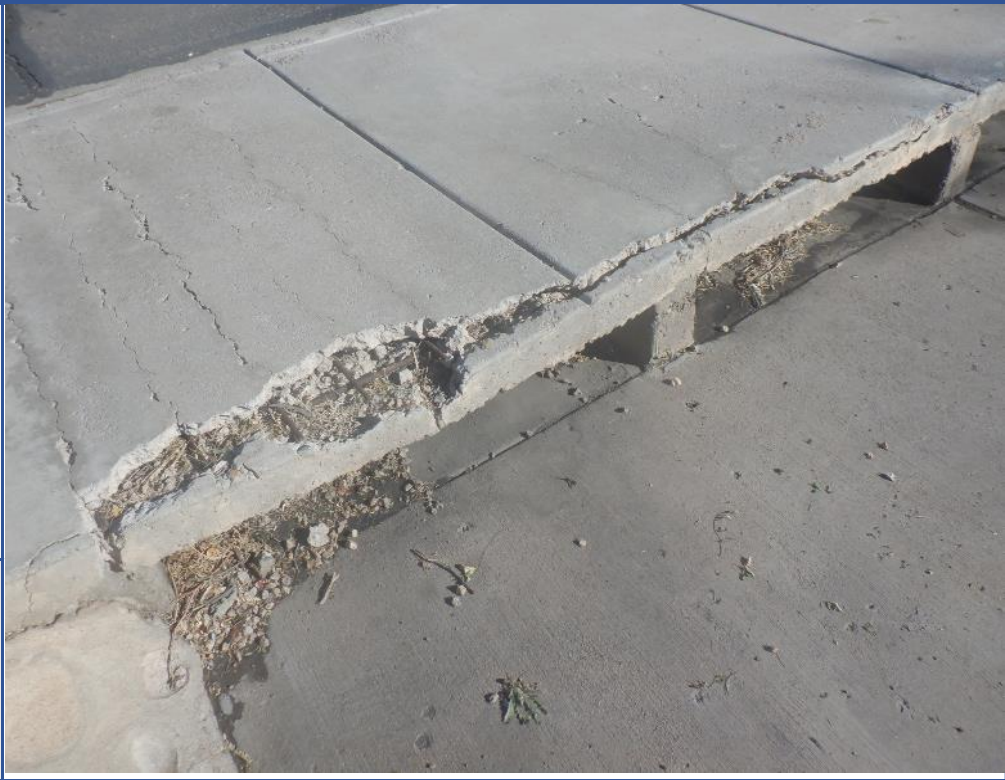
**D21**

The network of sidewalks and other walkways providing pedestrian routes across the property is in good general condition, although there are several areas that should be repaired and one located adjacent to a drainage culvert was identified to the community manager through an e-mail on January 16, 2024 as being a potential safety hazard and requires repair.

Deficiency - Damaged sidewalk and concrete drainage culvert - potential safety issue

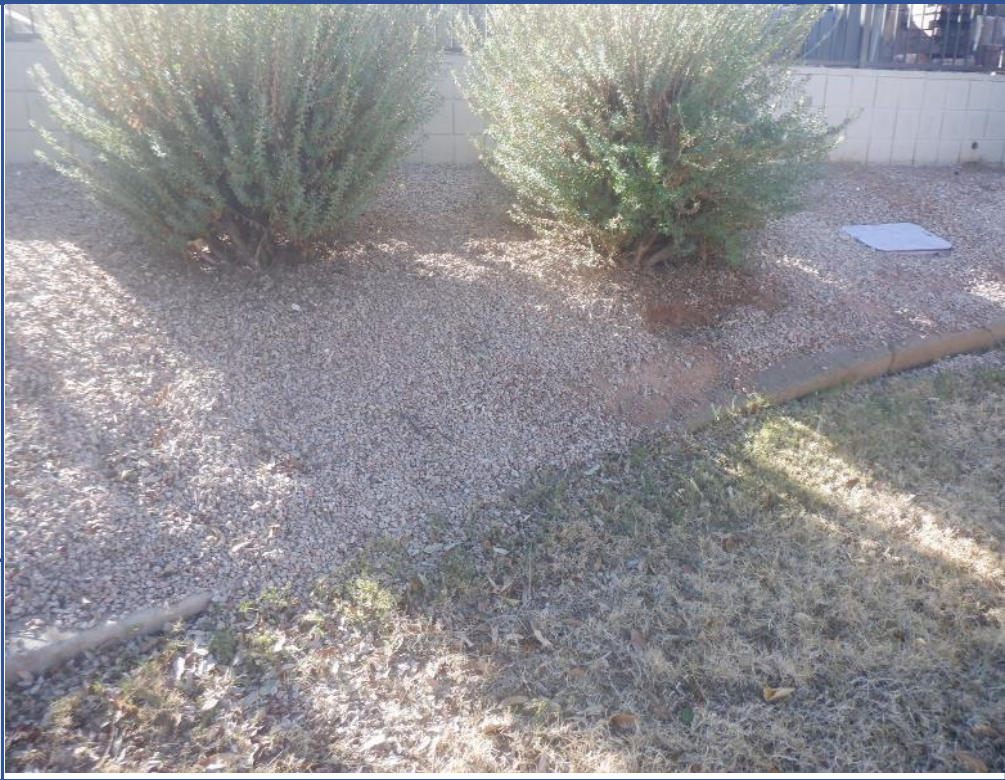
Deficiency - Damaged landscape curbing and erosion

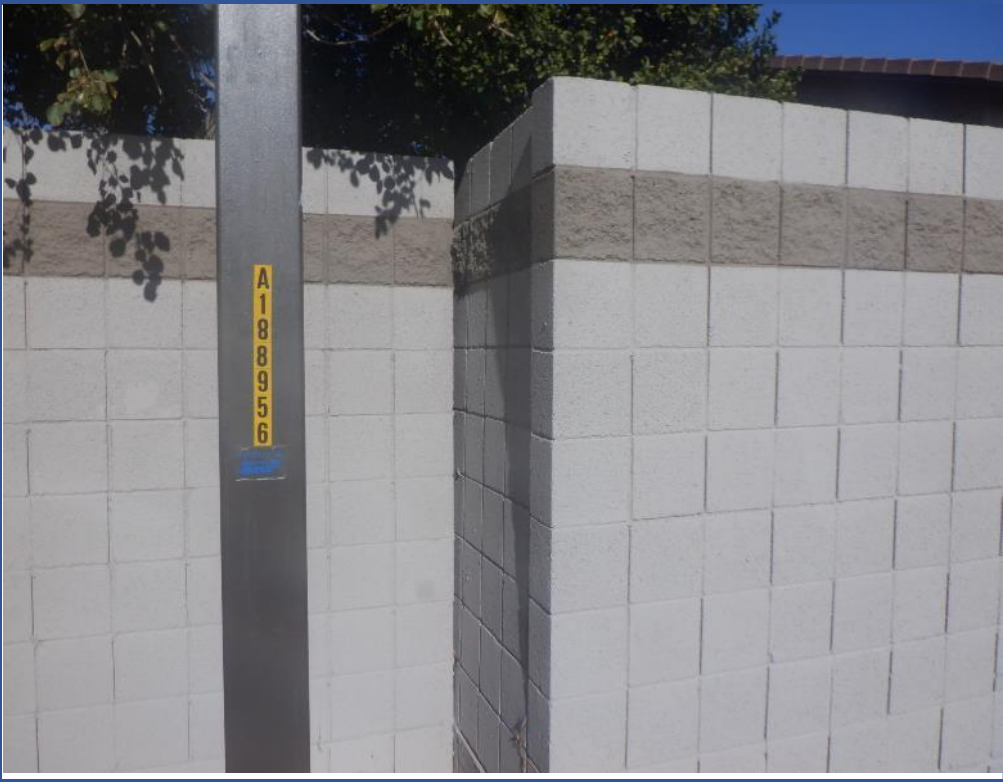
**D23**

Deficiency - Leaning block wall

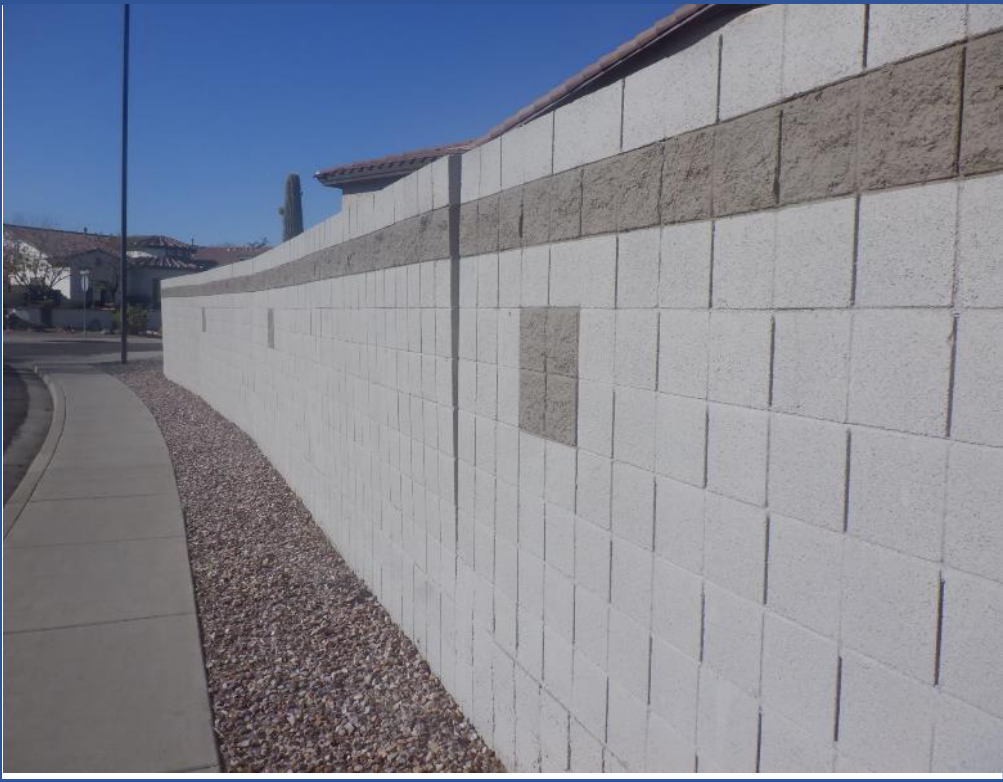
**D24**

Deficiency - Leaning block wall

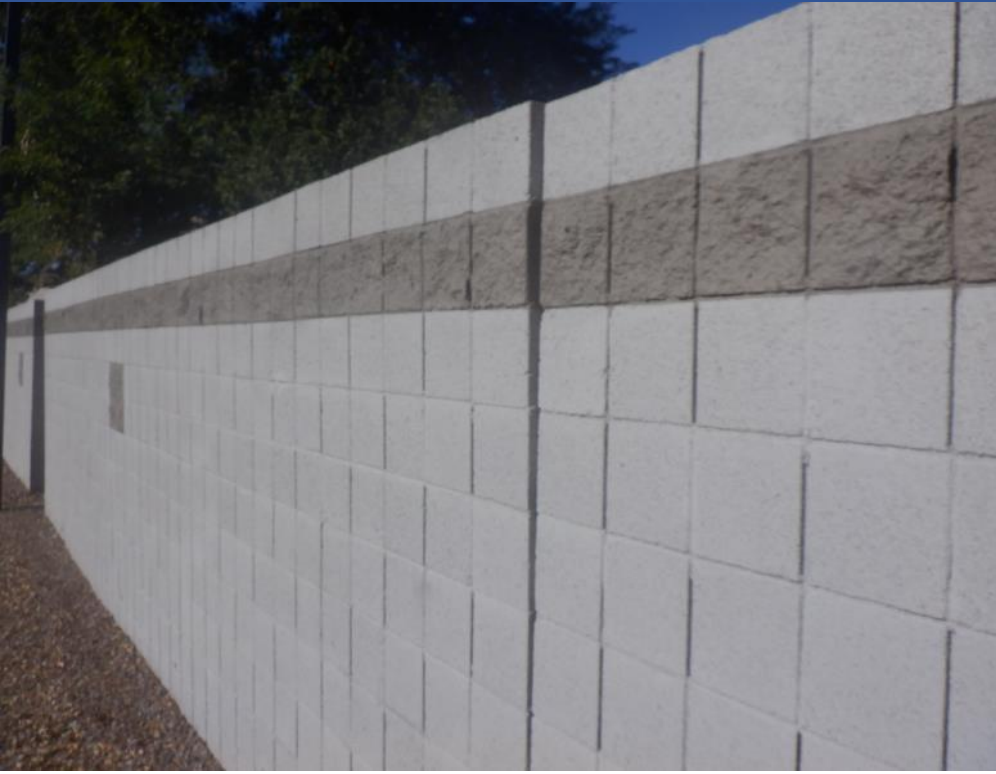
D27

Deficiency - Leaning  
block wall

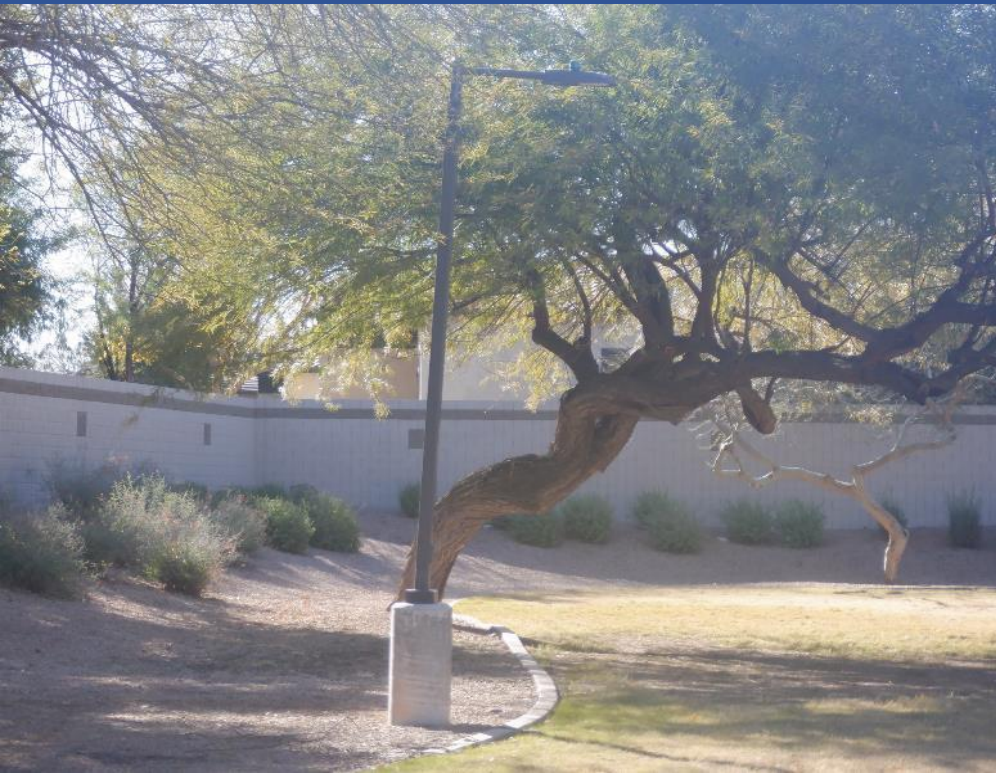
The interior street lights and those located in the greenbelts and retention basins around the community appear to be the responsibility of SRP (Salt River Project). We did not observe the lights at night. Several of the lights are leaning and SRP should be contacted to make repairs.

Deficiency - Pole light  
leaning (this actually  
belongs to SRP)

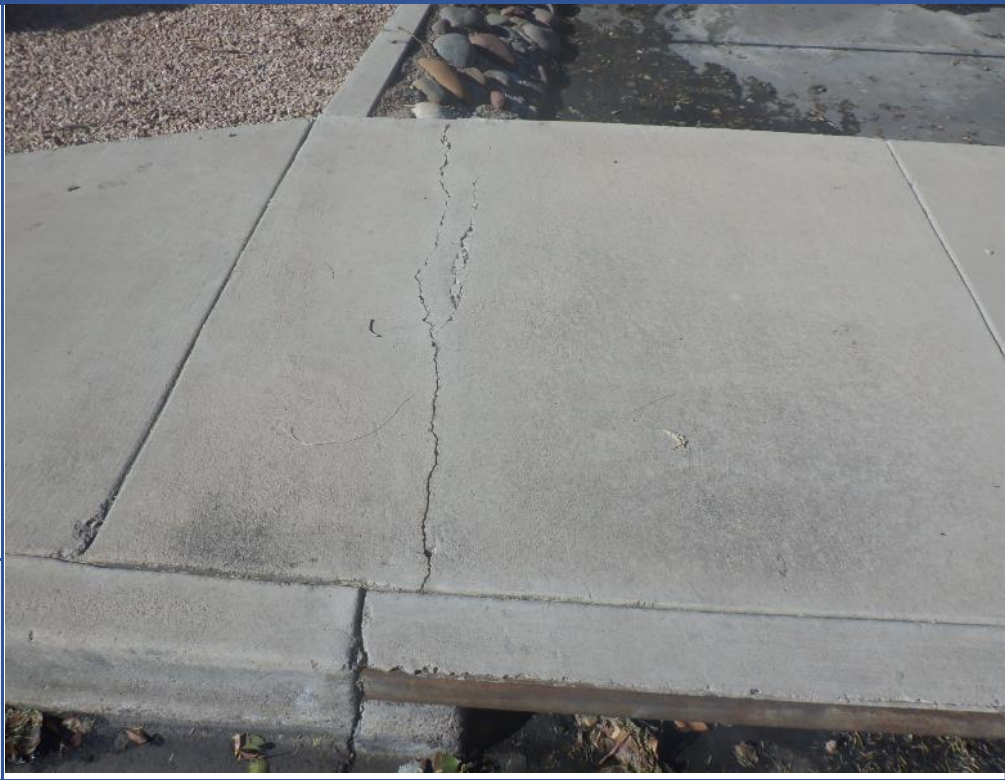
**D31**

Deficiency - Cracked sidewalk
