February 29, 2024 R1

**PROPERTY:** MESQUITE GROVES ESTATES  
CHANDLER, ARIZONA

**SERVICE:** FULL RESERVE FUND ANALYSIS

**ATTACHMENT:** 23-0446 – FINAL REPORT

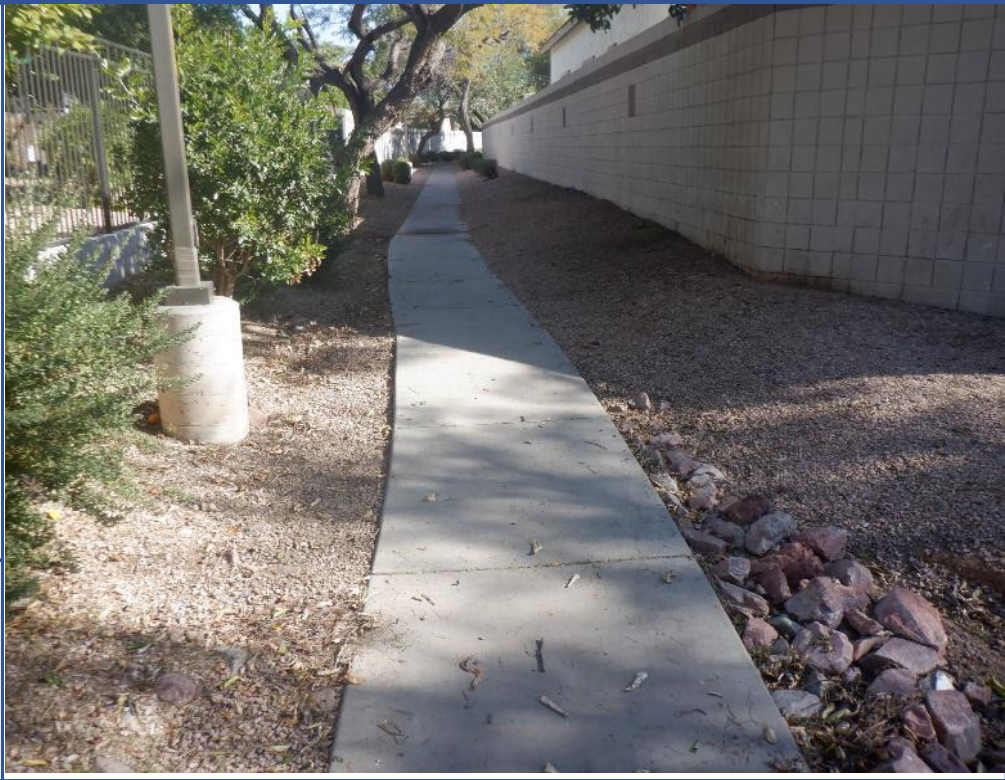
Deficiency - Water management issues; requires repair

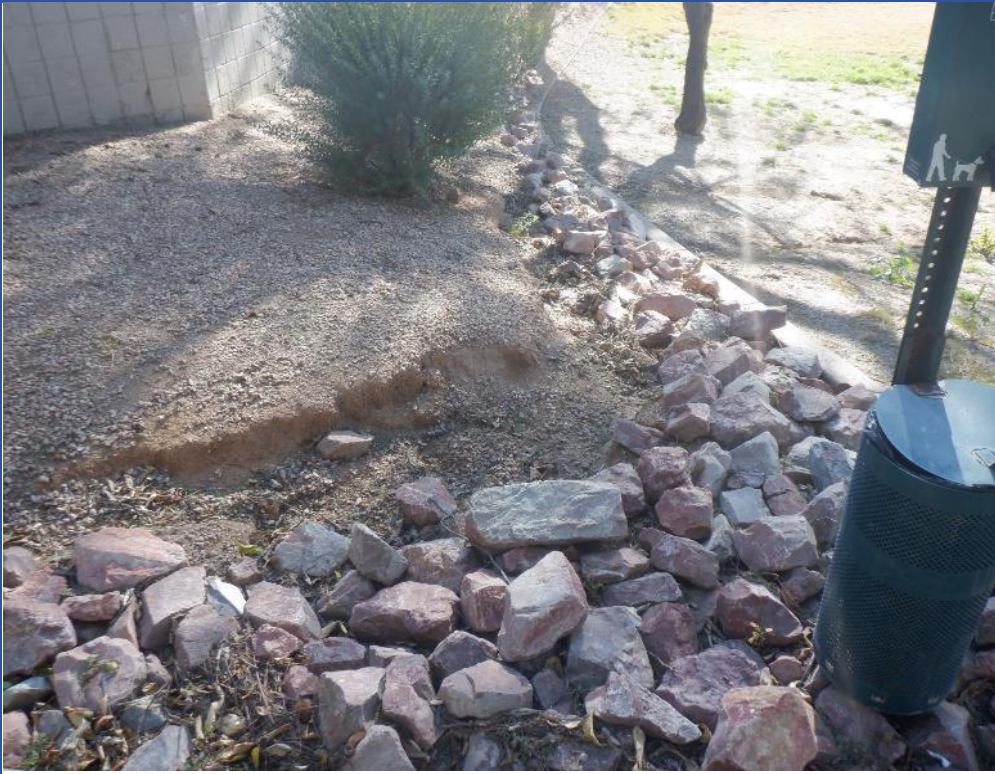
D33

Deficiency - Water management issues; requires repair

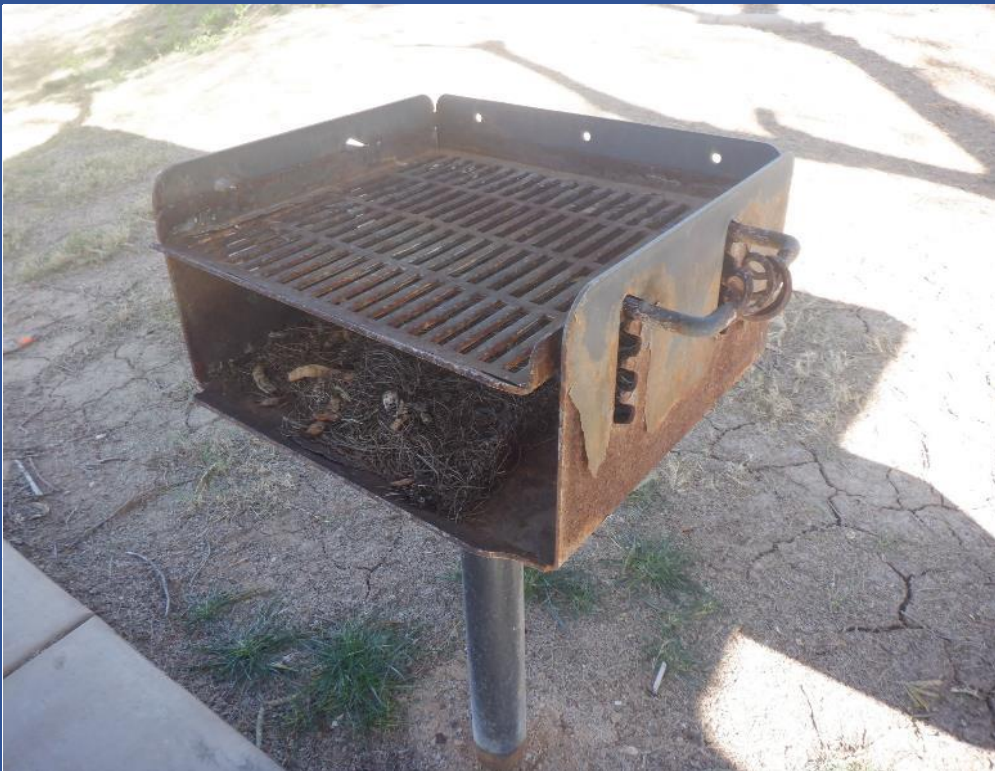
Deficiency - Corroded BBQ

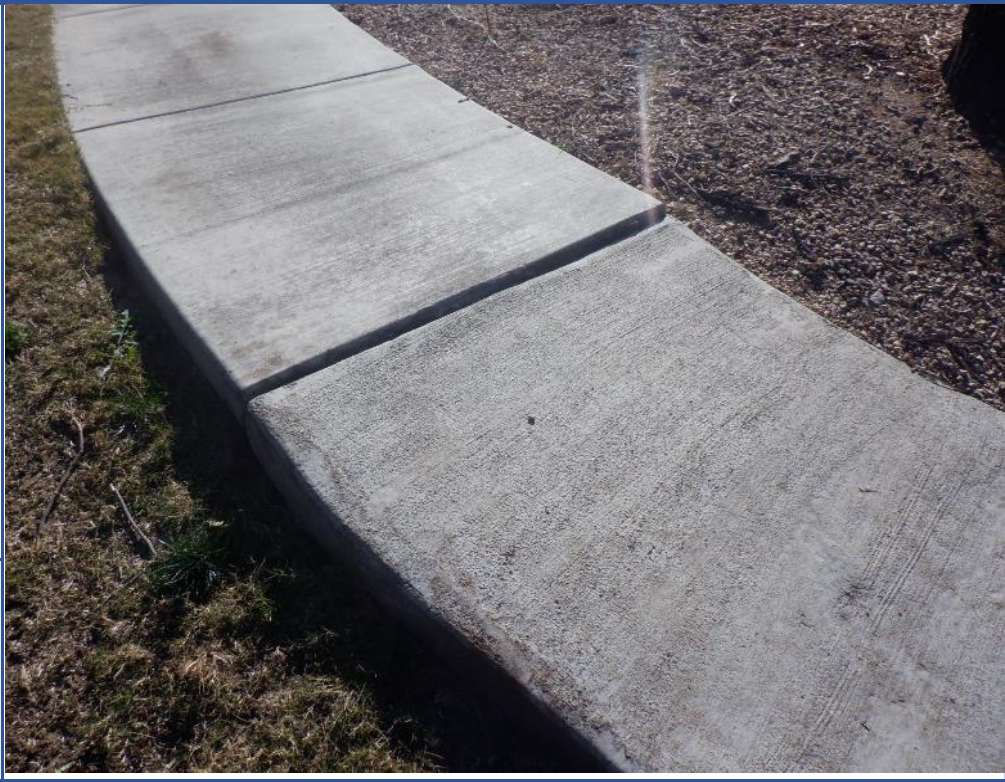
PHOTO NUMBER  
**D35**

Deficiency - Trip hazard on concrete sidewalk in Tract E

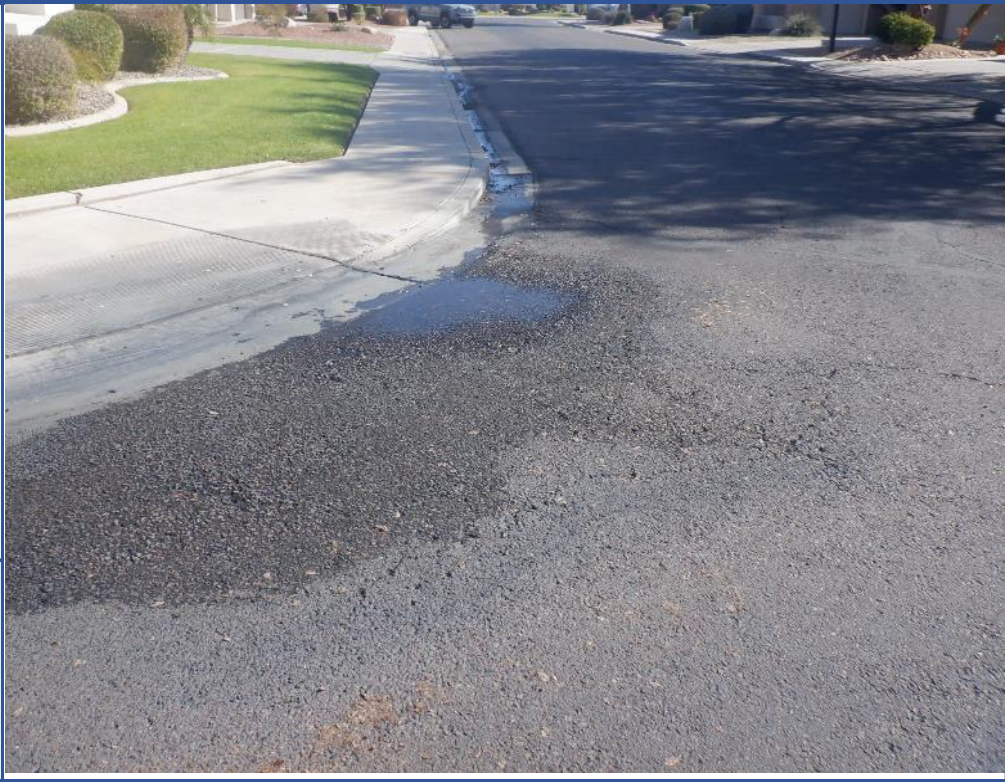
PHOTO NUMBER  
**D36**

Deficiency - Standing water on asphalt; Aquarius and Rincon

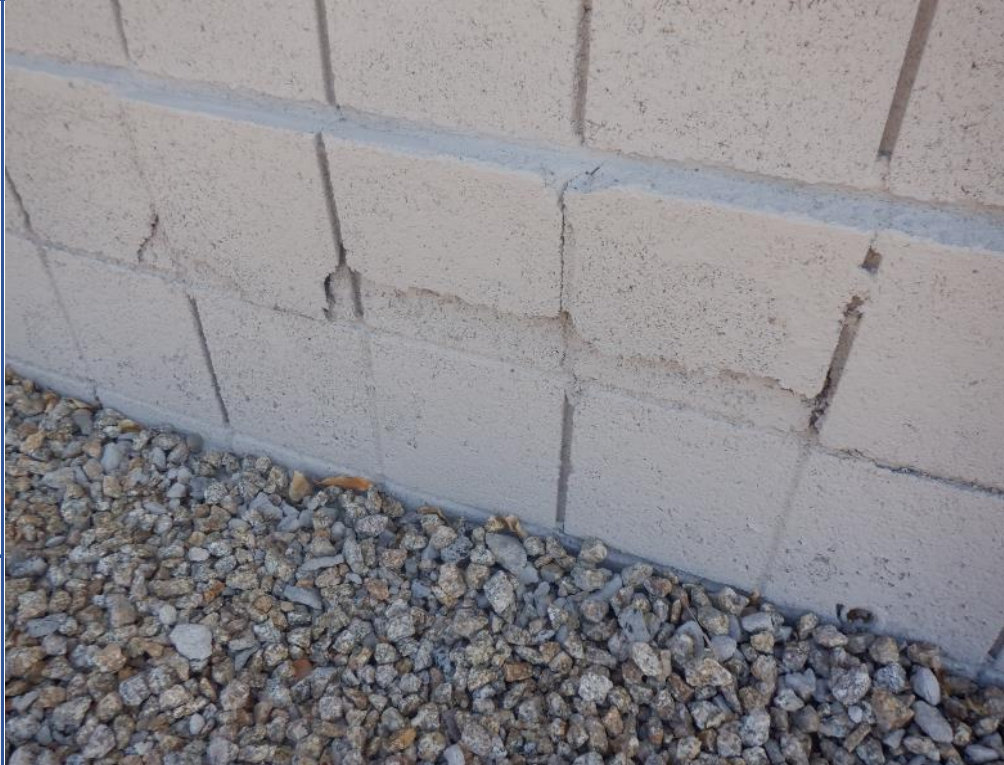
<p><b>Description:</b></p> <p>Deficiency - Wall deterioration and leaning</p>
<p><b>D38</b></p>
