February 29, 2024 R1

**PROPERTY:** MESQUITE GROVES ESTATES  
CHANDLER, ARIZONA

**SERVICE:** FULL RESERVE FUND ANALYSIS

**ATTACHMENT:** 23-0446 – FINAL REPORT

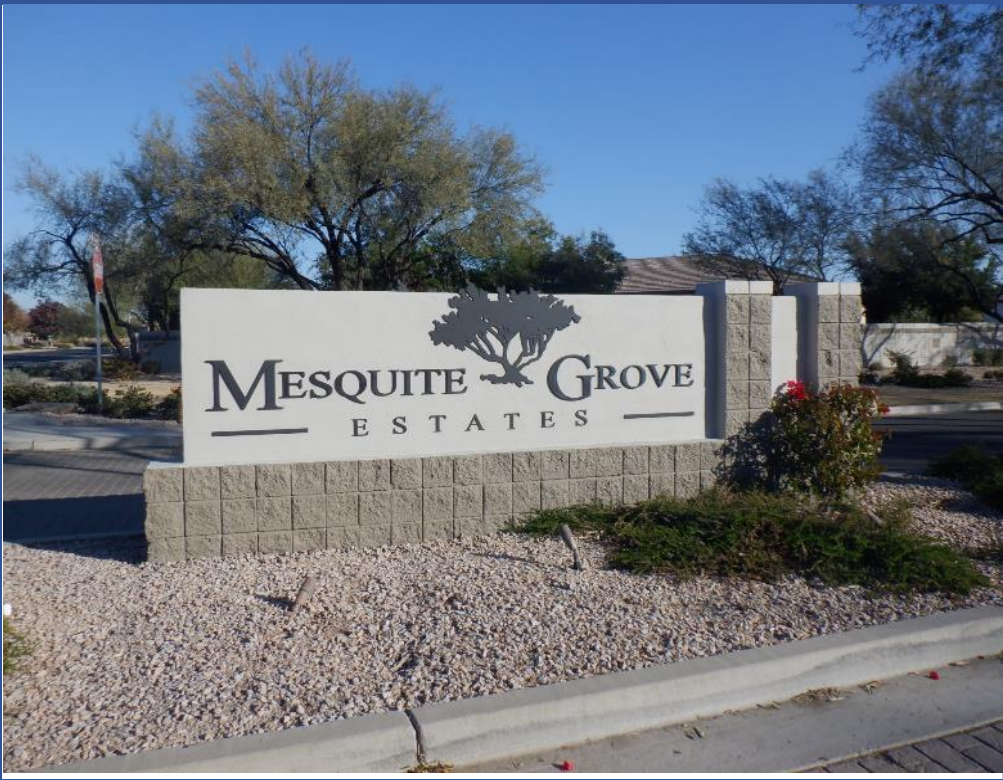
Entrance Monument  
Sign - Gilbert Road

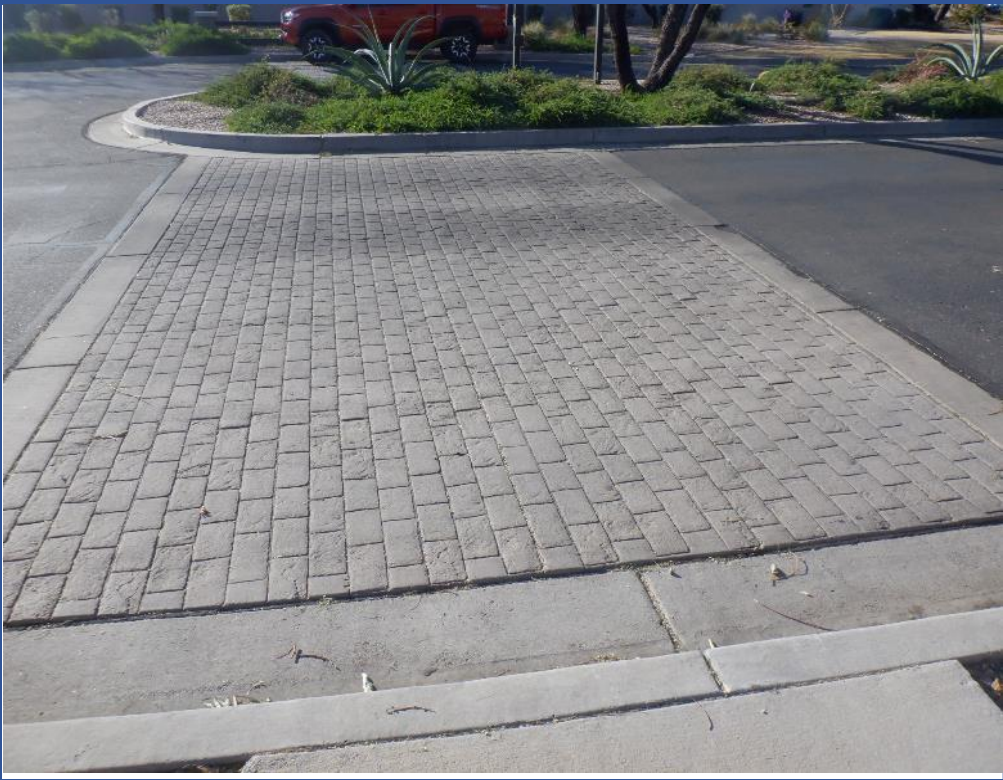
Stamped asphalt -  
Gilbert Road entrance

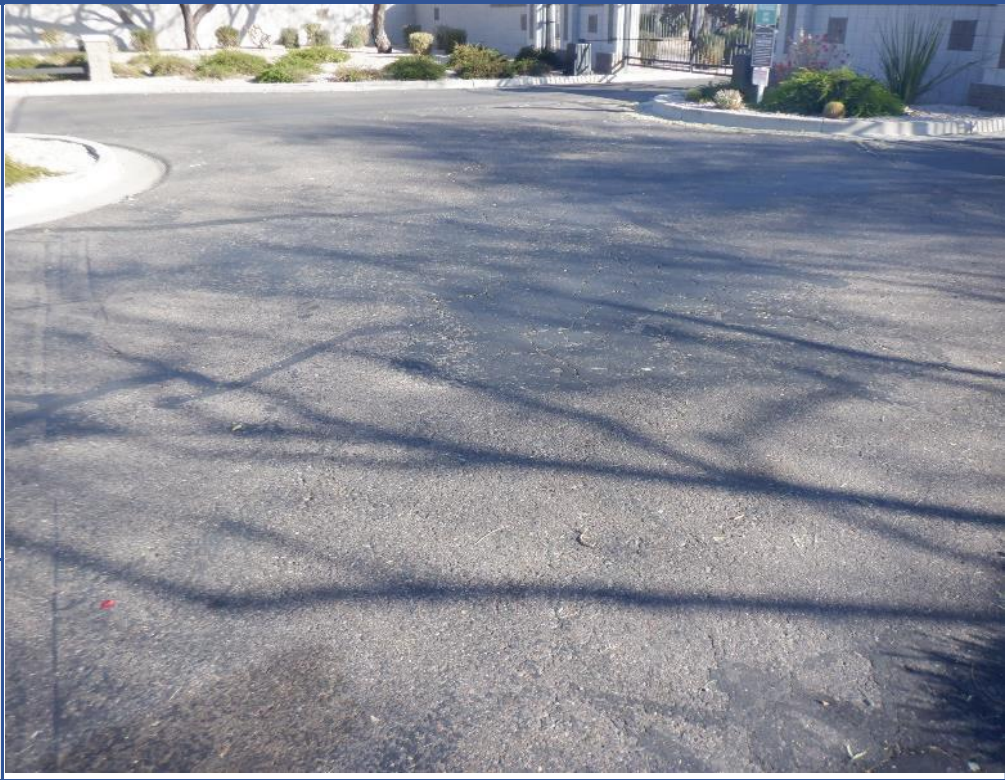
Gilbert Road entrance

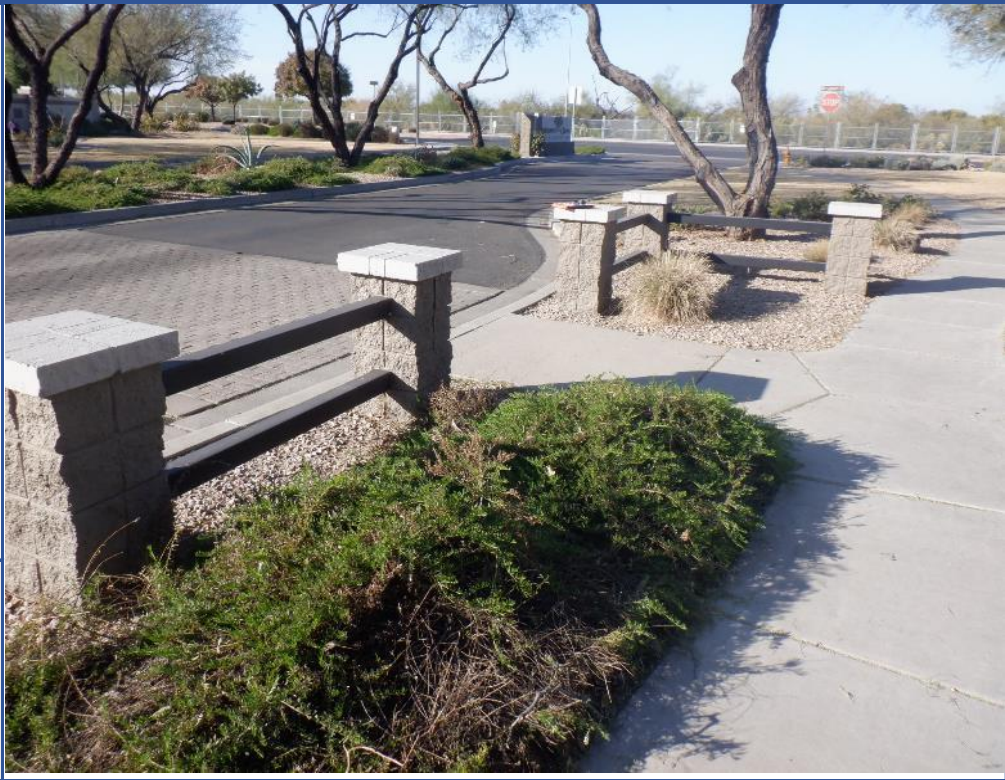
Decorative elements / landscaping at entrance

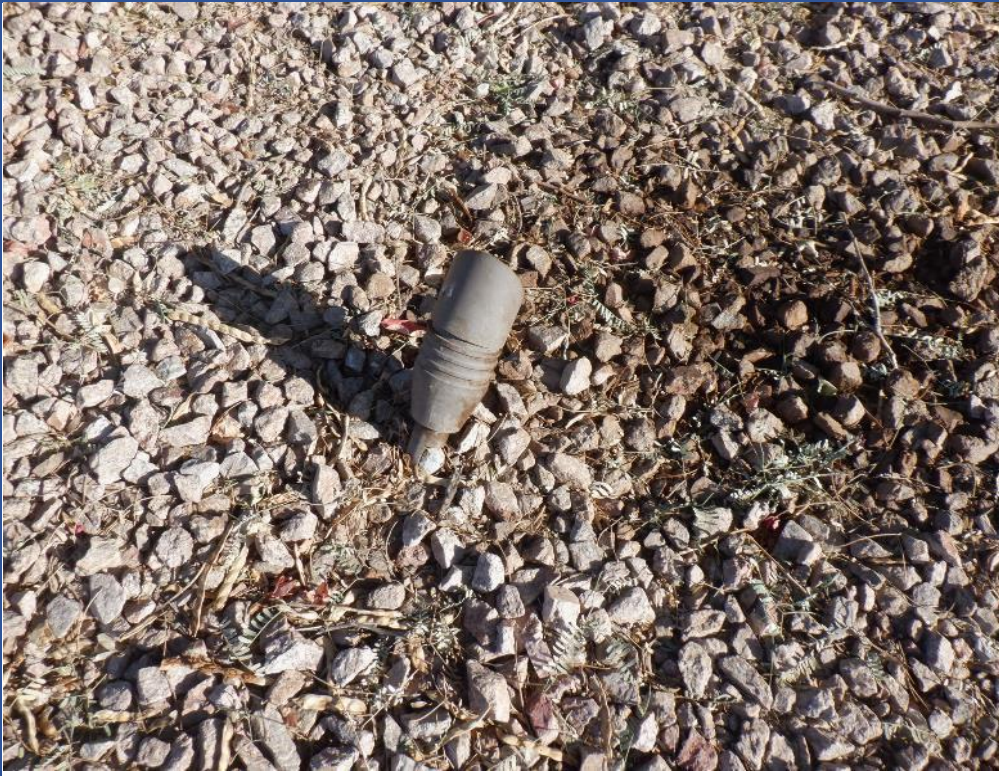
Landscape lighting

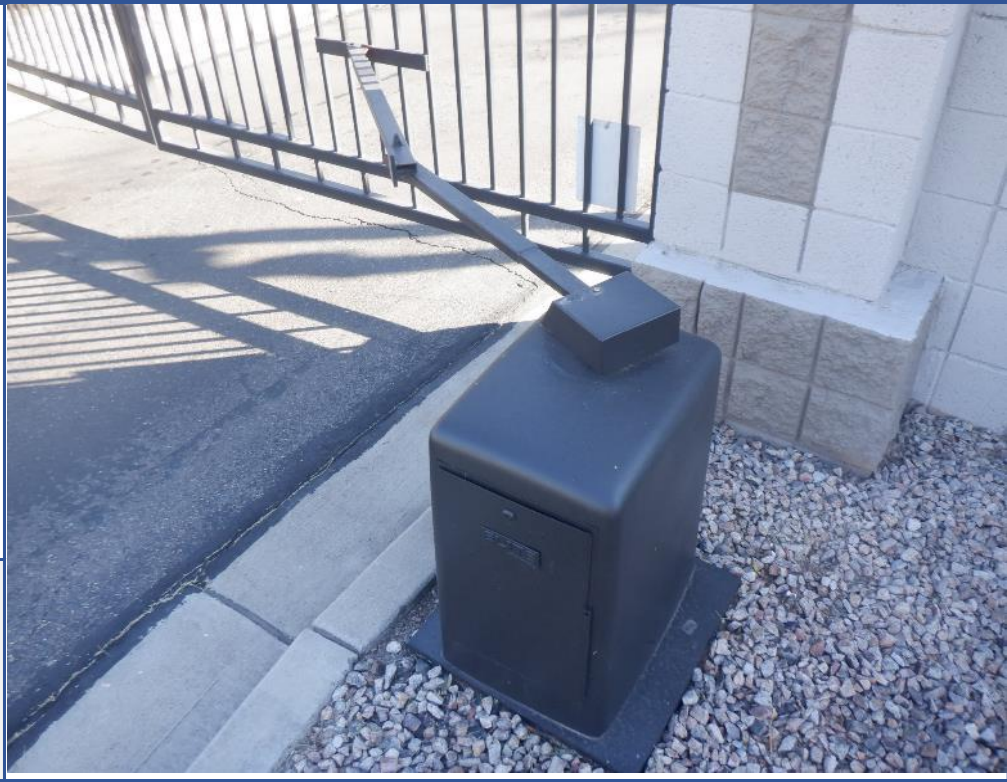
7

Gate operator at Gilbert Road entrance

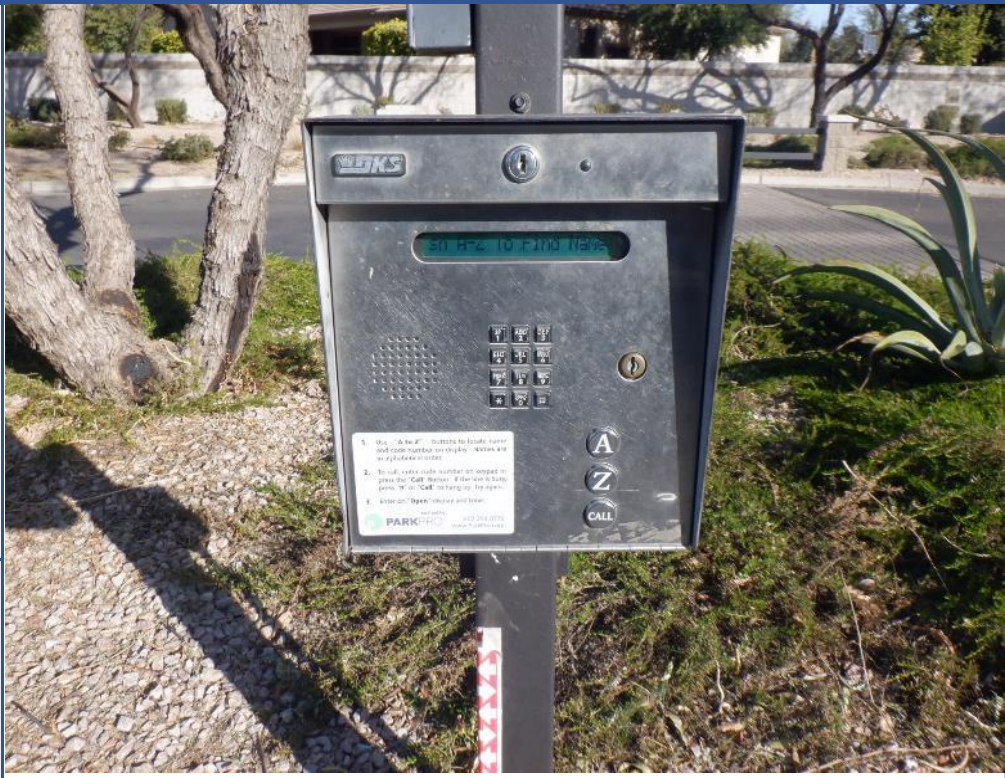
Access control system  
Gilbert Road entrance

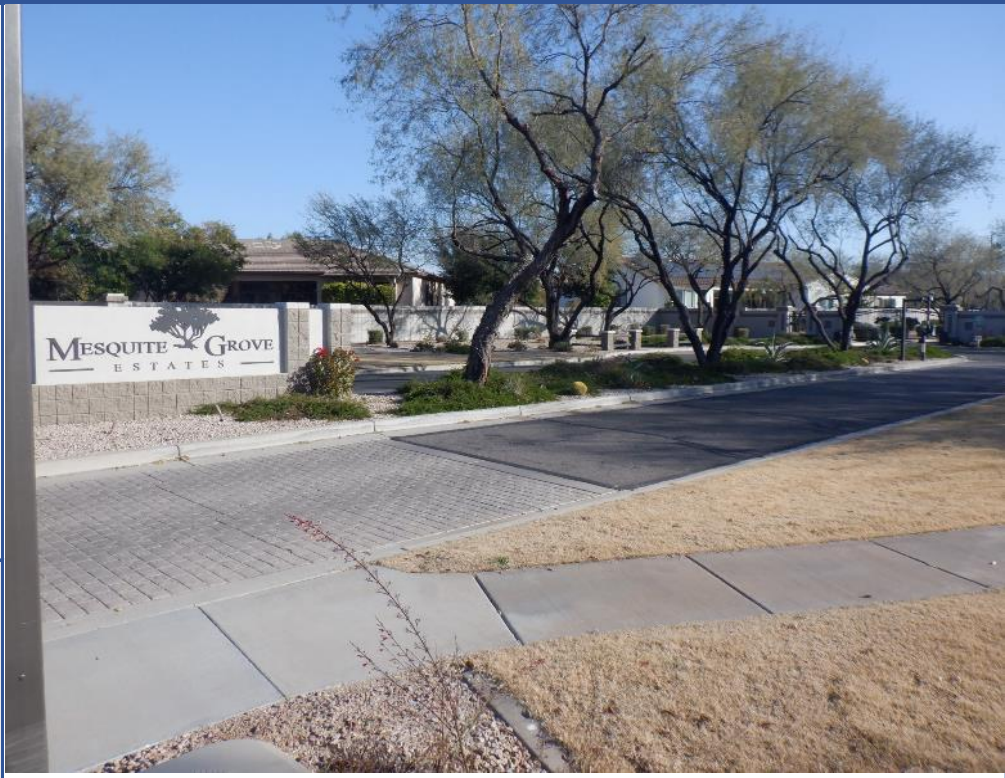
Overview of Gilbert  
Road entrance

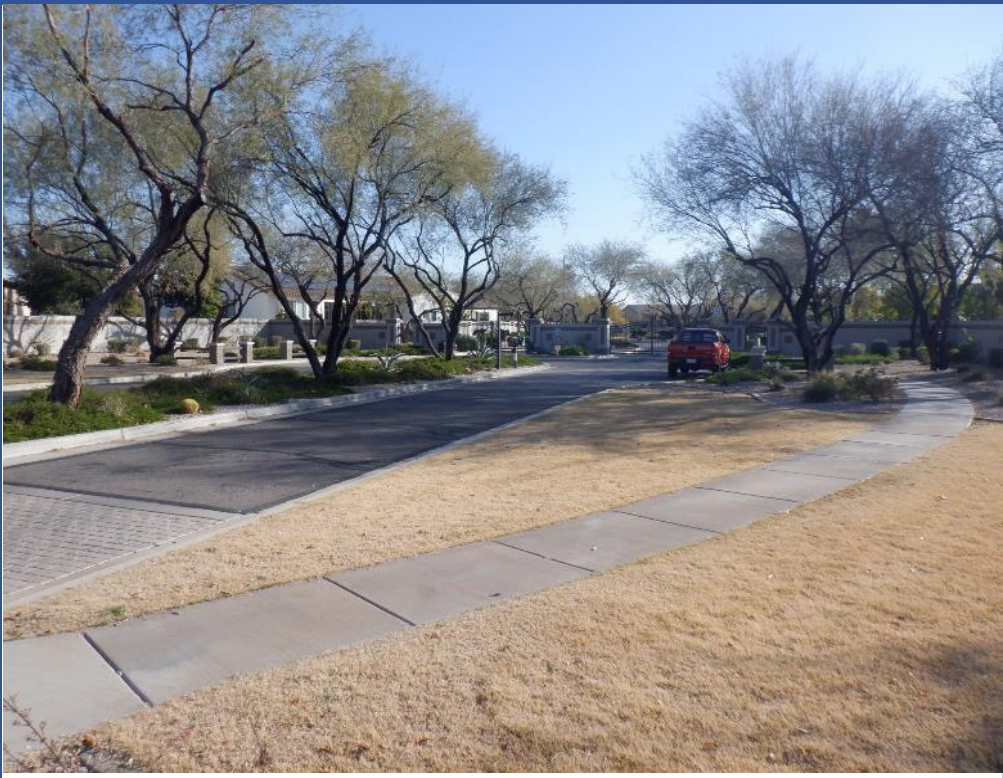
Overview of Gilbert Road entrance

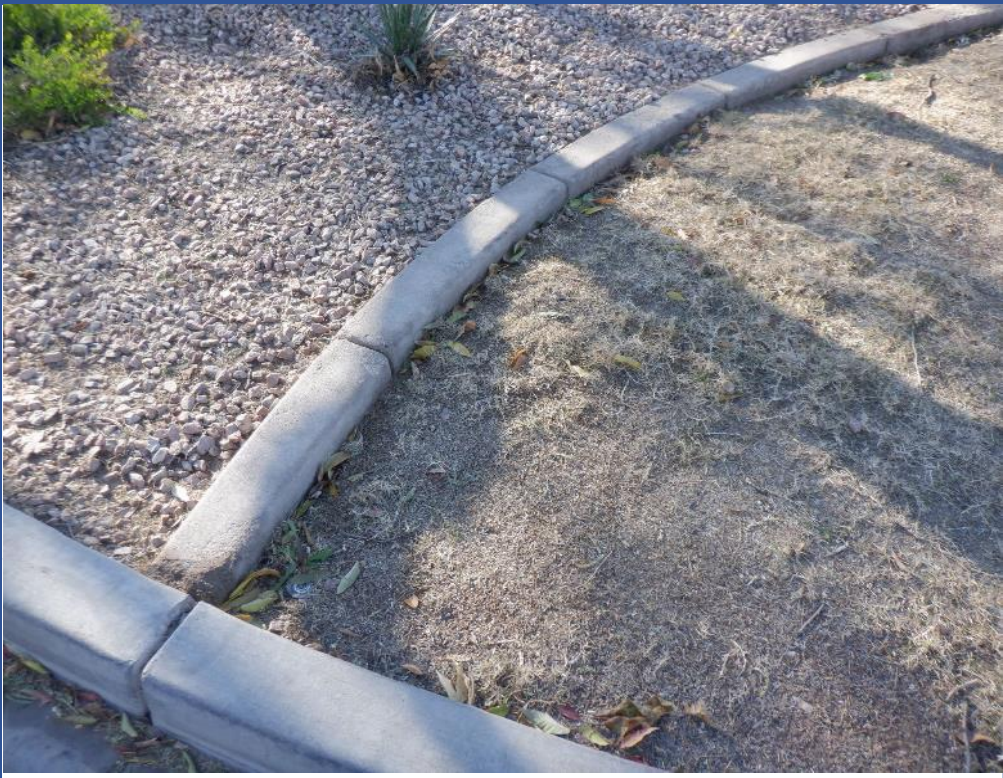
Concrete landscape curbing

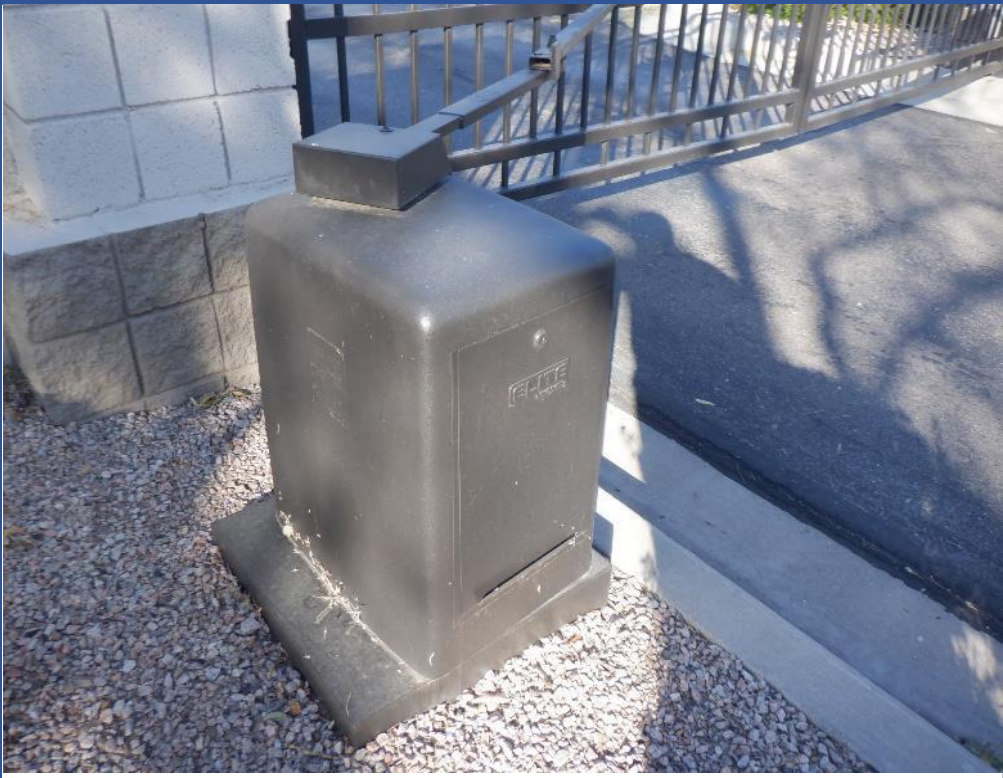
Gate operator at Gilbert Road entrance

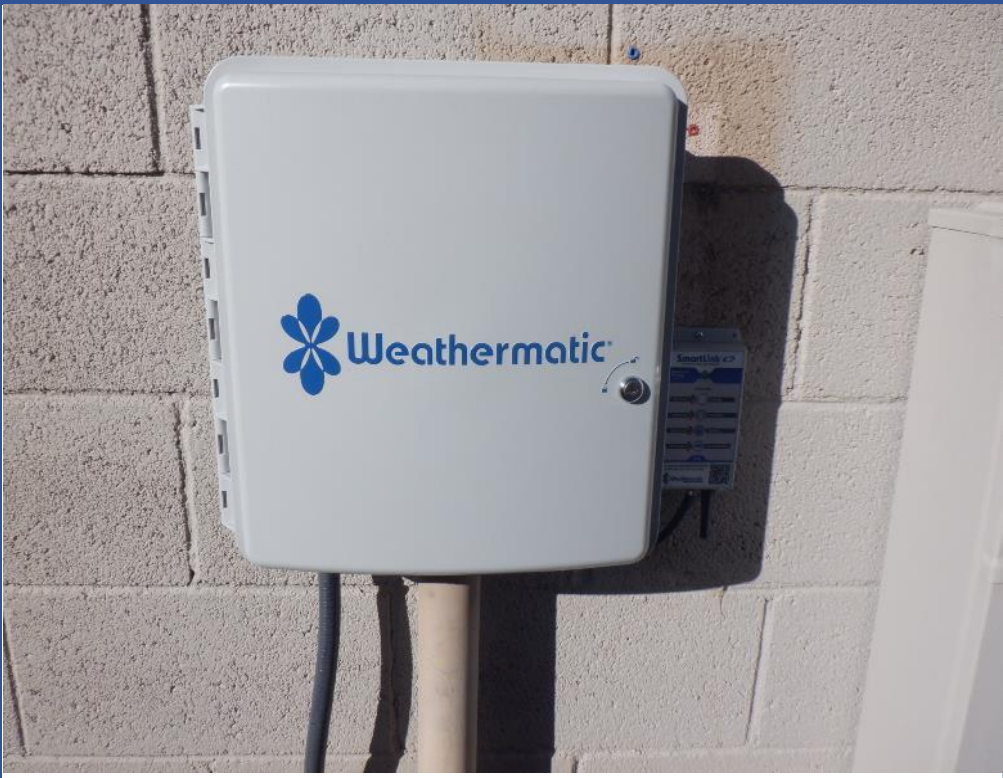
Weathermatic irrigation controller at Gilbert Road entrance

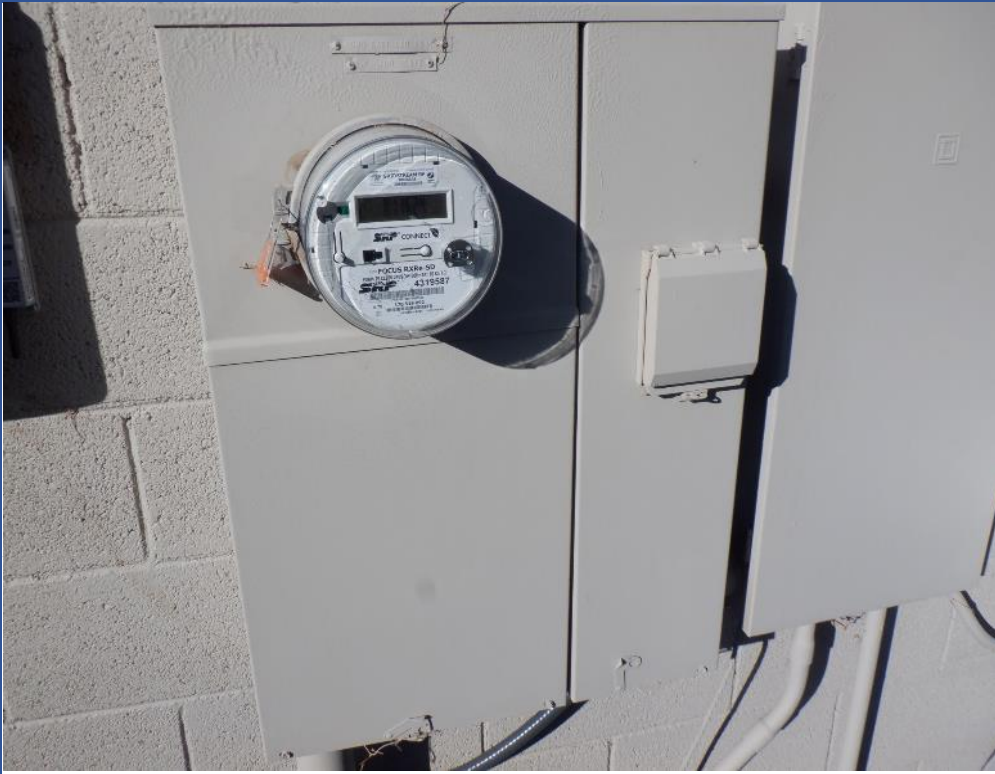
15

Electric control meter at  
Gilbert Road entrance

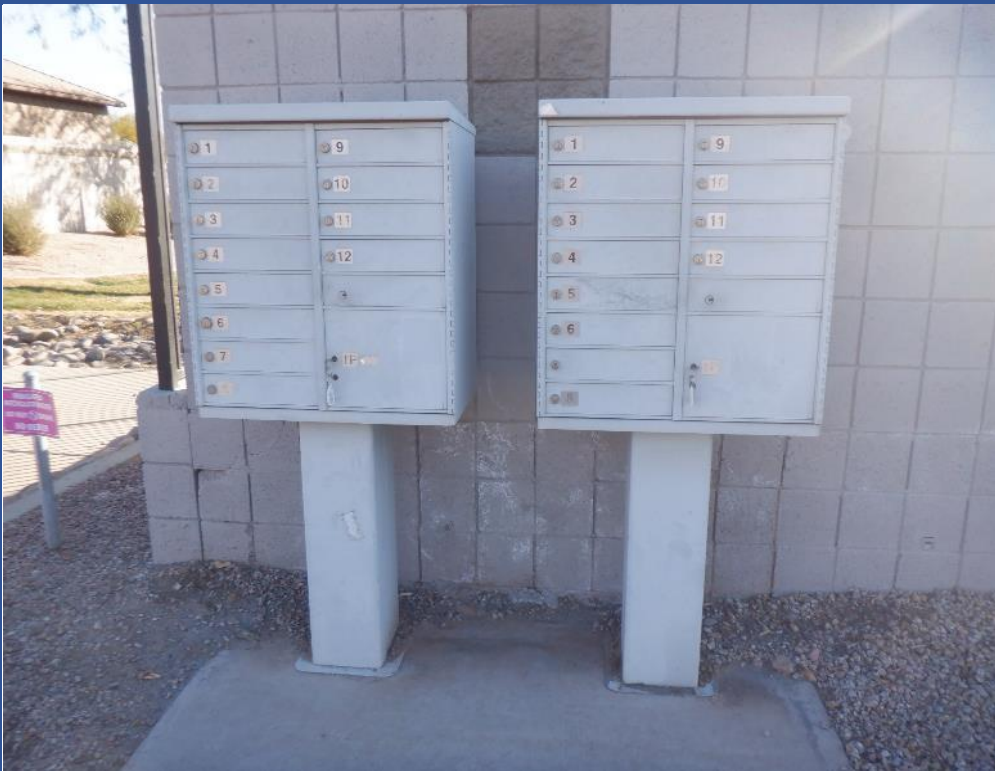
16

Mailbox kiosks at  
Scorpio and Dragoon

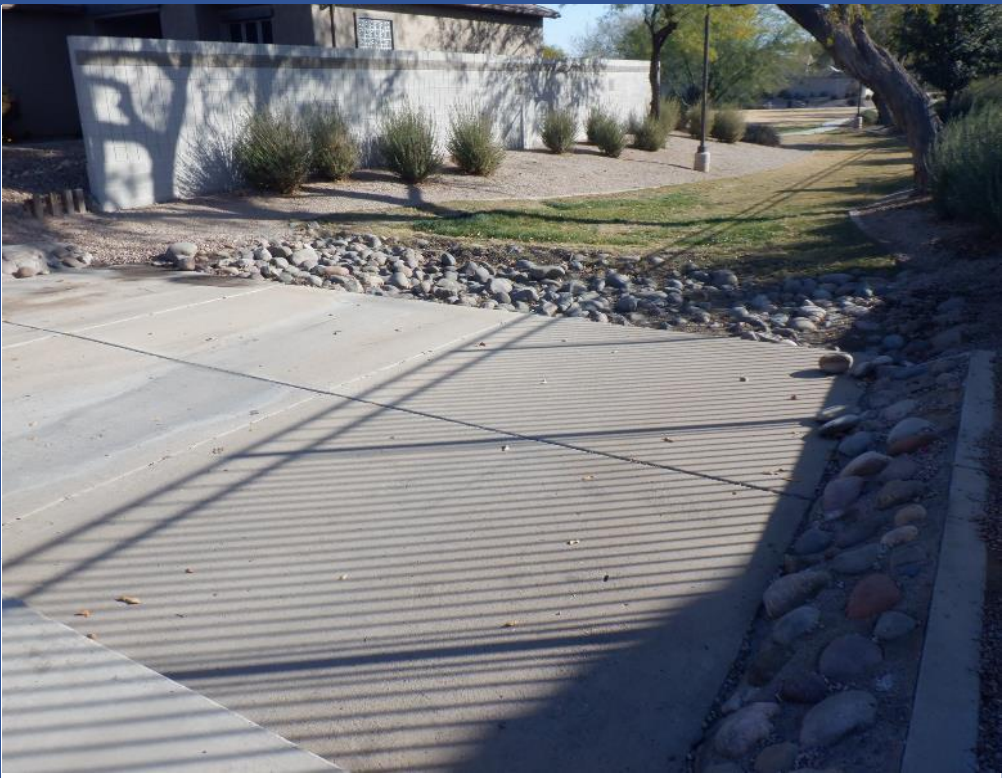
Drainage culvert for  
Tract I

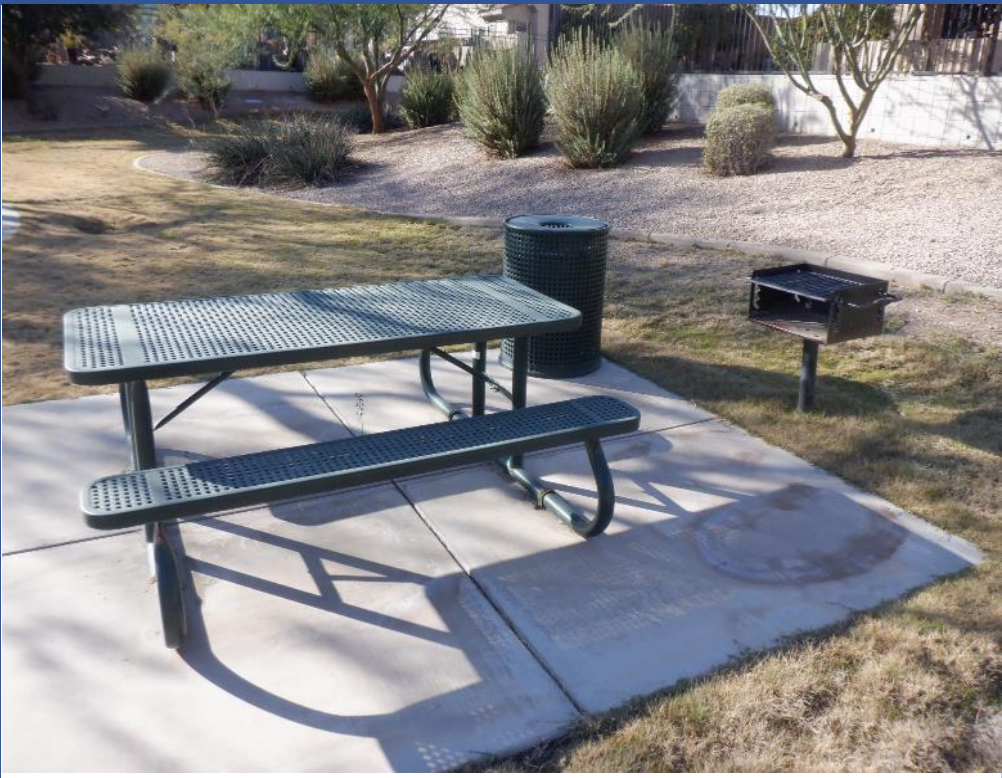
Park equipment in Tract  
I

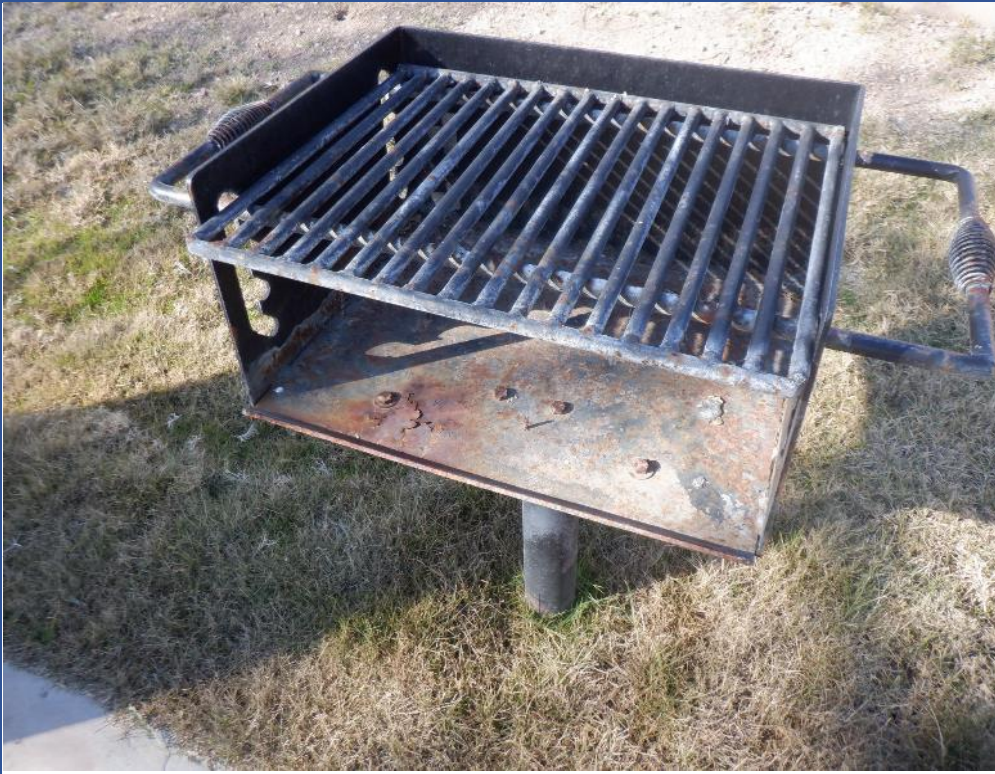
BBQ grill in Tract I

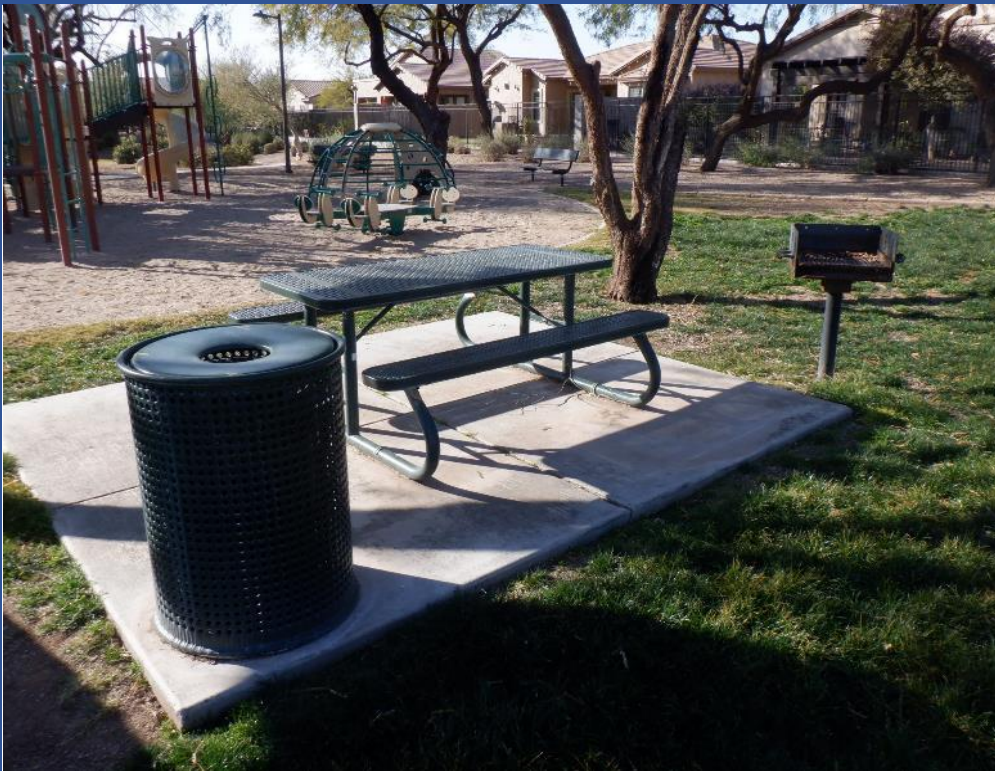
Park equipment in Tract I

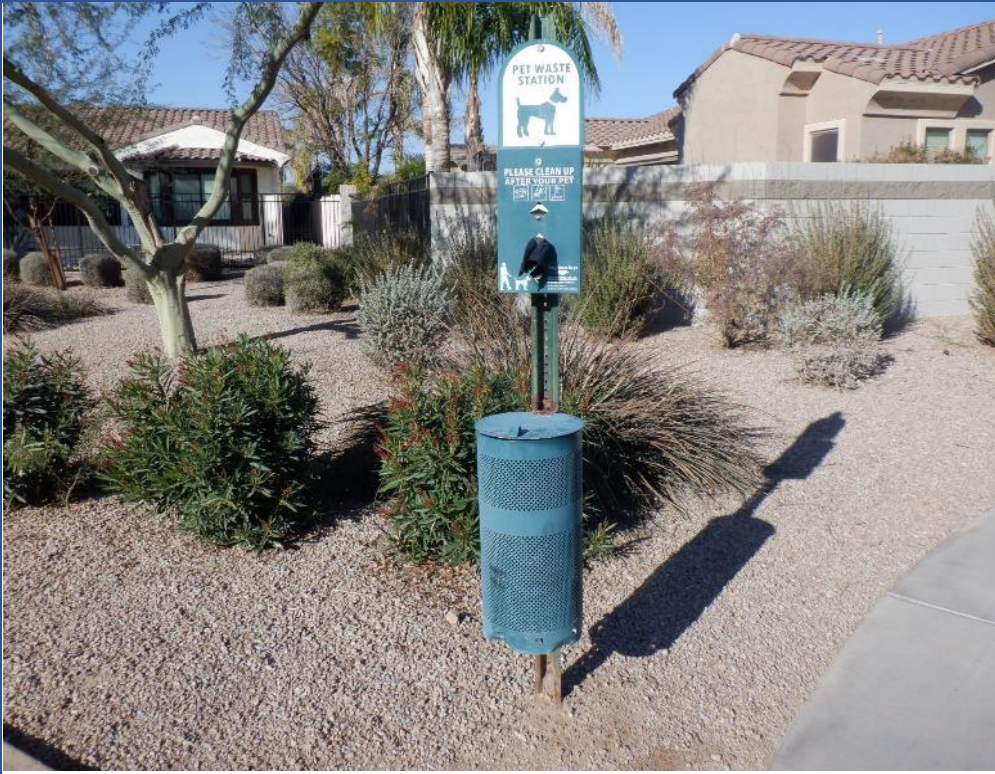
21

Pet station in Tract I

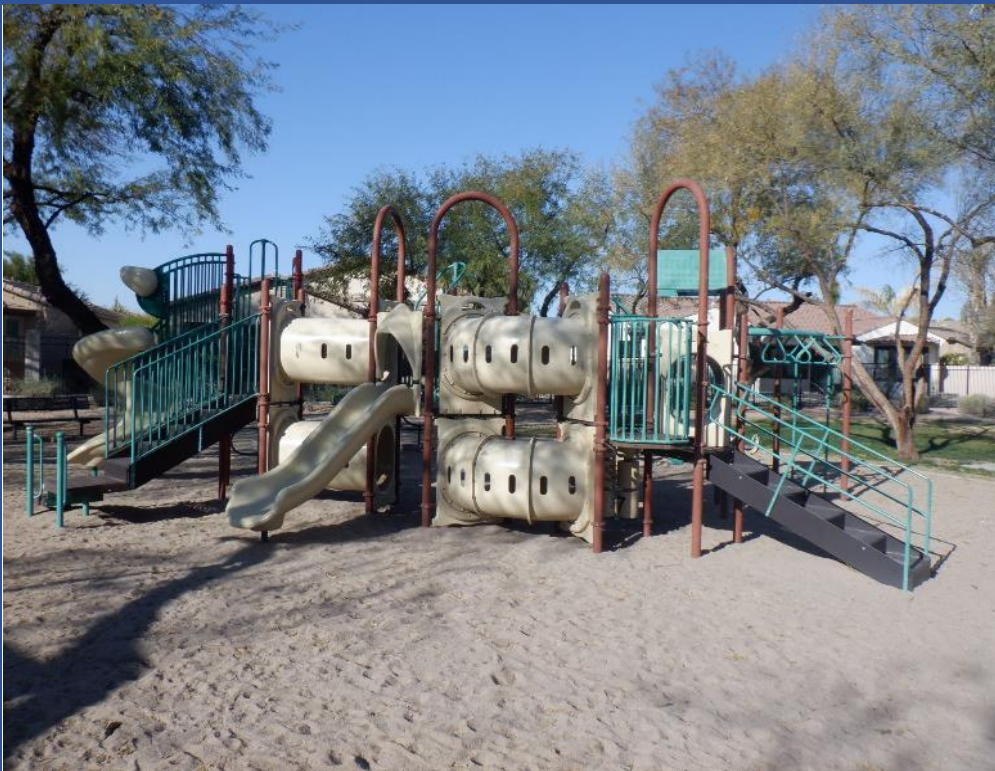
22

Playground equipment  
in Tract I

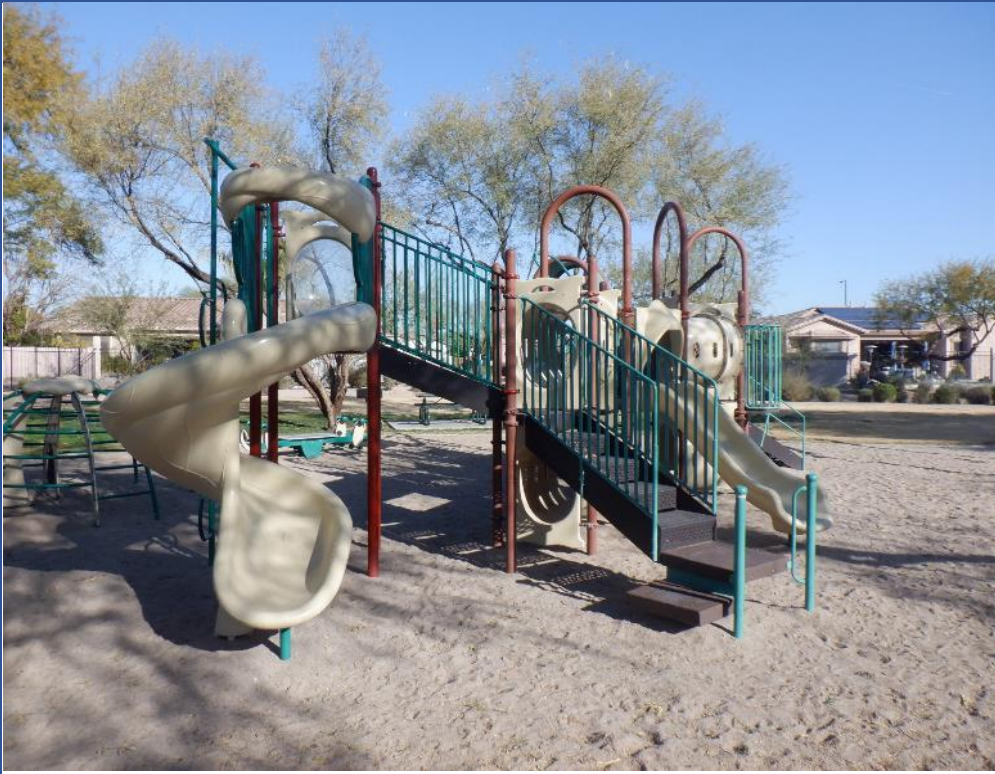
23

Playground equipment  
in Tract I

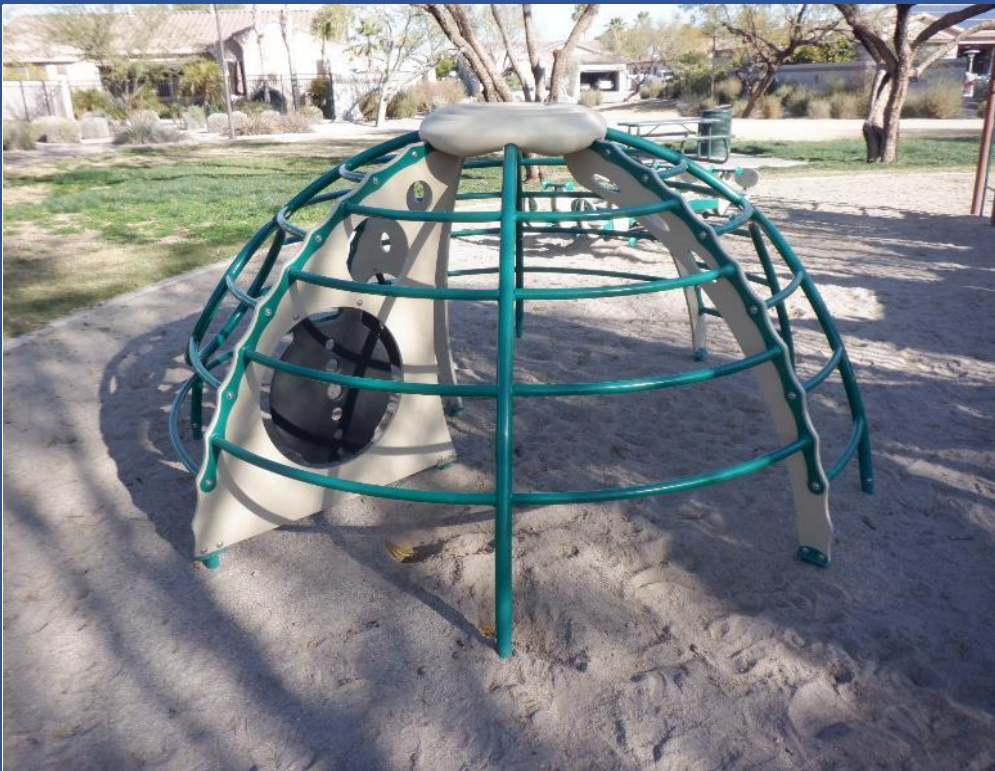
24

Playground equipment  
in Tract I

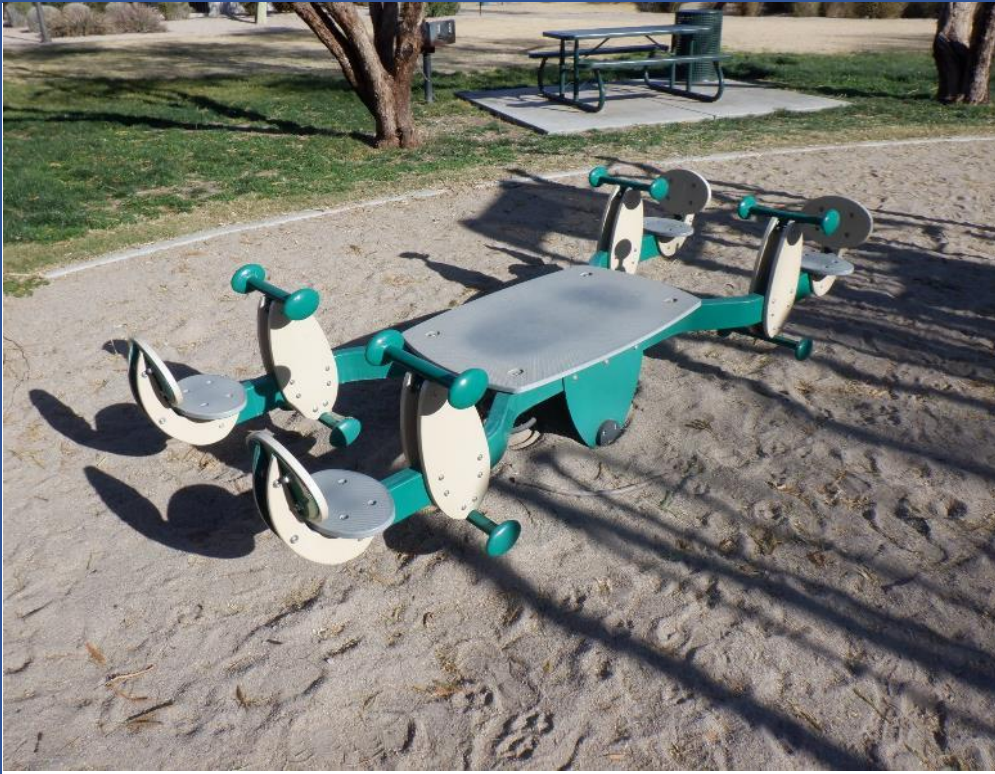
25

Playground equipment  
in Tract I

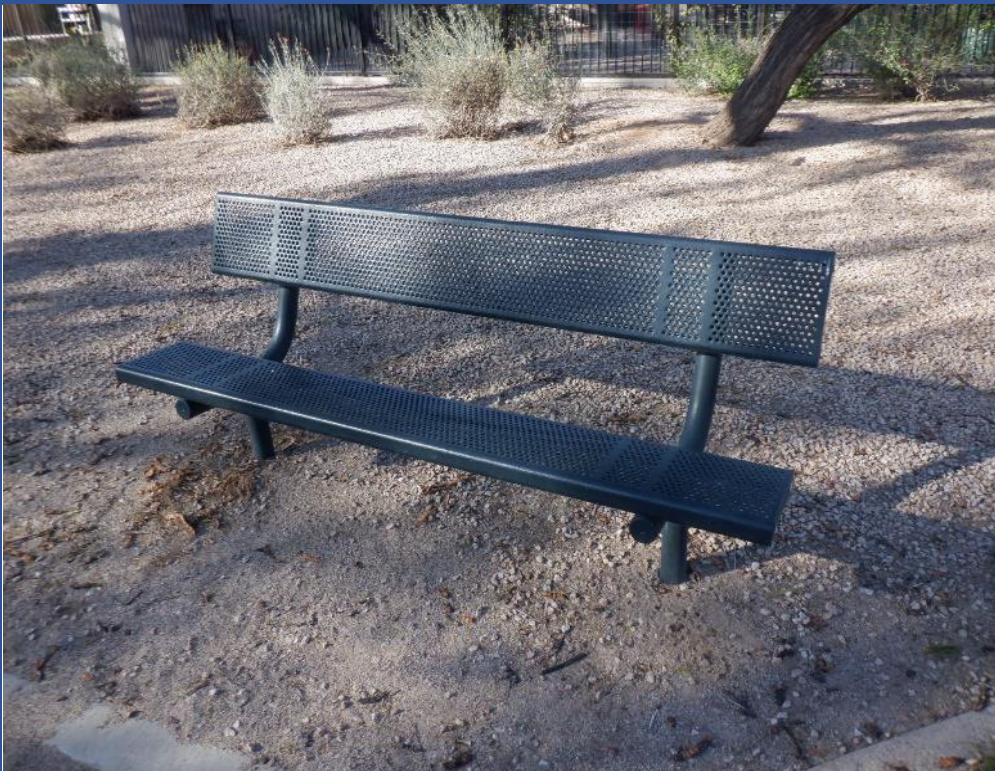
26

Park bench in Tract I

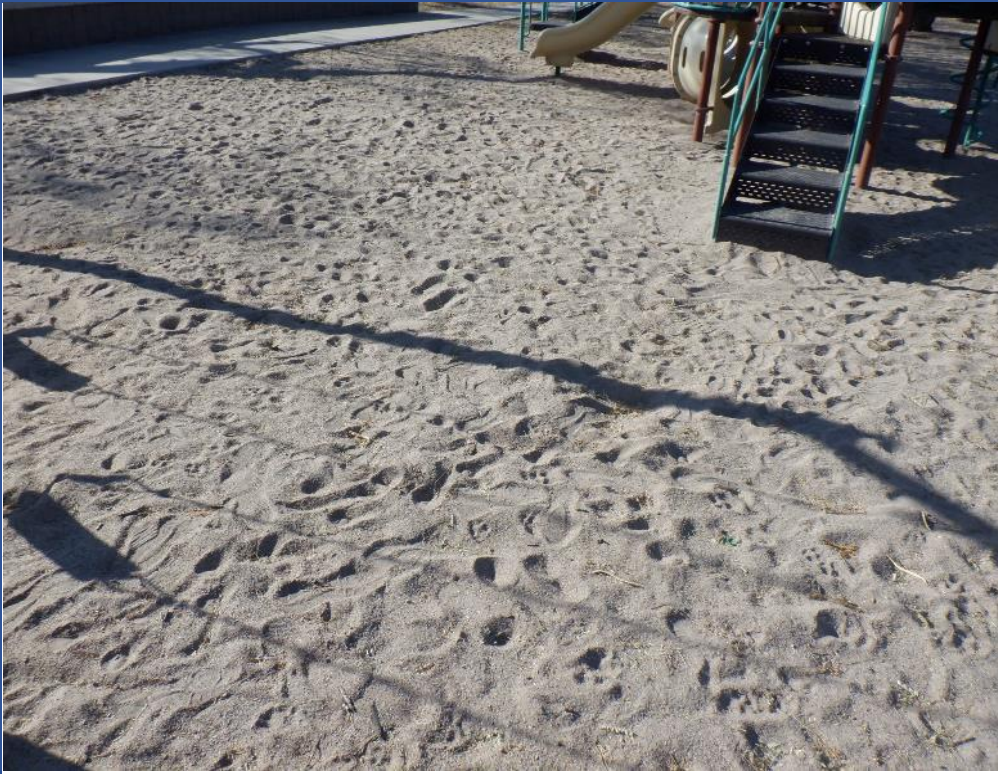
27

Sand in playground area  
in Tract I

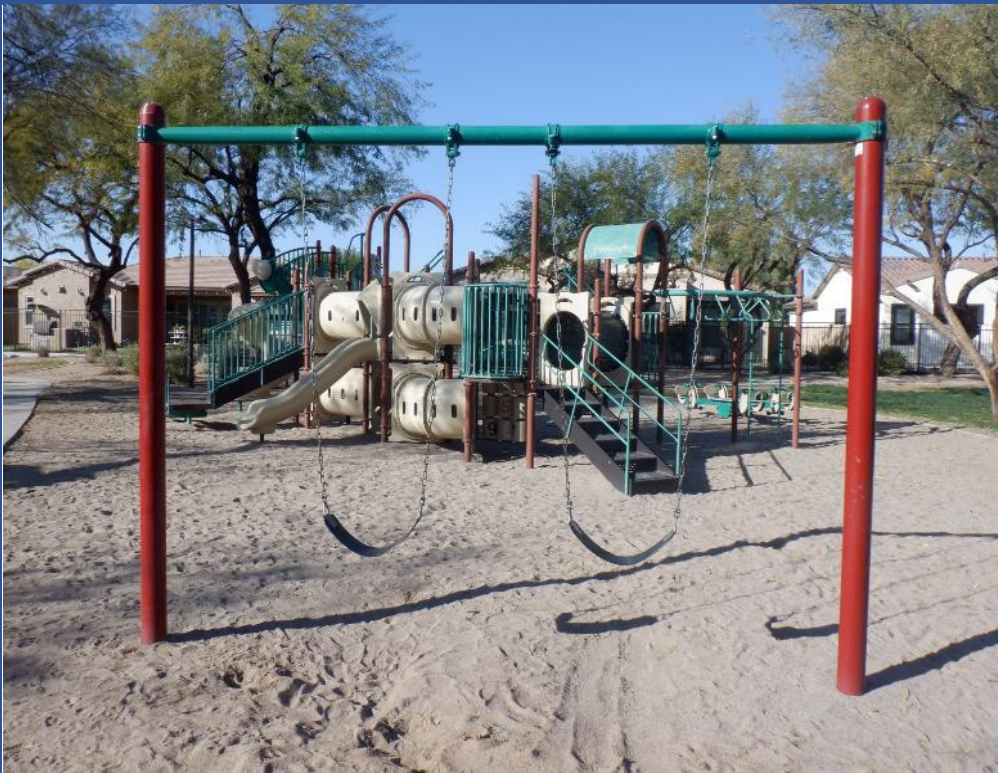
28

Swings in Tract I  
playground

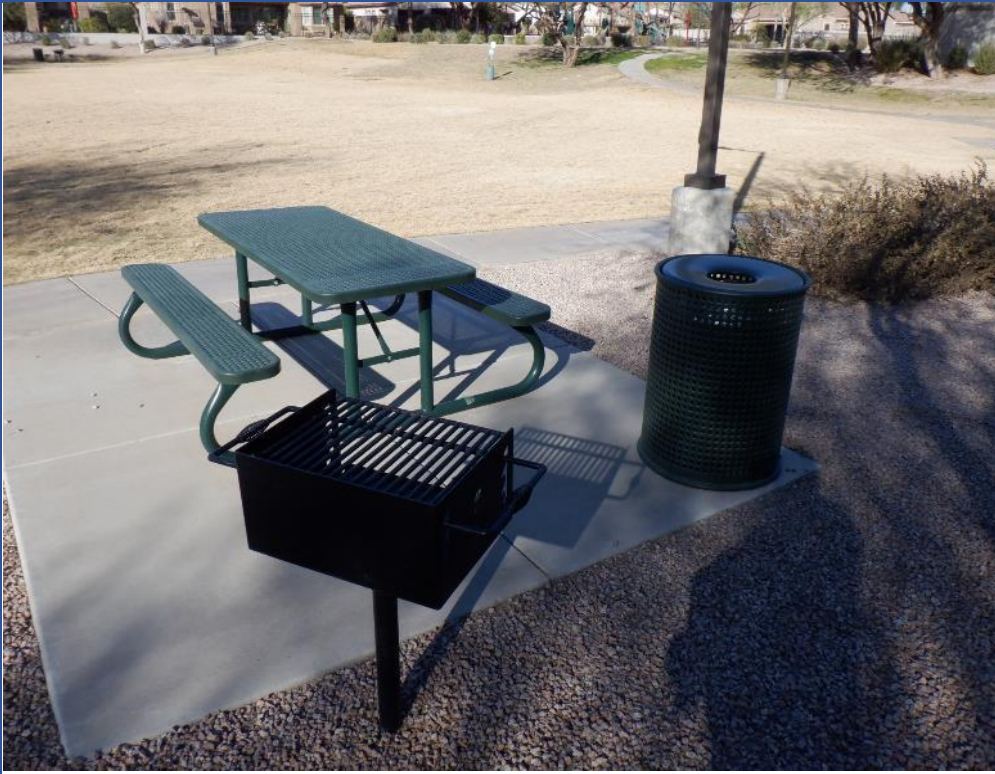
Park equipment in Tract  
I

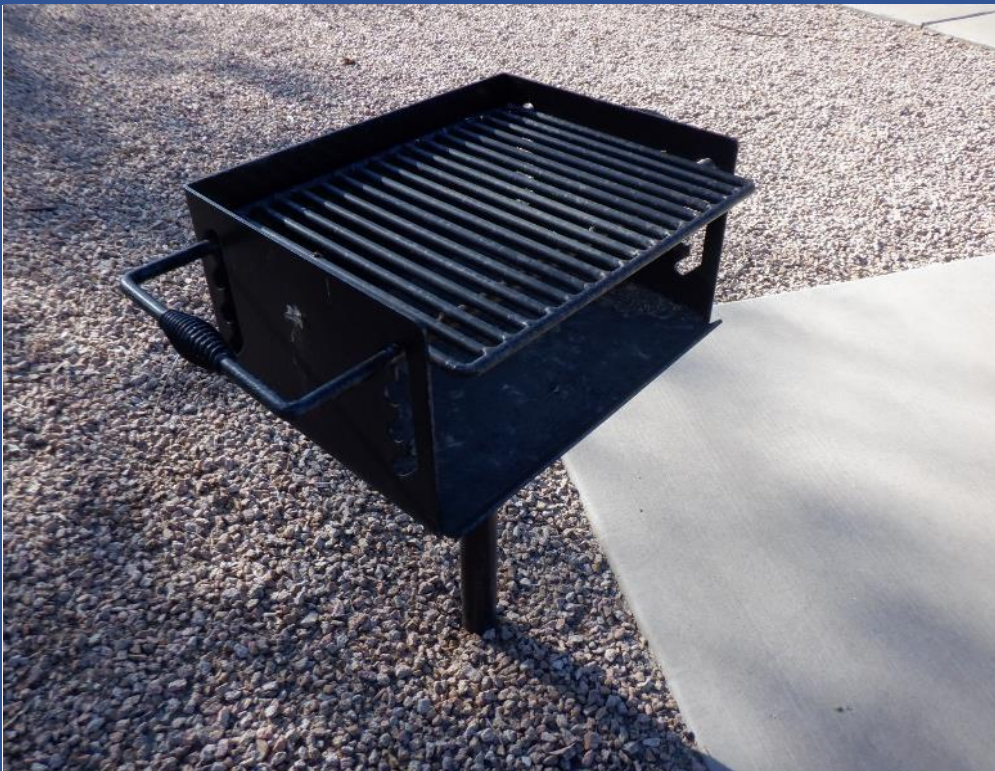
29

BBQ in Tract I (new)

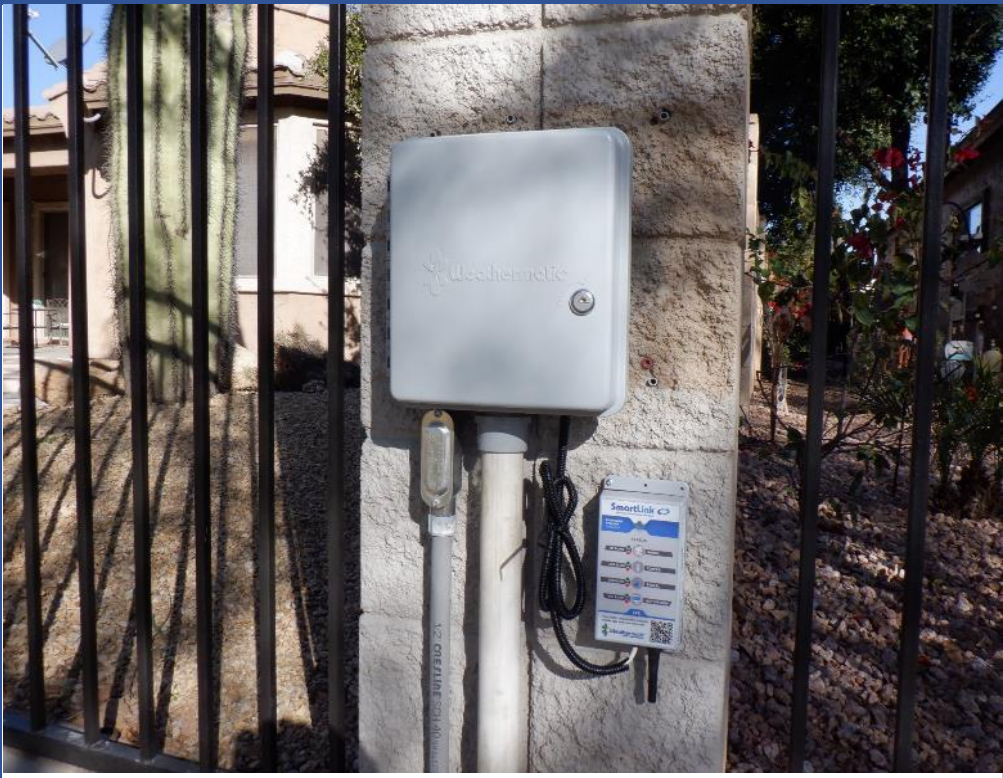
30

Weathermatic irrigation controller
