February 29, 2024 R1

**PROPERTY:** MESQUITE GROVES ESTATES  
CHANDLER, ARIZONA

**SERVICE:** FULL RESERVE FUND ANALYSIS

**ATTACHMENT:** 23-0446 – FINAL REPORT

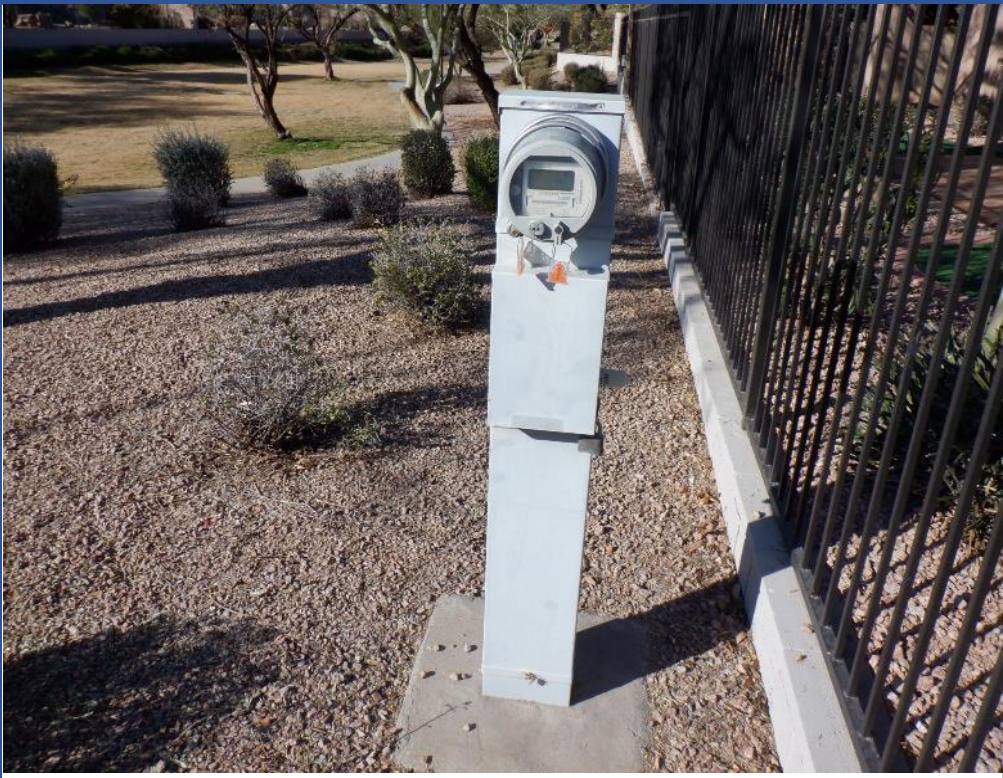
31

Electric control meter in Tract I

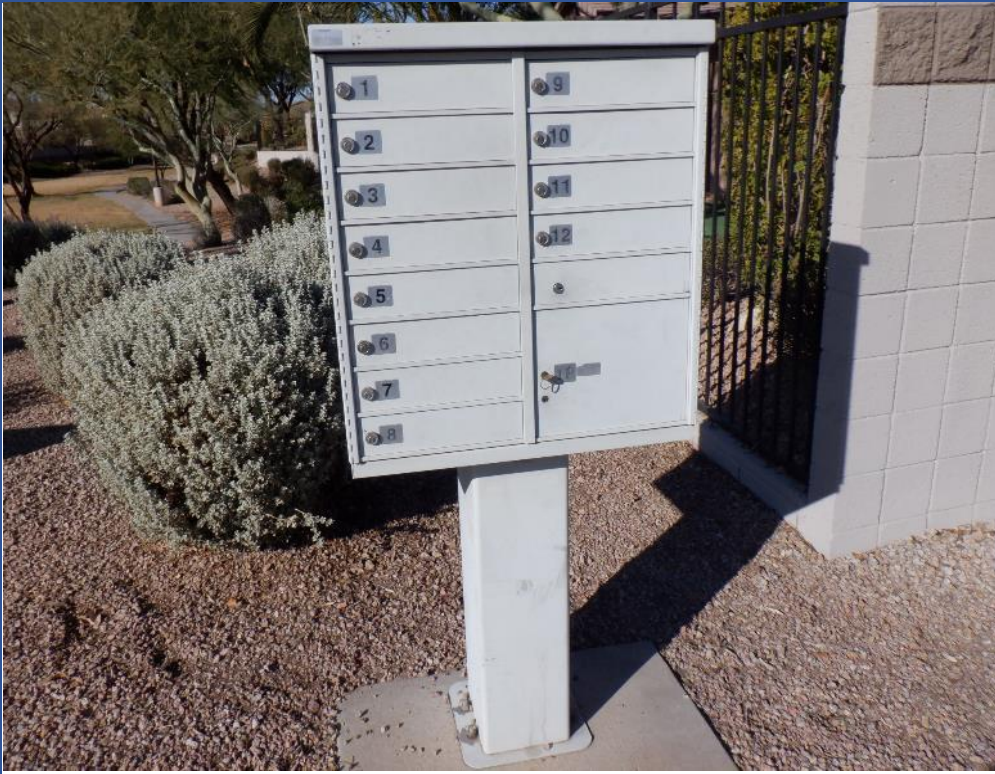
33

Mailbox Kiosk at  
Mesquite Grove Way  
and Scorpio Court

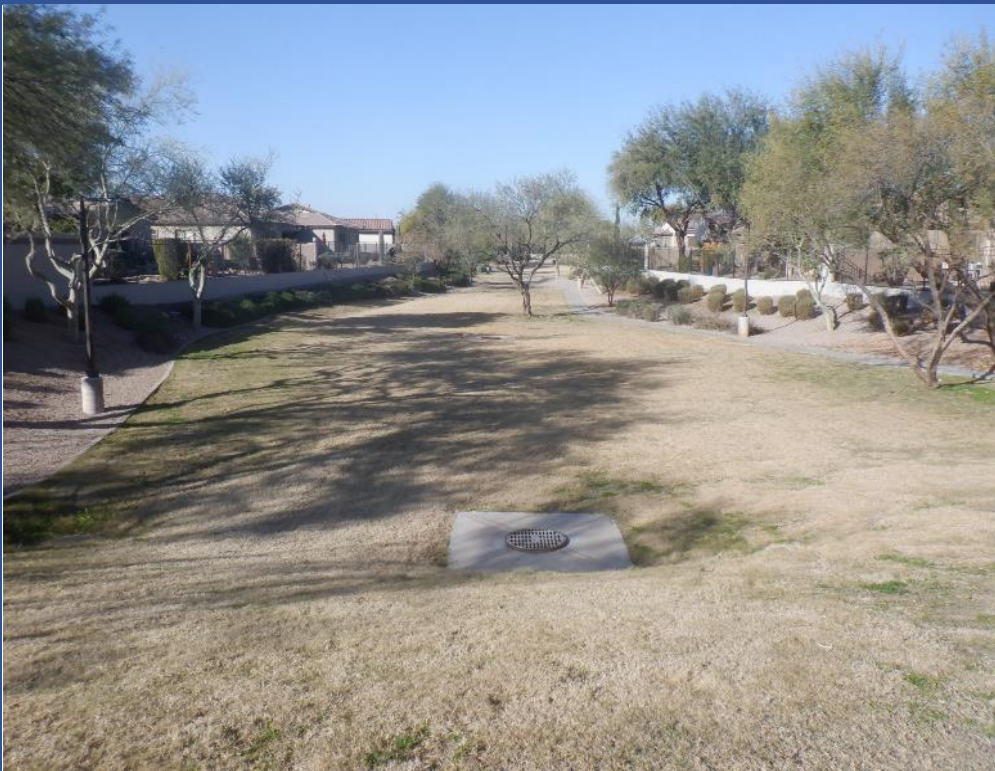
34

Tract I park overview

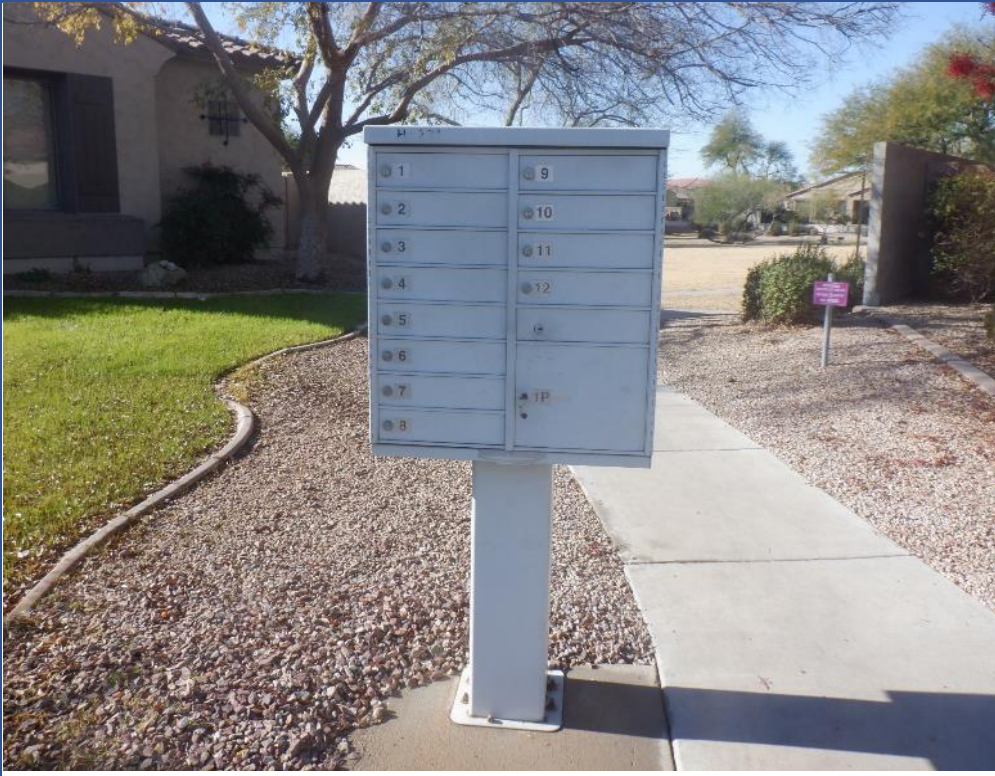
Mailbox kiosk at  
Aquarius and Rincon

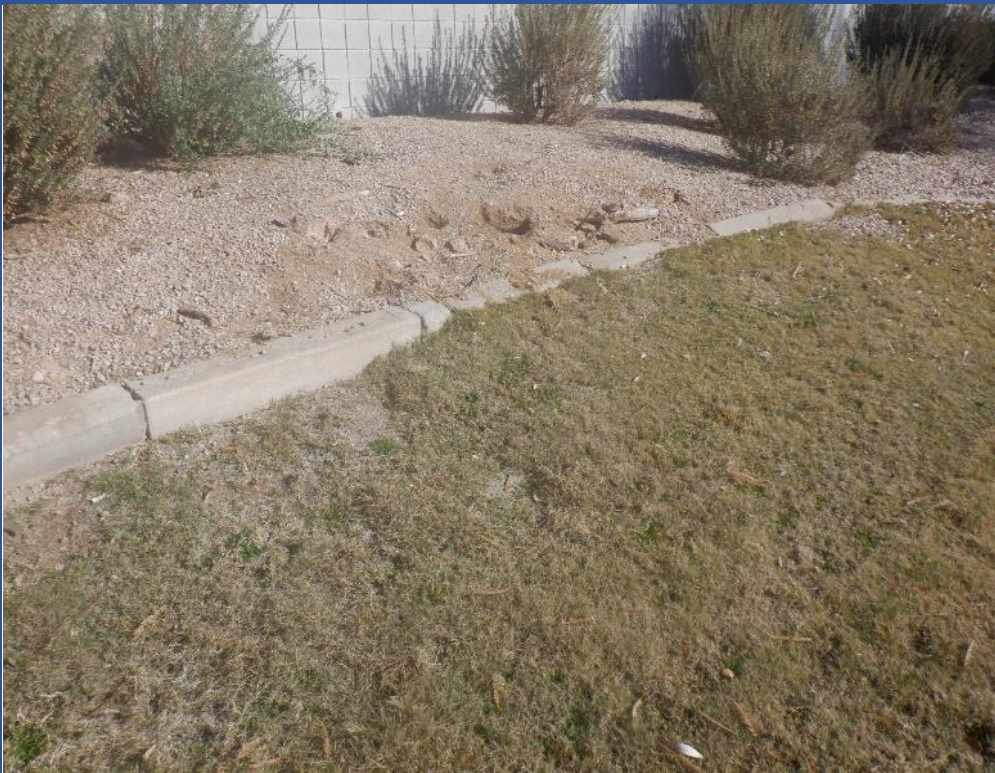
35

Concrete landscape  
curbing

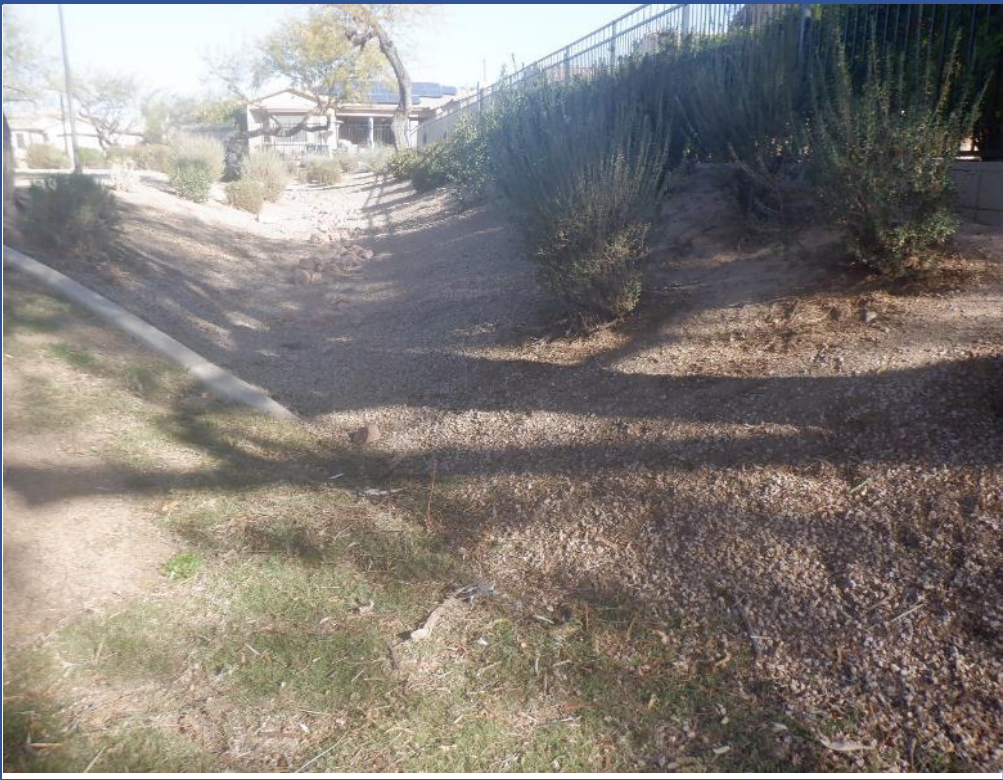
**37**

Tract I drainage

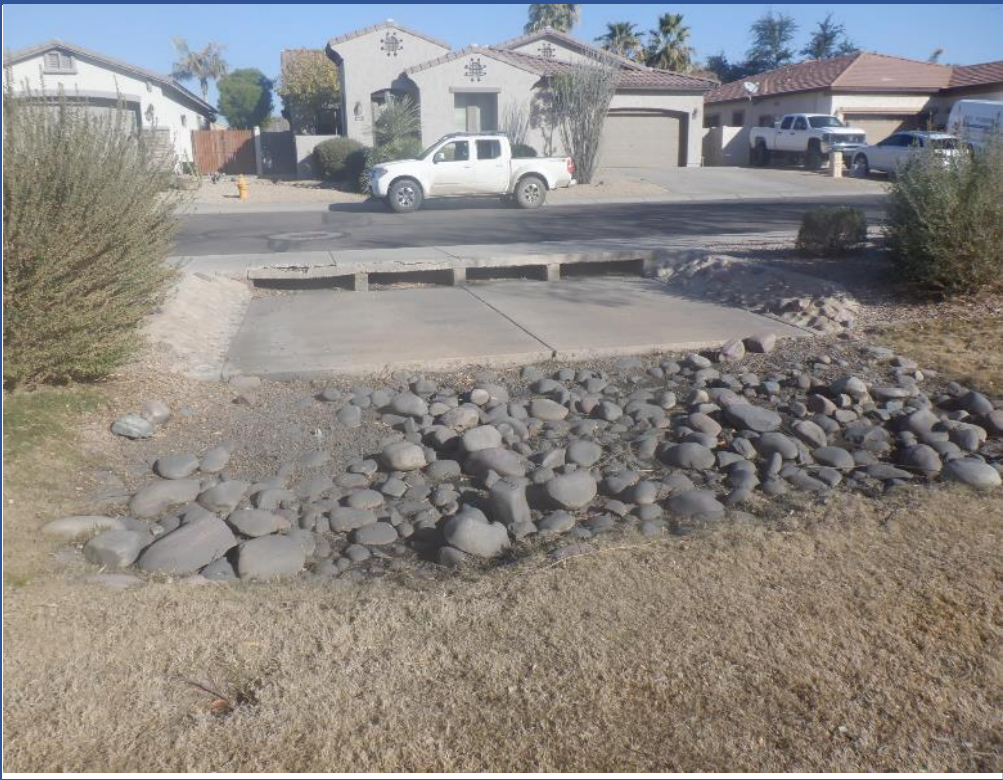
**38**

Tract I drainage culvert

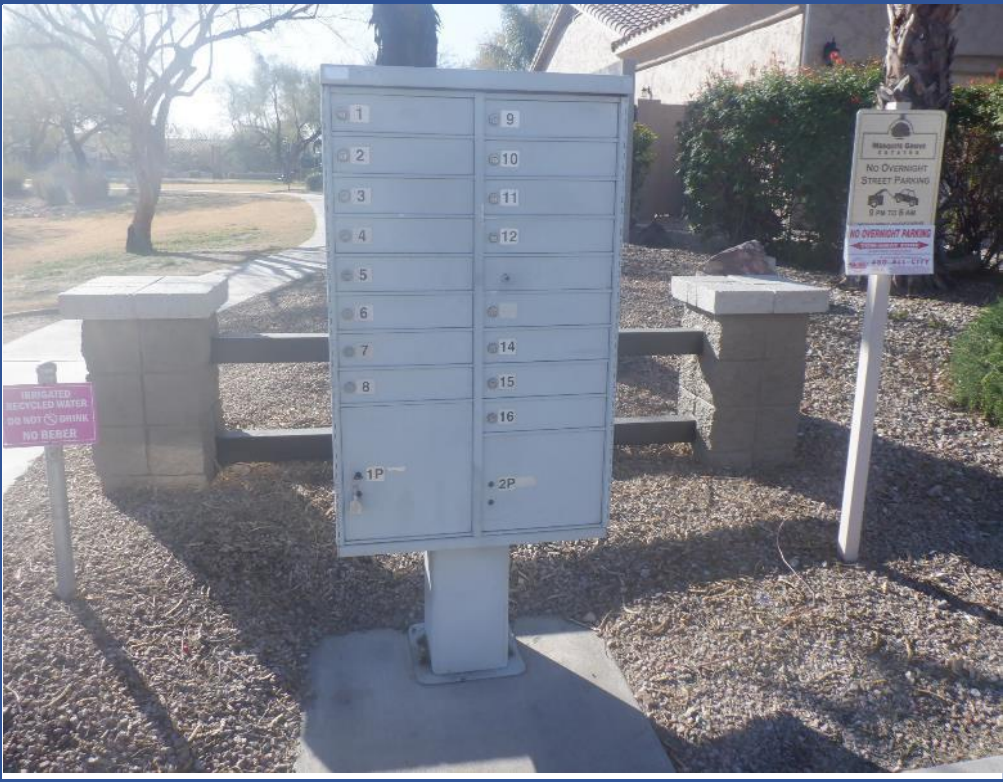
**39**

Mailbox Kiosk on  
Capricorn

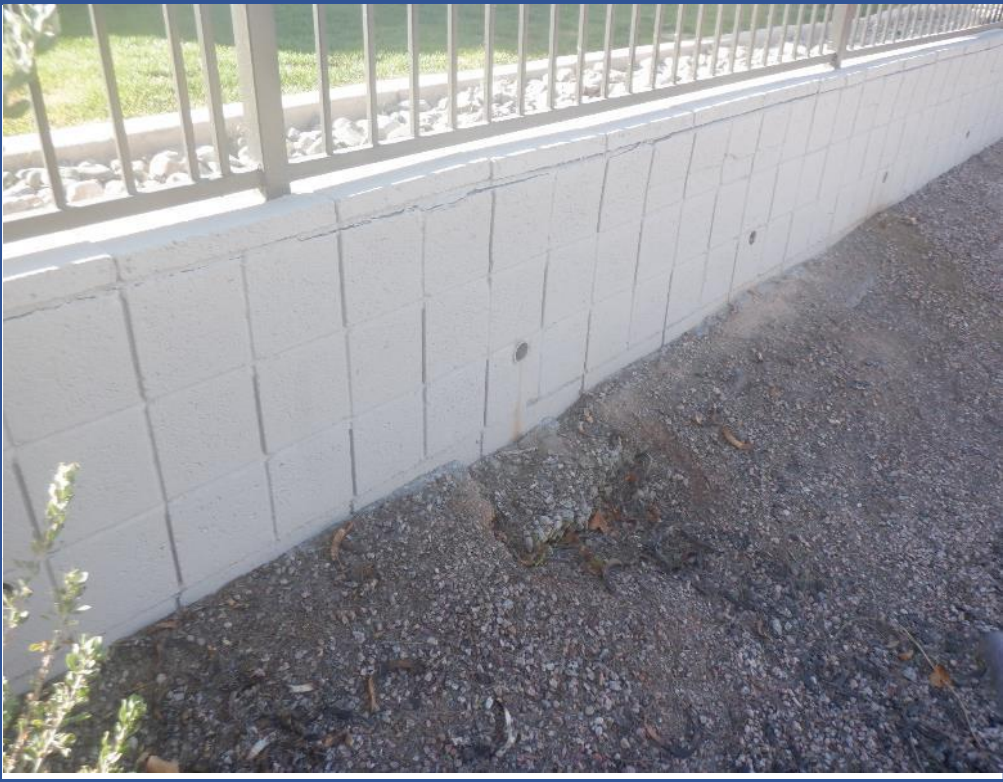
**40**

Block wall in Tract I

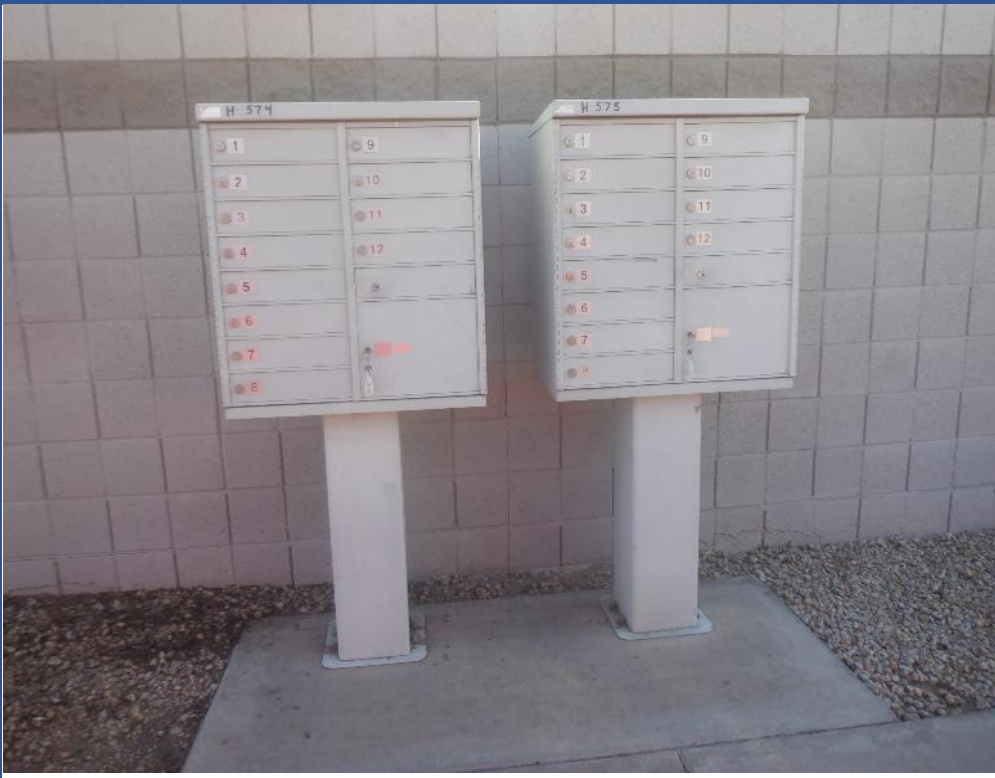
43

Mailbox kiosks at  
Mesquite Grove Way  
and Sagittarius Court

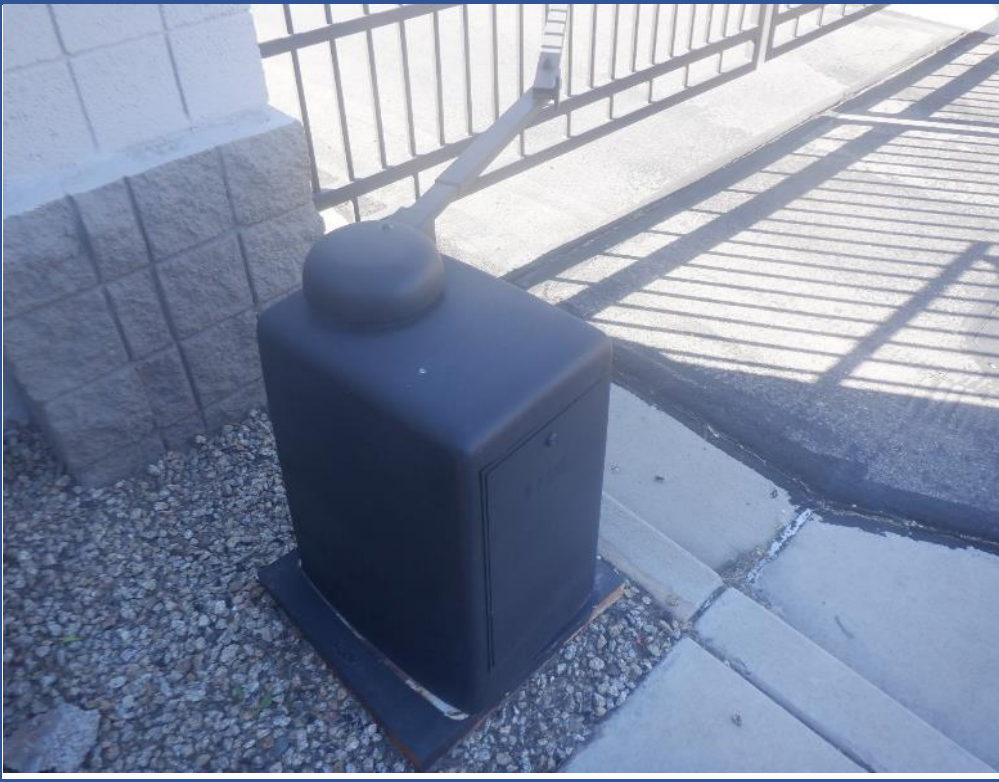
46

Gate operator at Riggs Road

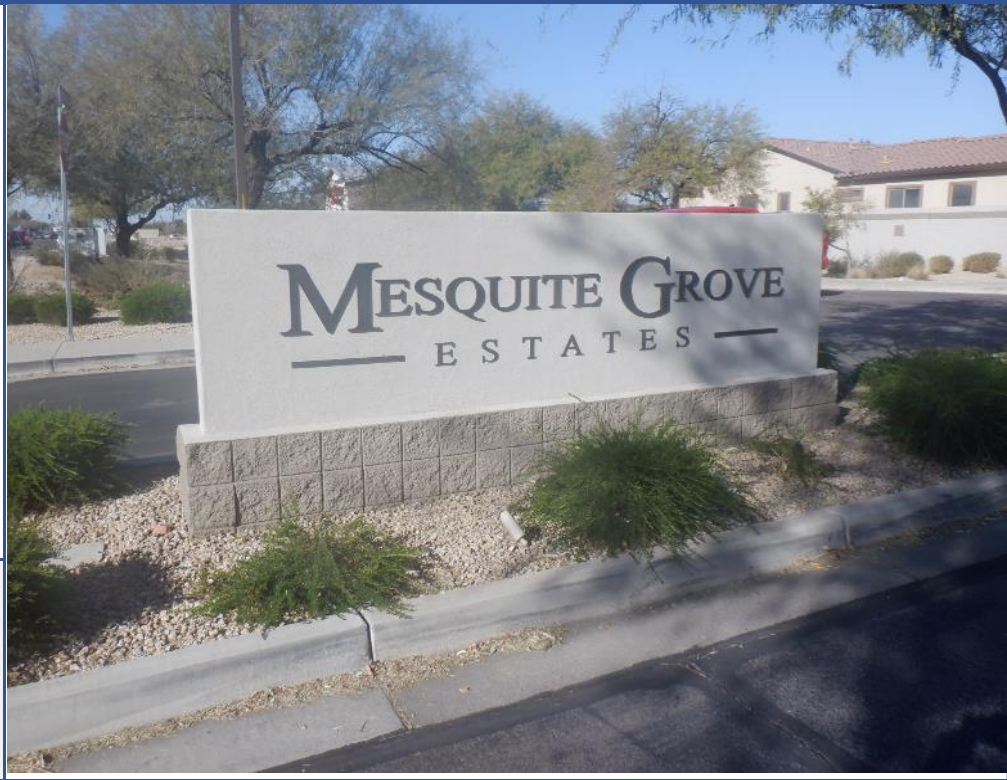
Entrance monument sign - Riggs Road

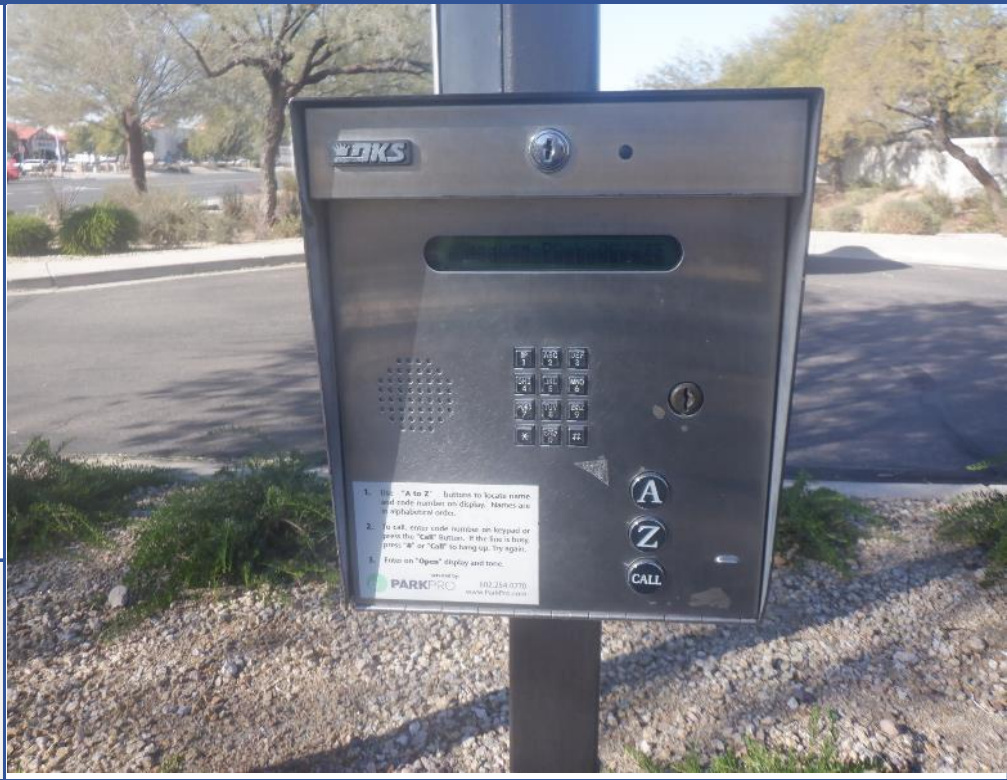
Access control system - Riggs Road

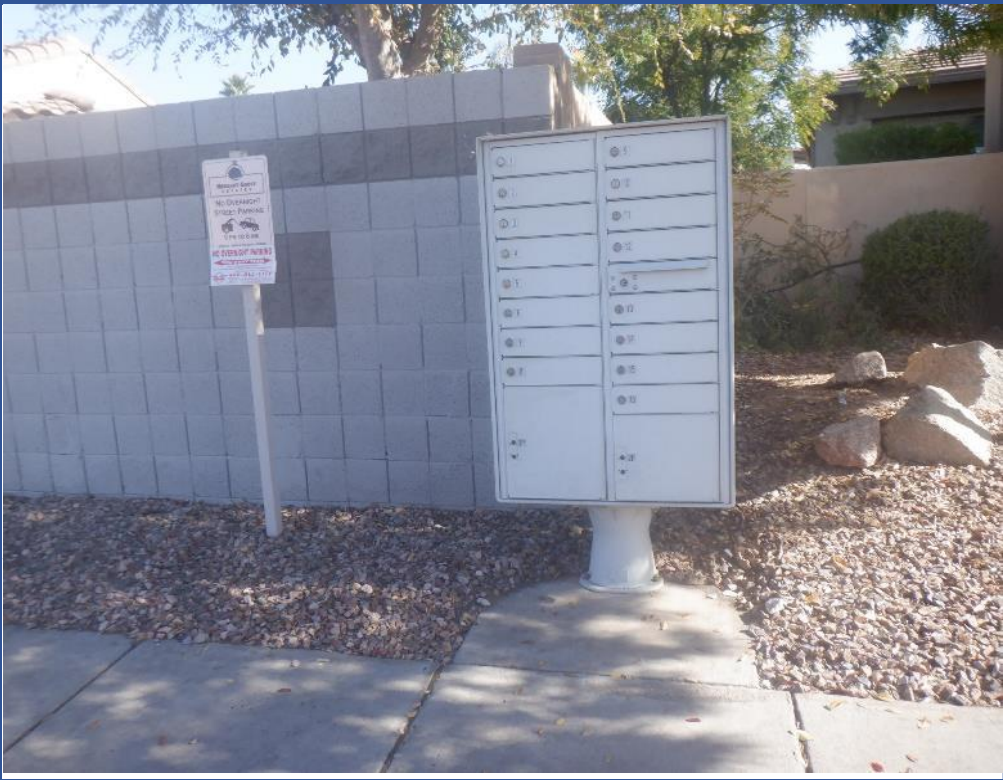
Mailbox kiosk at  
Mesquite Grove Way  
and Four Peaks Place

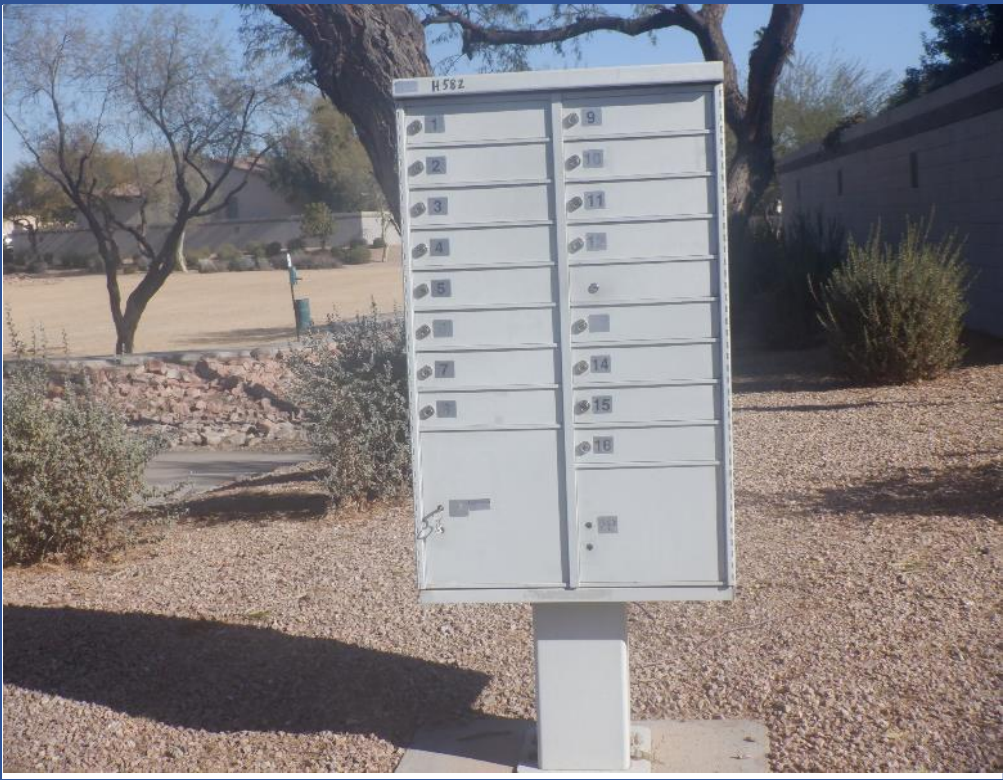
Mailbox kiosk at  
Mesquite Grove Way  
and Virgo Place

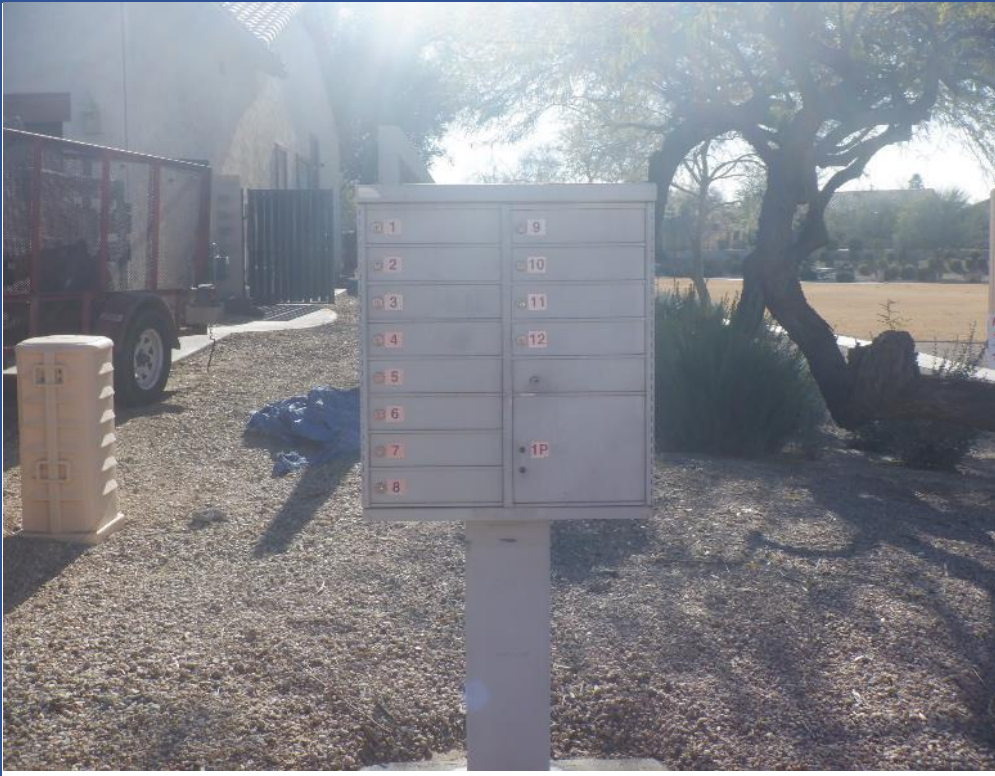
Mailbox kiosk at  
Mesquite Grove Way  
and Libra Place

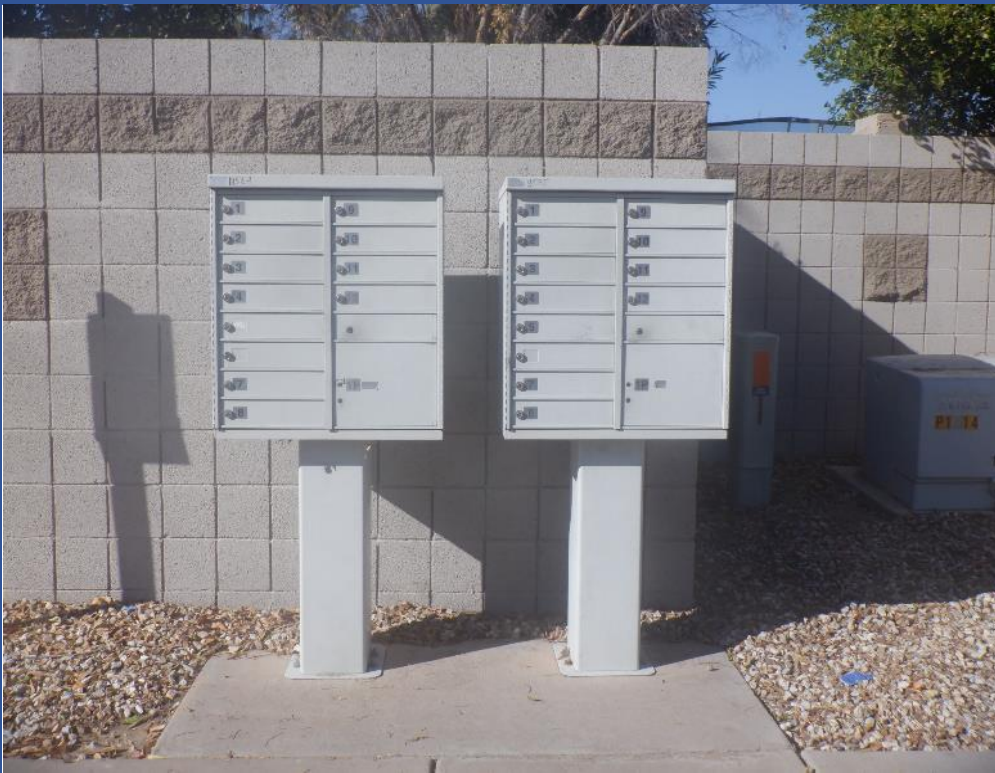
Mailbox kiosk at Four  
Peaks Place and  
Mesquite Grove Way

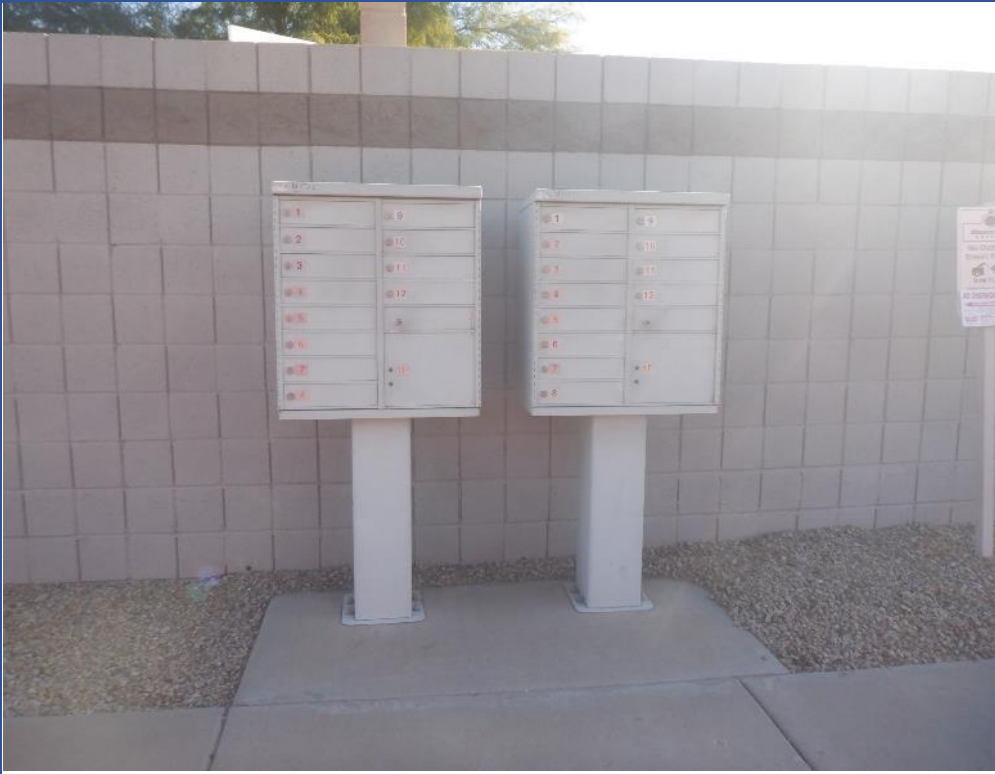
53

Mailbox kiosk at  
Dragoon and Taurus

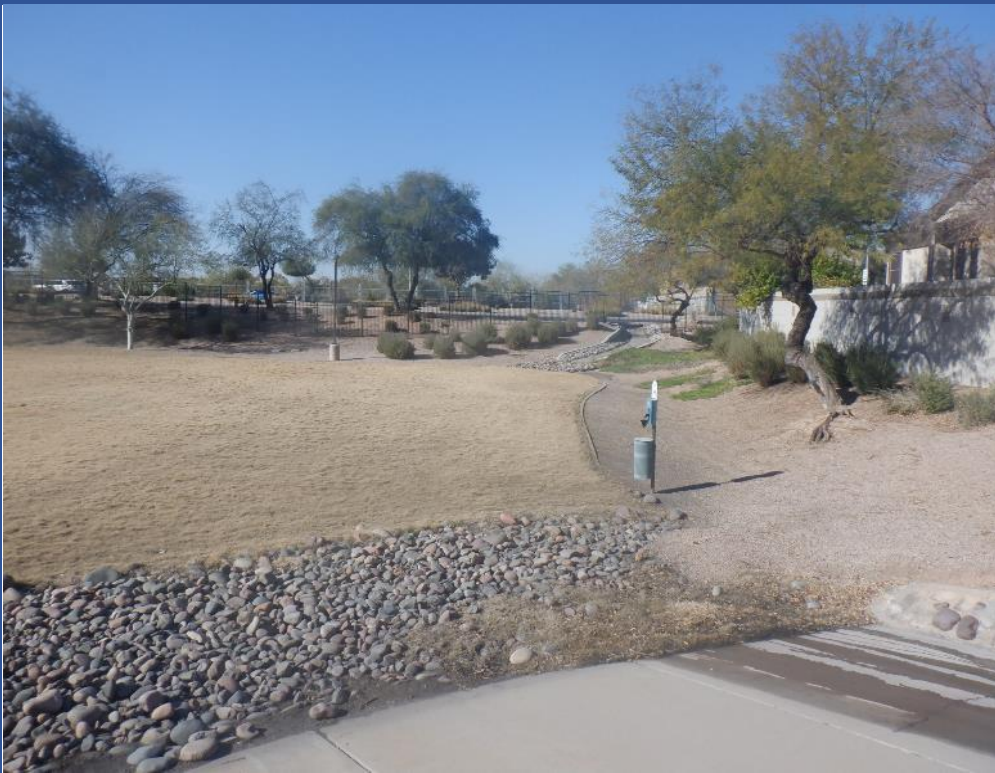
54

Tract B drainage wash  
and park overview

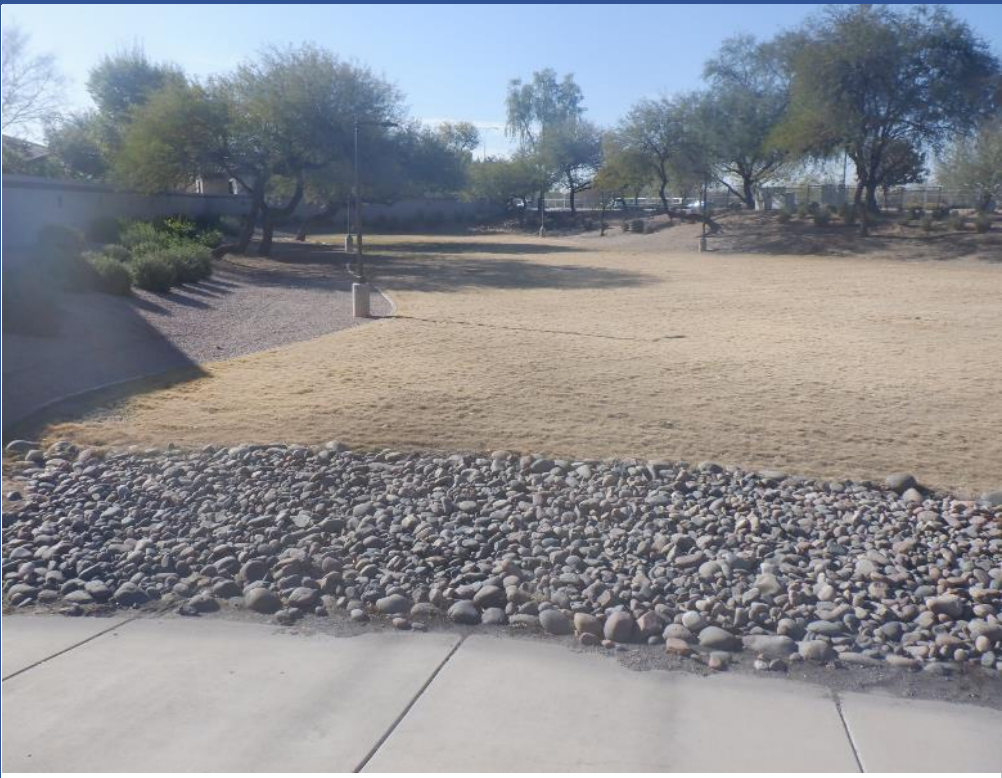
Tract B drainage wash  
and park overview

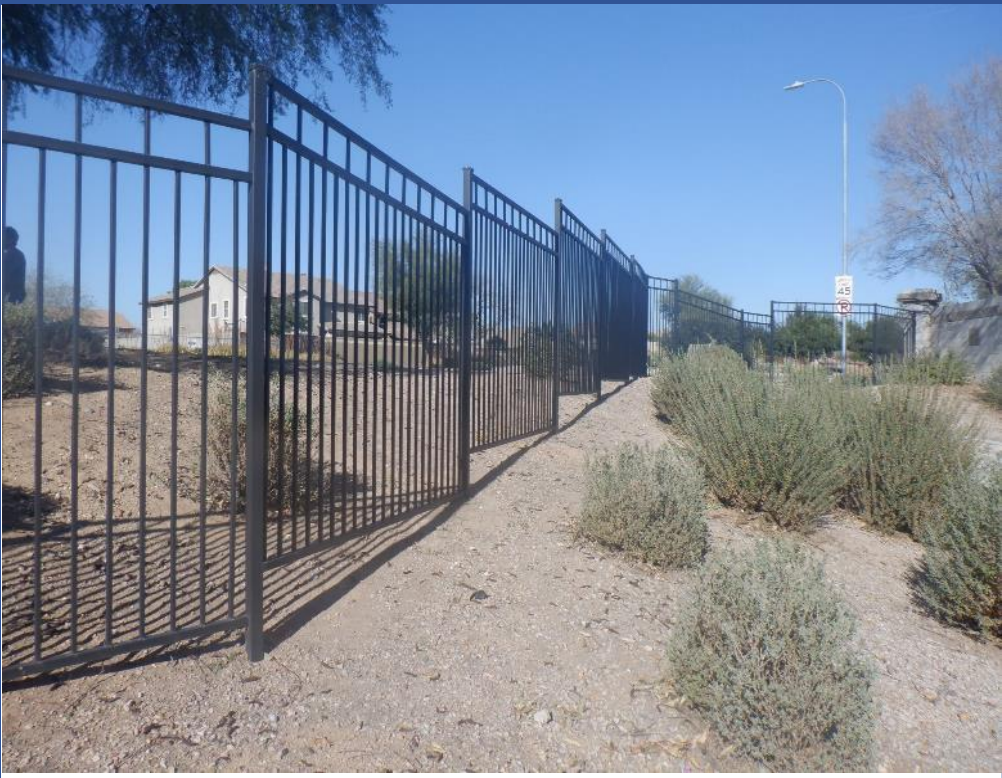
Wrought iron fencing on  
the exterior perimeter in  
Tract B

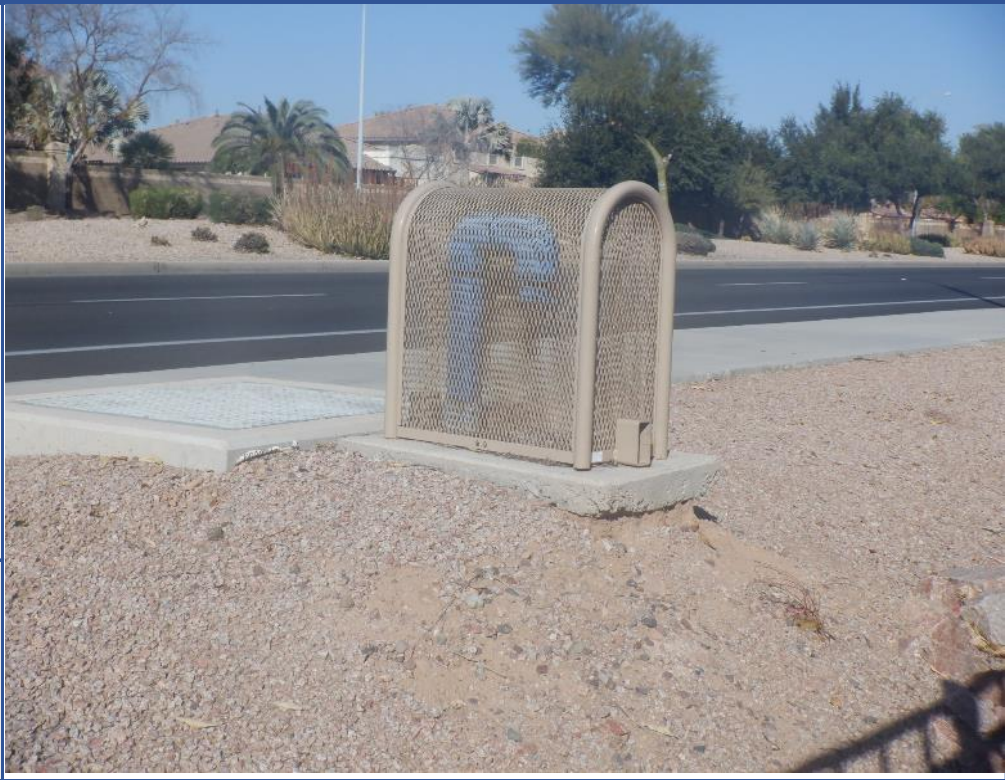
Backflow preventer

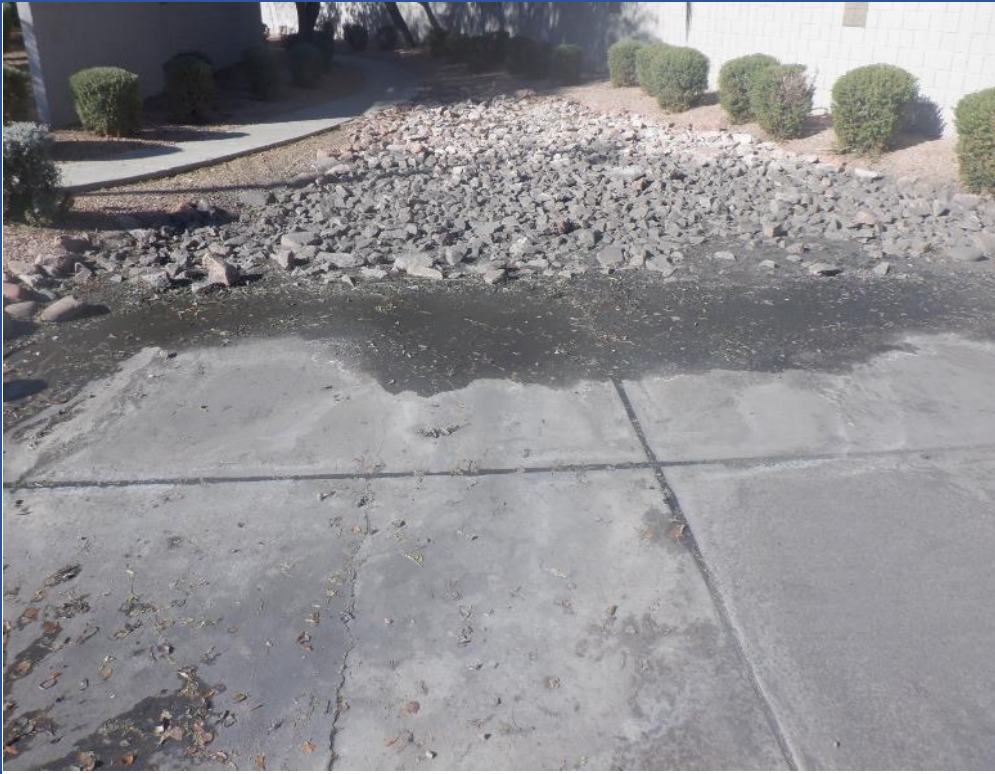
Drainage culvert from  
Four Peaks Place to  
Tract E common area

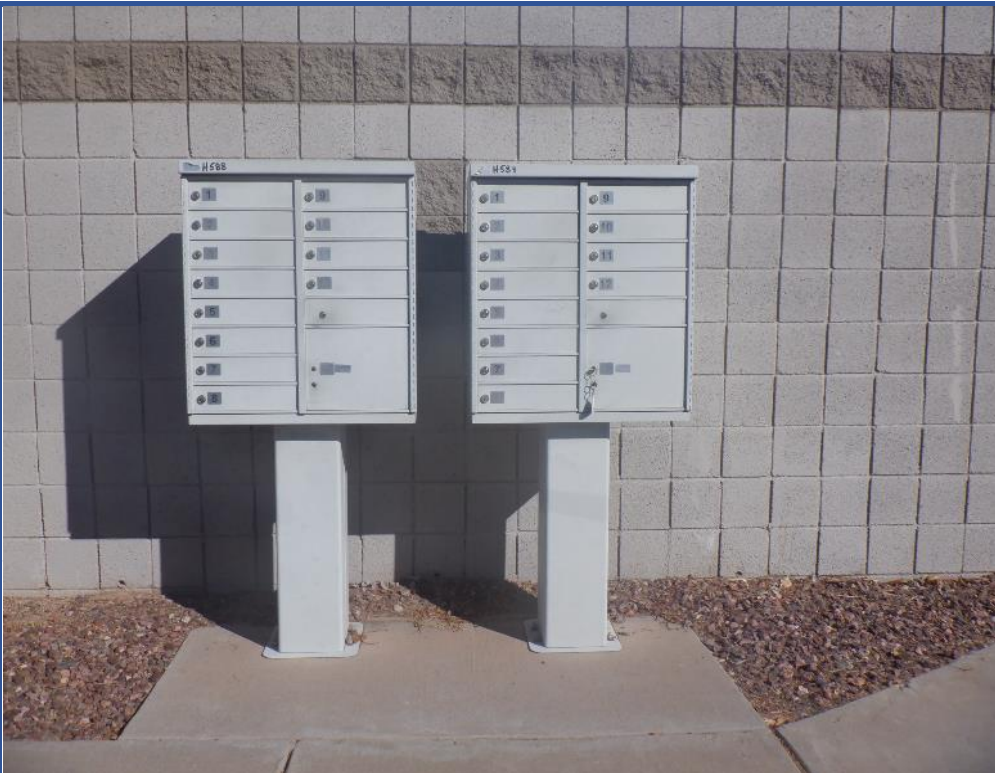
Mailbox kiosks on  
Elmwood and Rincon

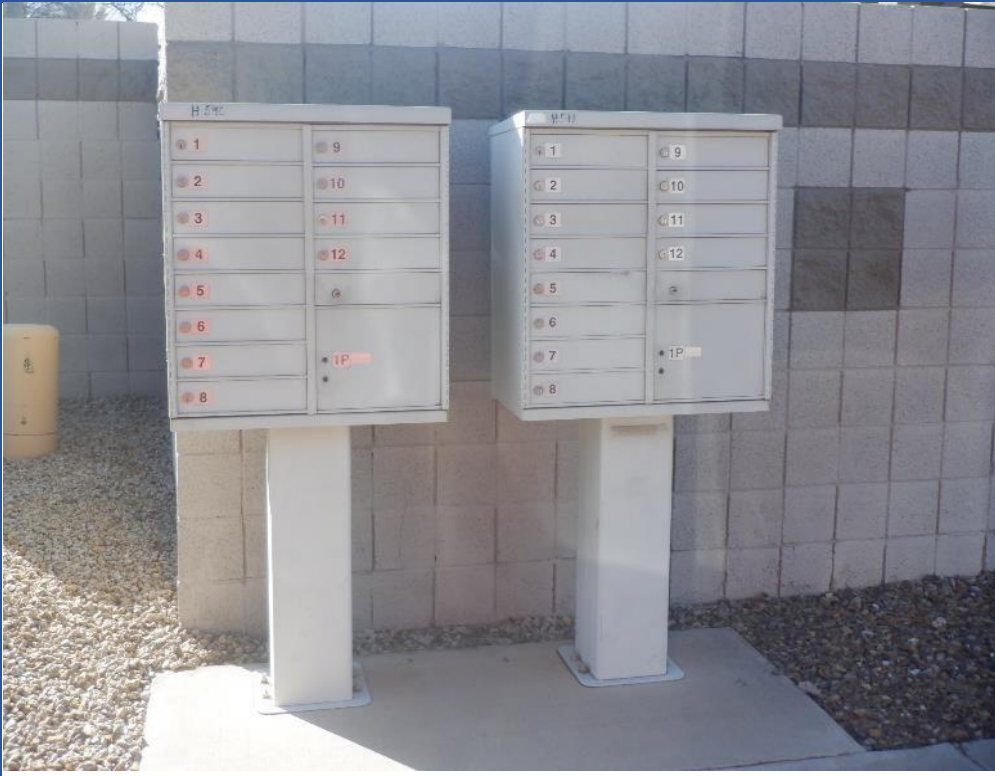
61

Mailbox kiosks on Cedar  
and Dragoon

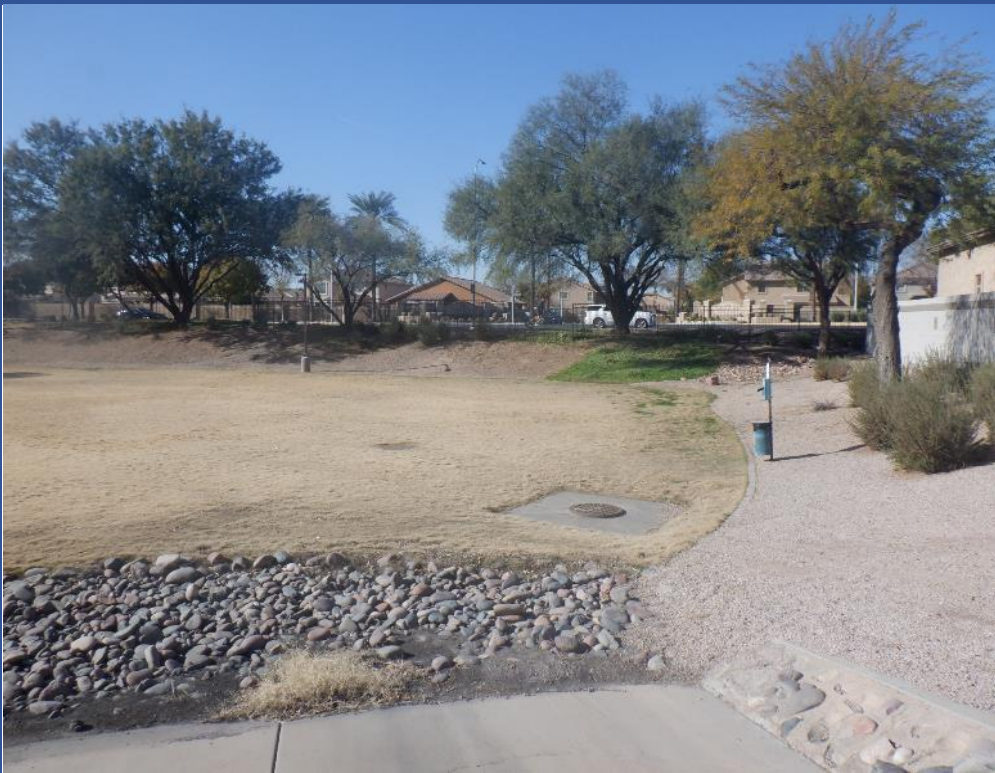
62

Tract B drainage culvert  
and common area  
overview

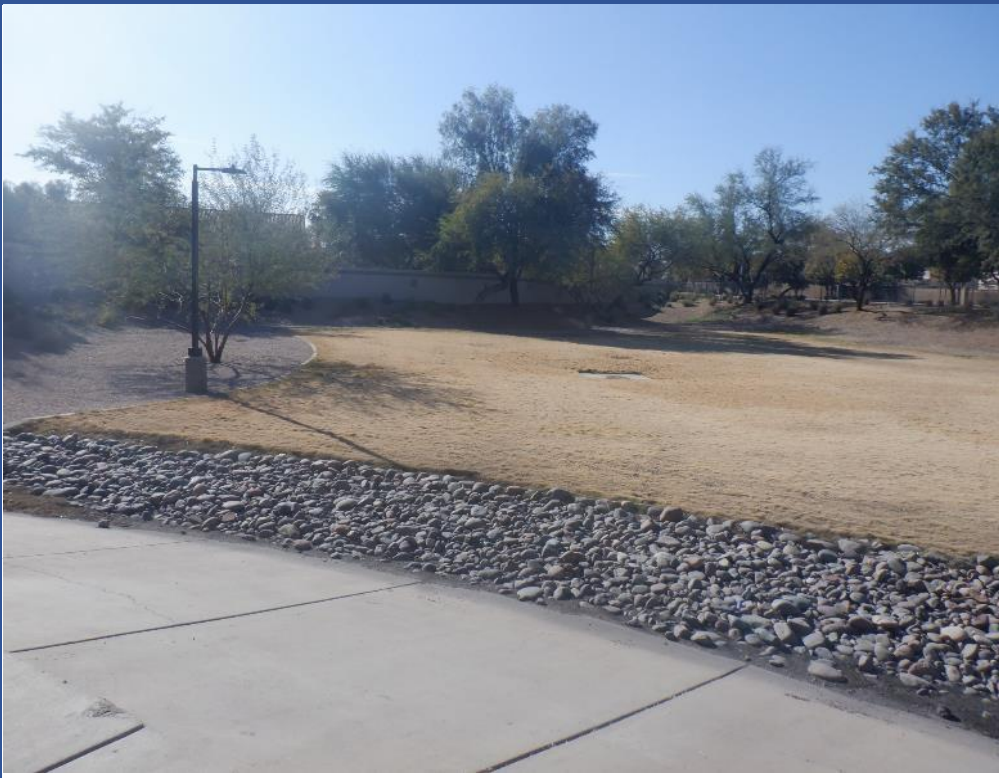
Tract B drainage culvert  
and common area  
overview

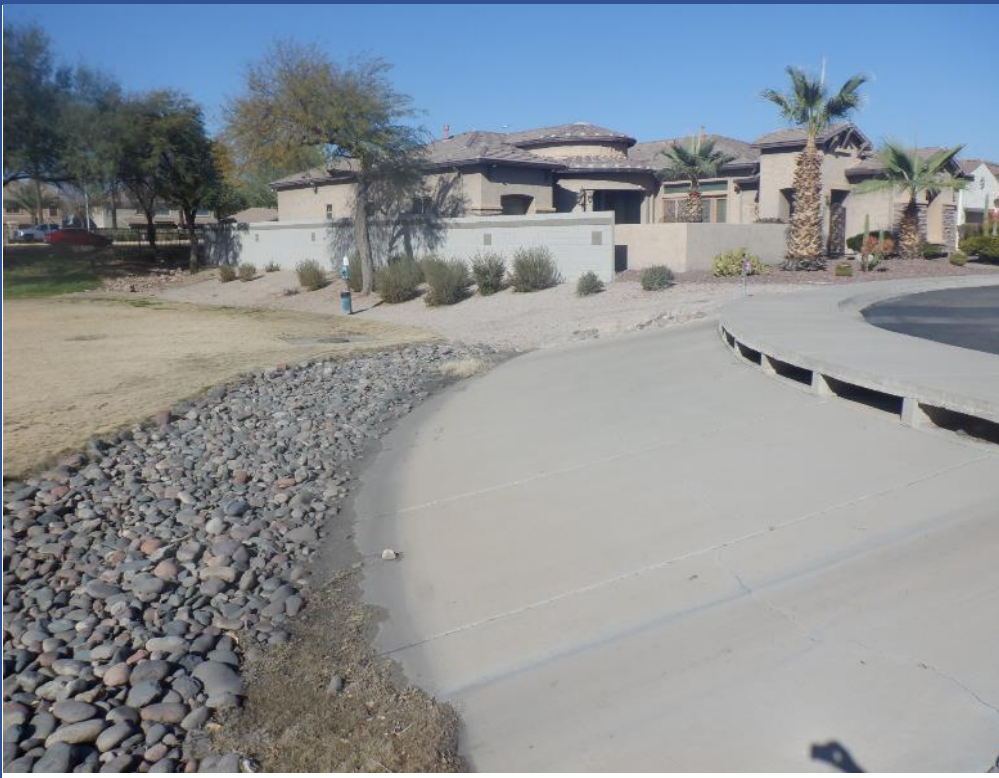
Tract B drainage culvert  
and common area  
overview

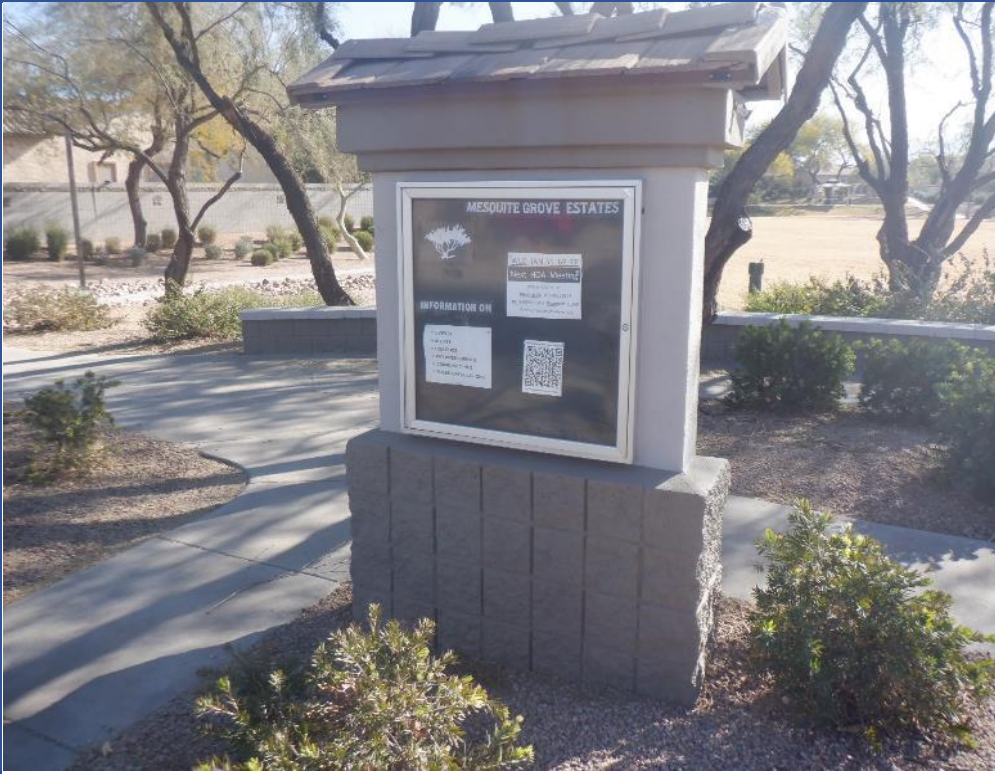
Community  
announcement  
monument in Tract E  
common area park
