February 29, 2024 R1

**PROPERTY:** MESQUITE GROVES ESTATES  
CHANDLER, ARIZONA

**SERVICE:** FULL RESERVE FUND ANALYSIS

**ATTACHMENT:** 23-0446 – FINAL REPORT

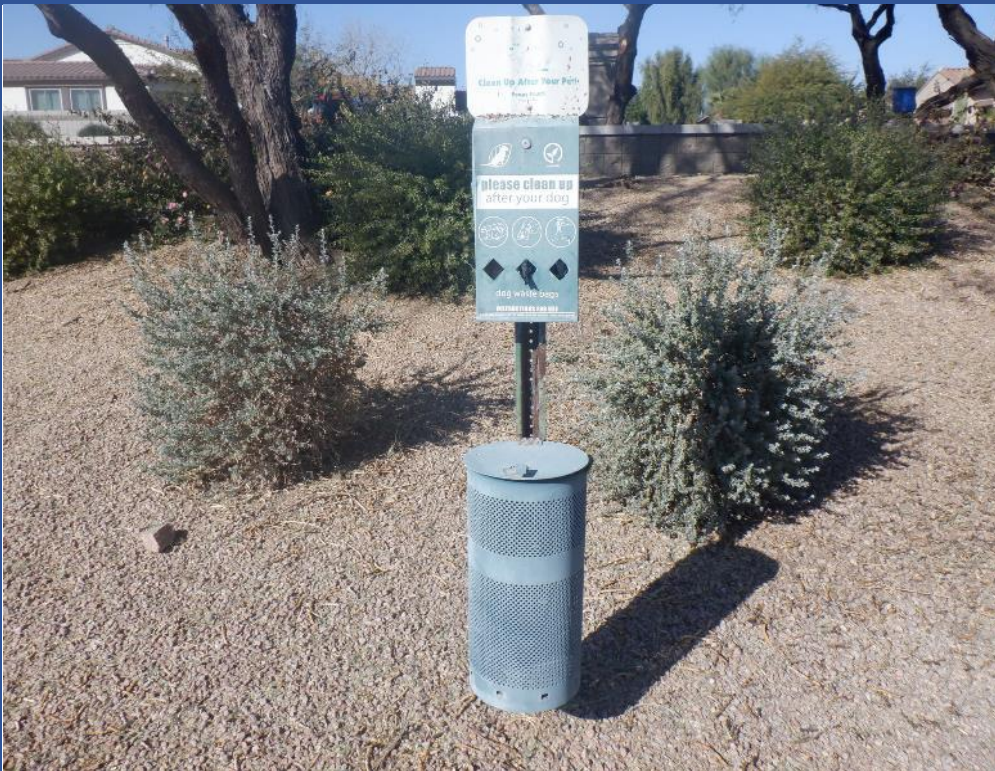
Pet station in Tract E  
park

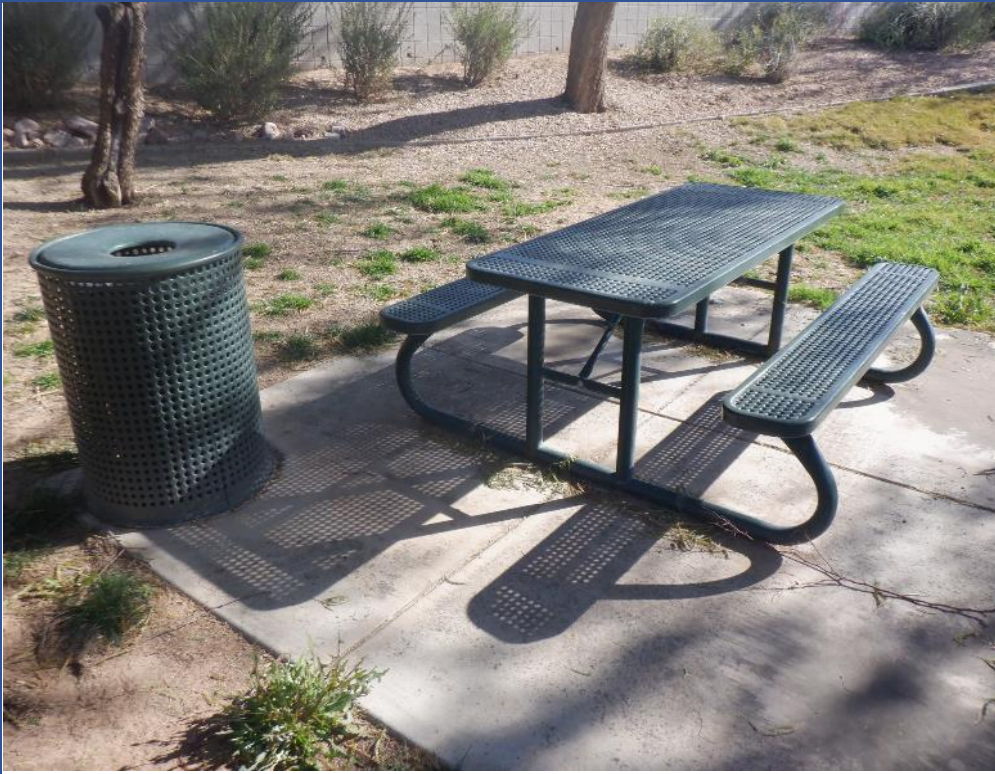
Park equipment in Tract E park

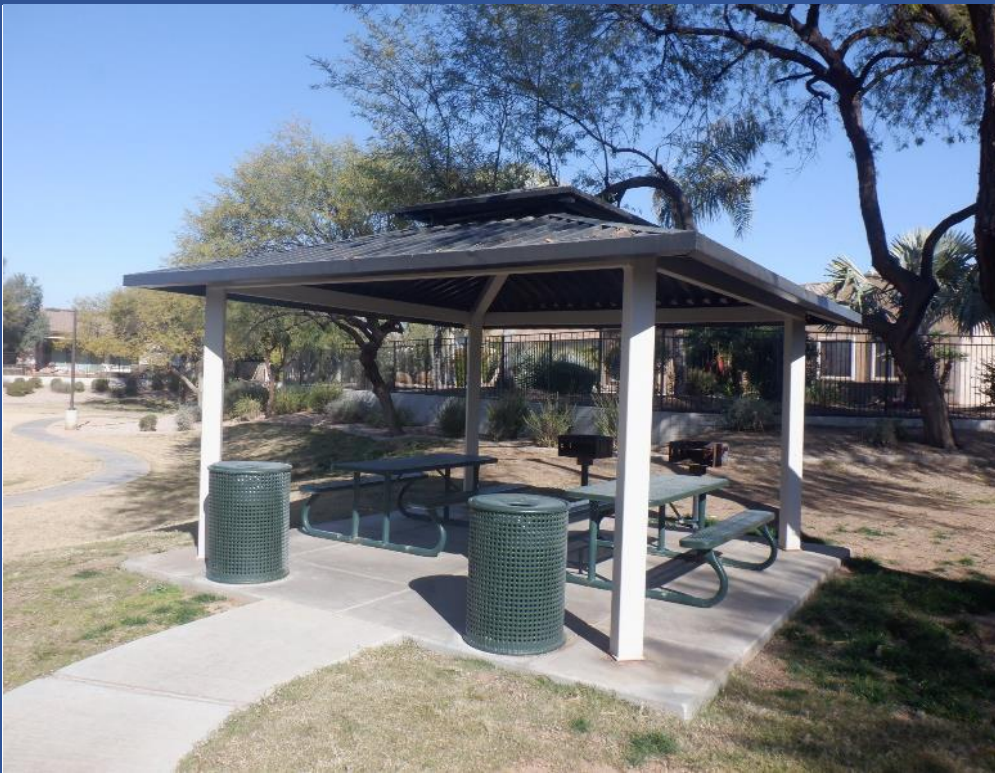
Ramada and park equipment in Tract E park

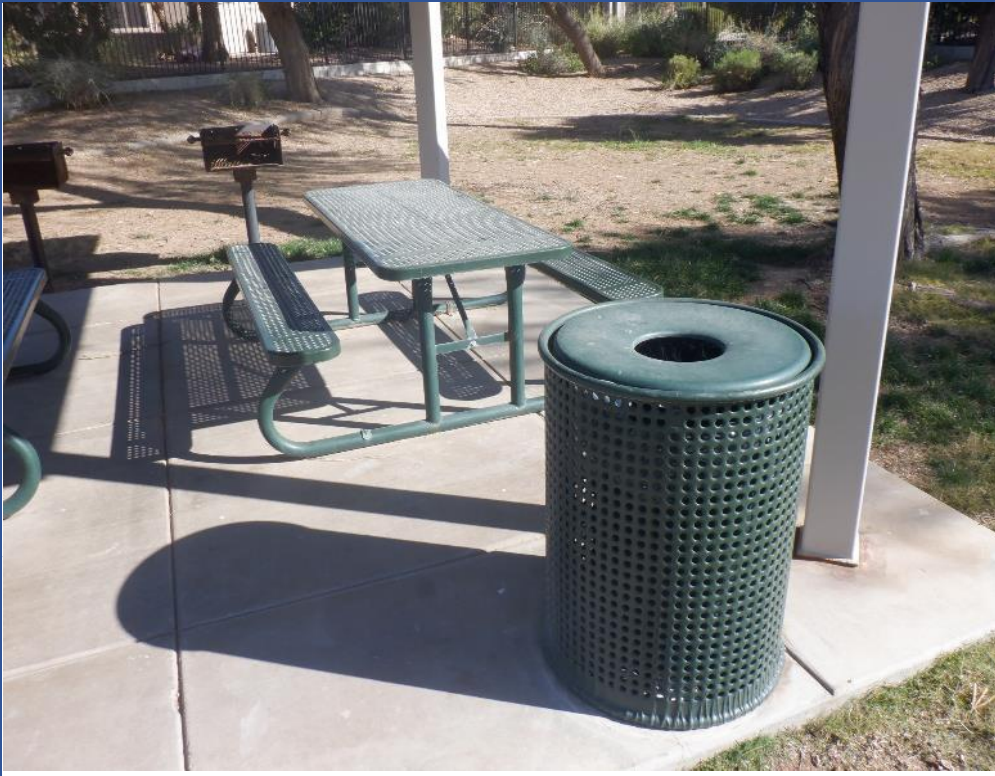
Park equipment in Tract  
E park

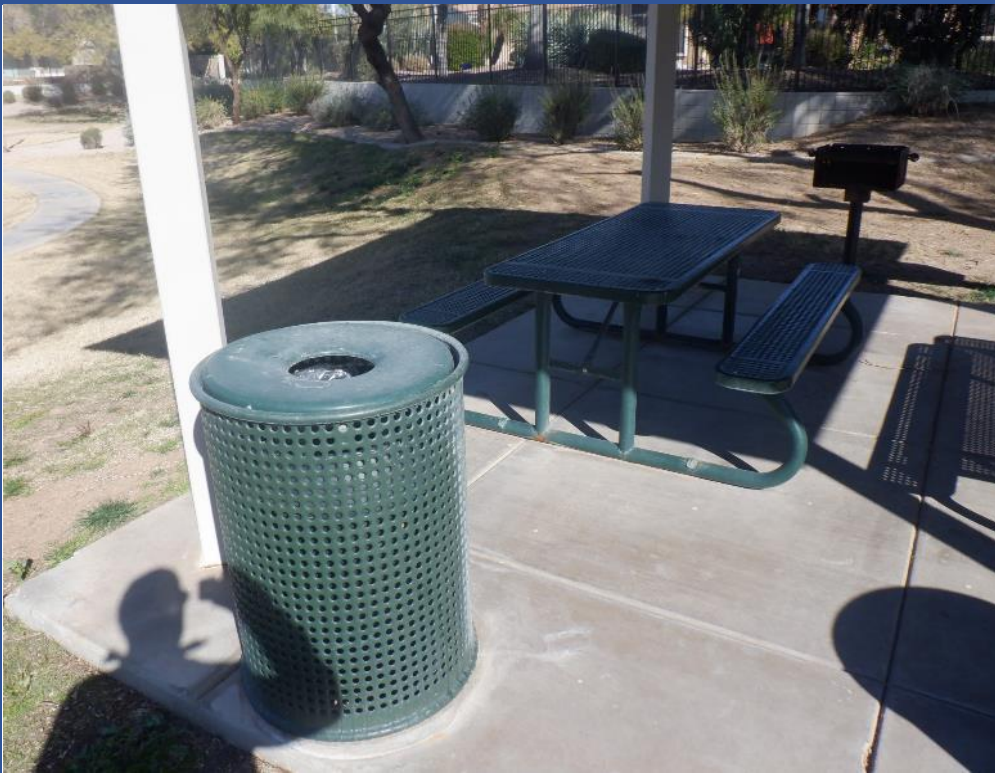
Park equipment in Tract  
E park

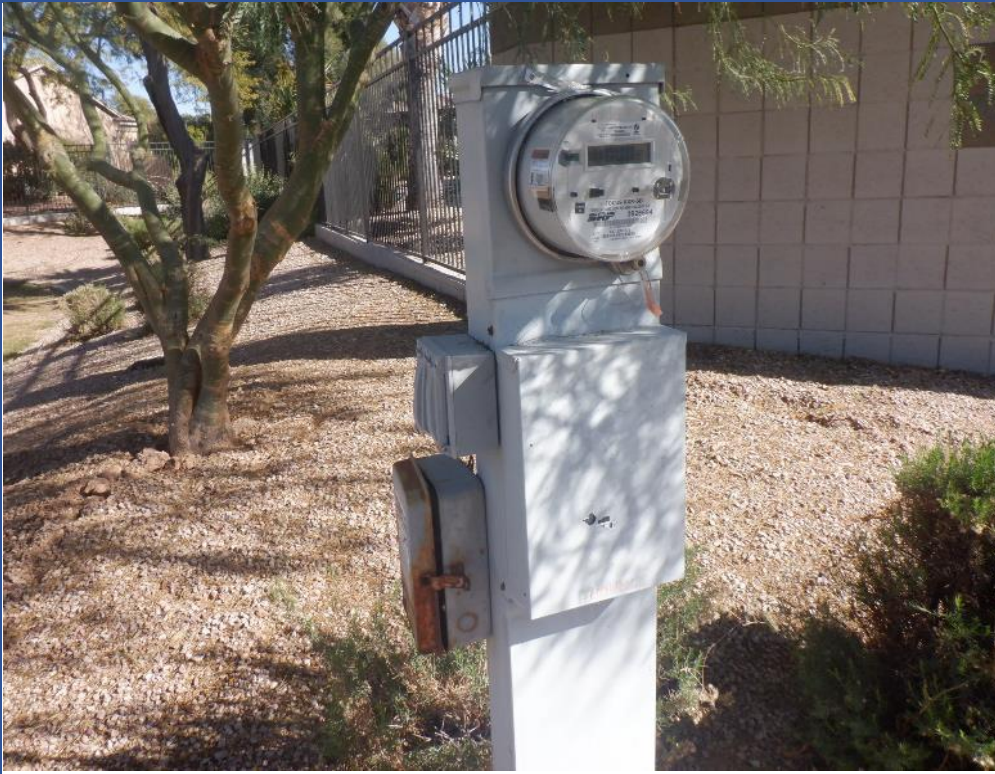
71

Electric control meter in  
Tract E

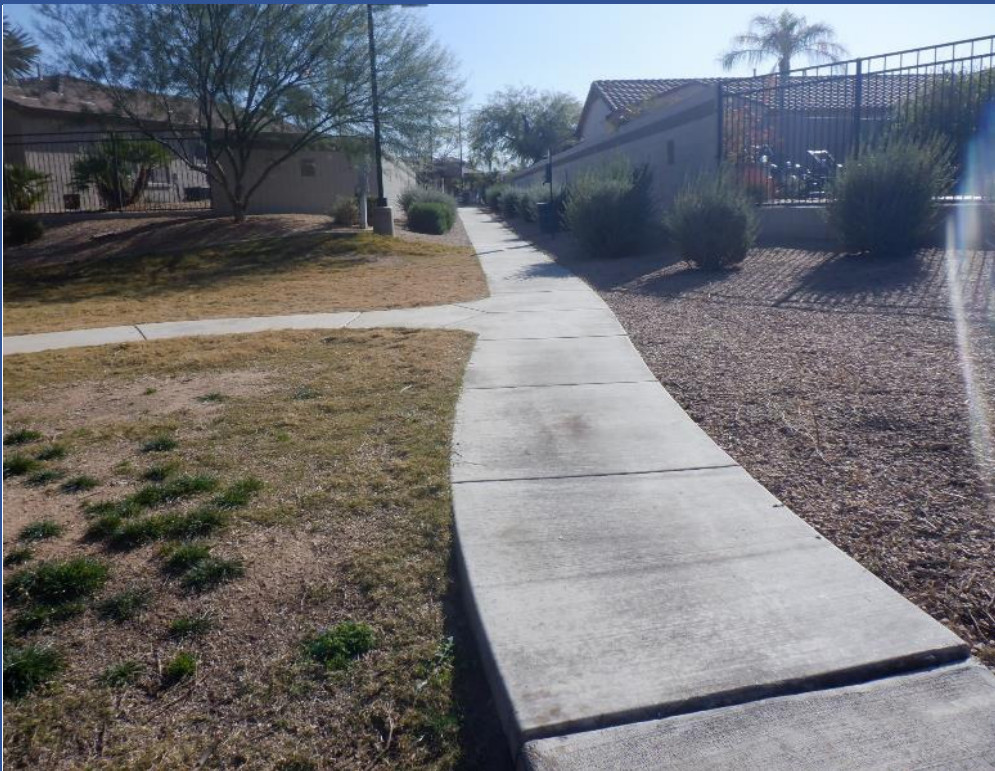
72

Concrete sidewalk in  
Tract E

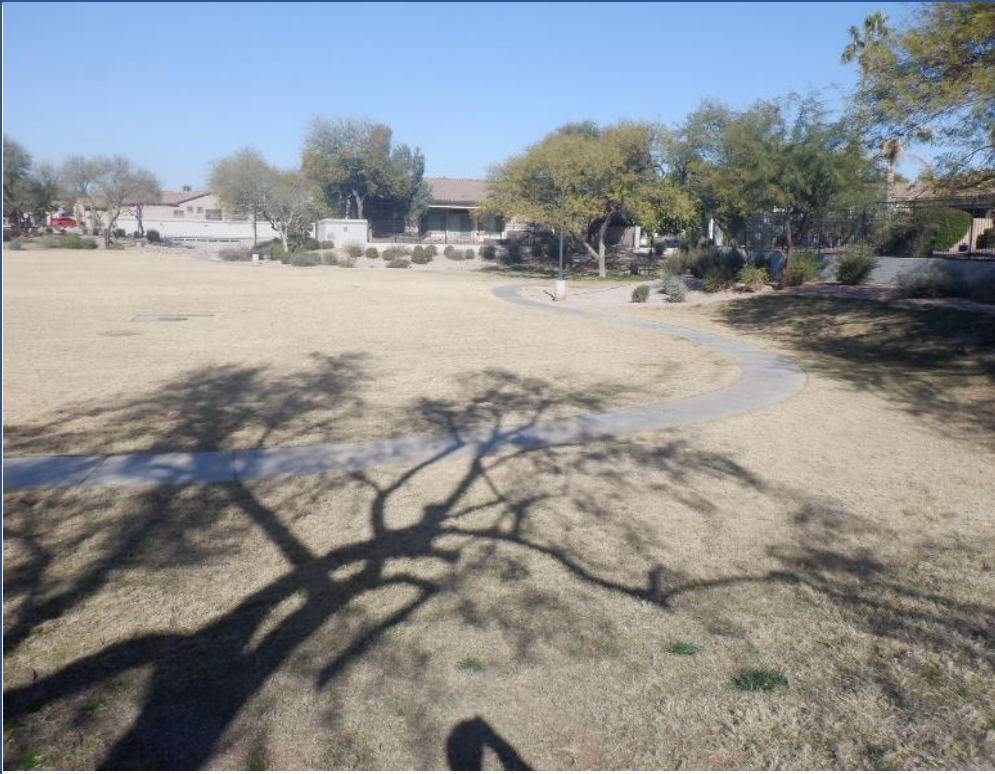
Tract E park overview

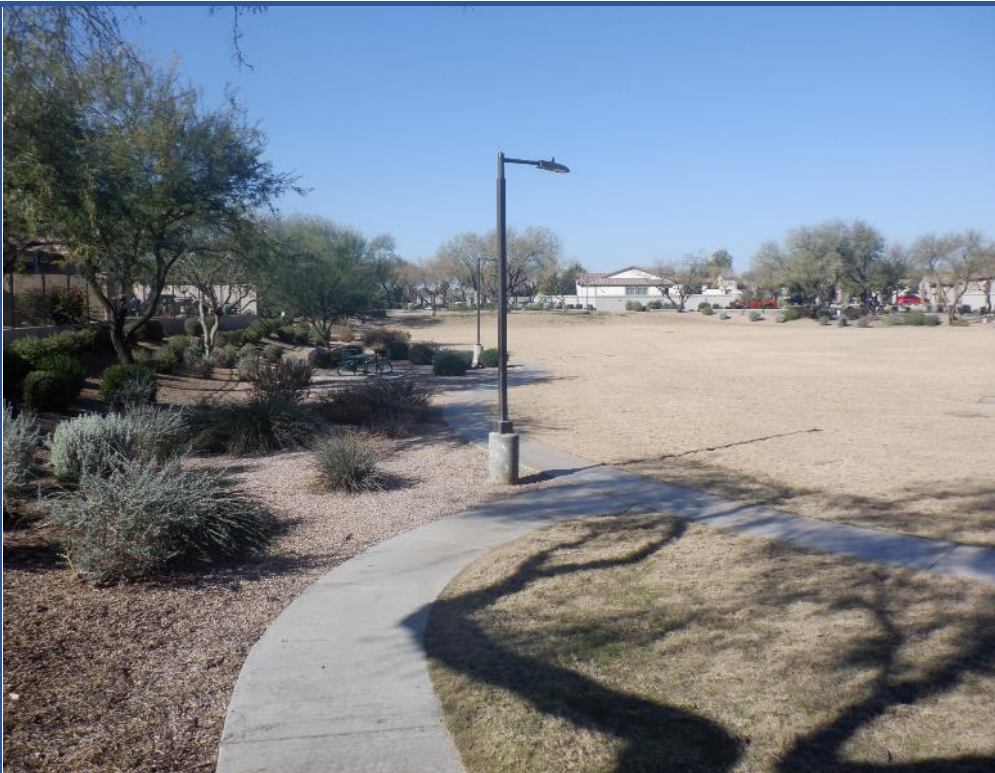
Tract E park overview

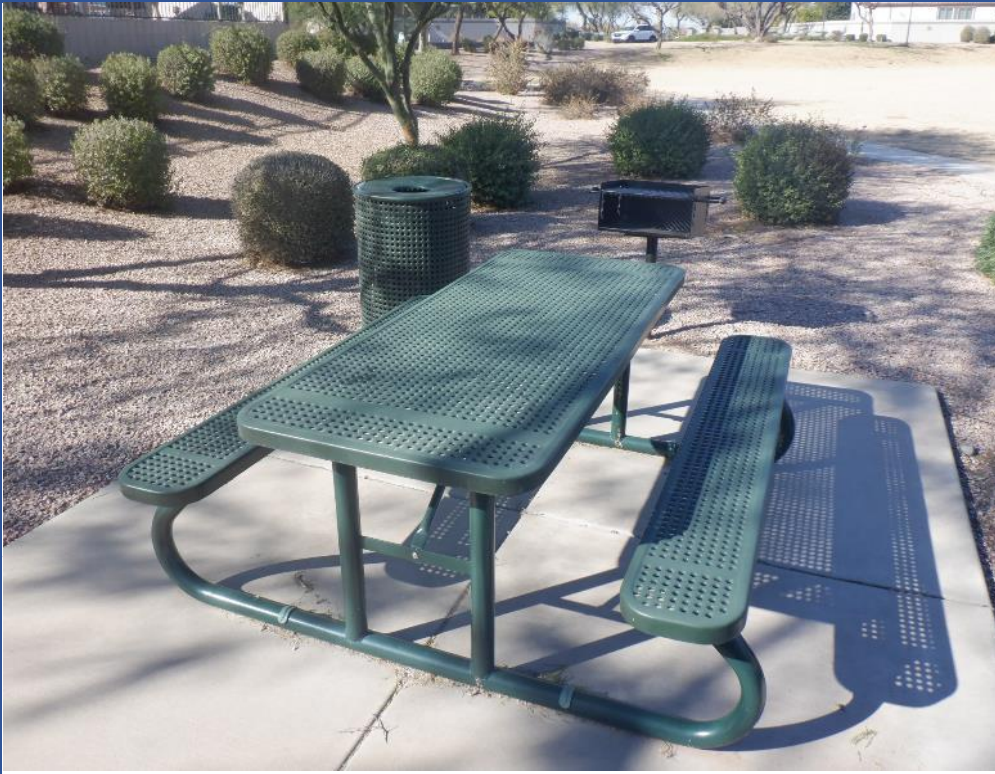
Park equipment in Tract E

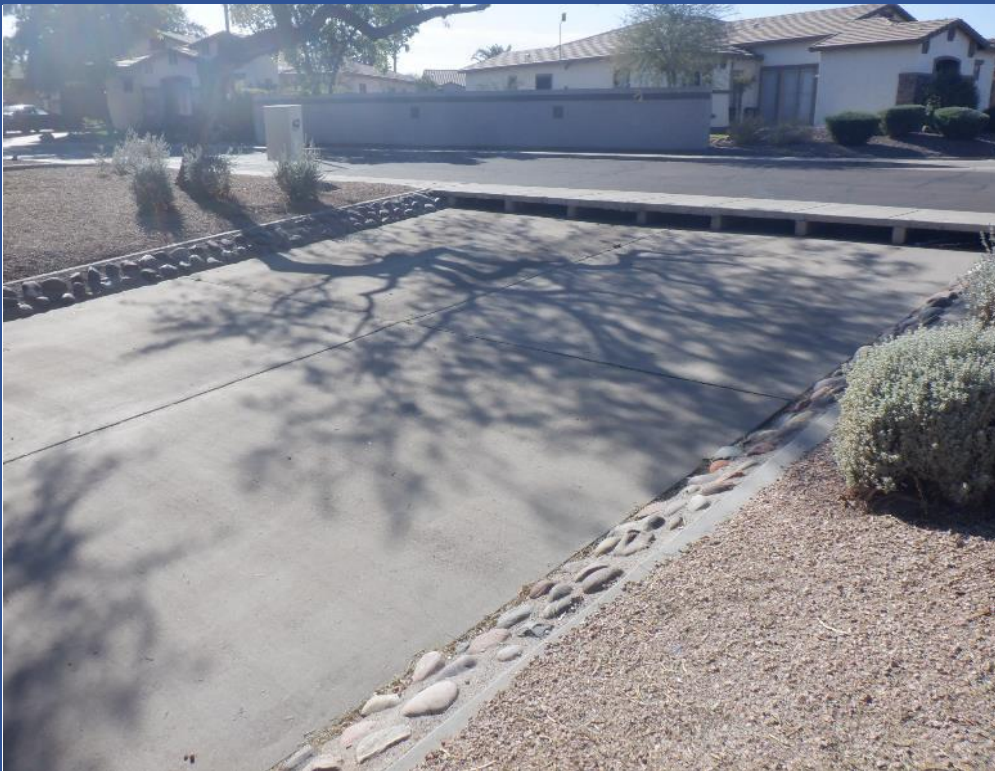
Concrete drainage culvert in Tract E

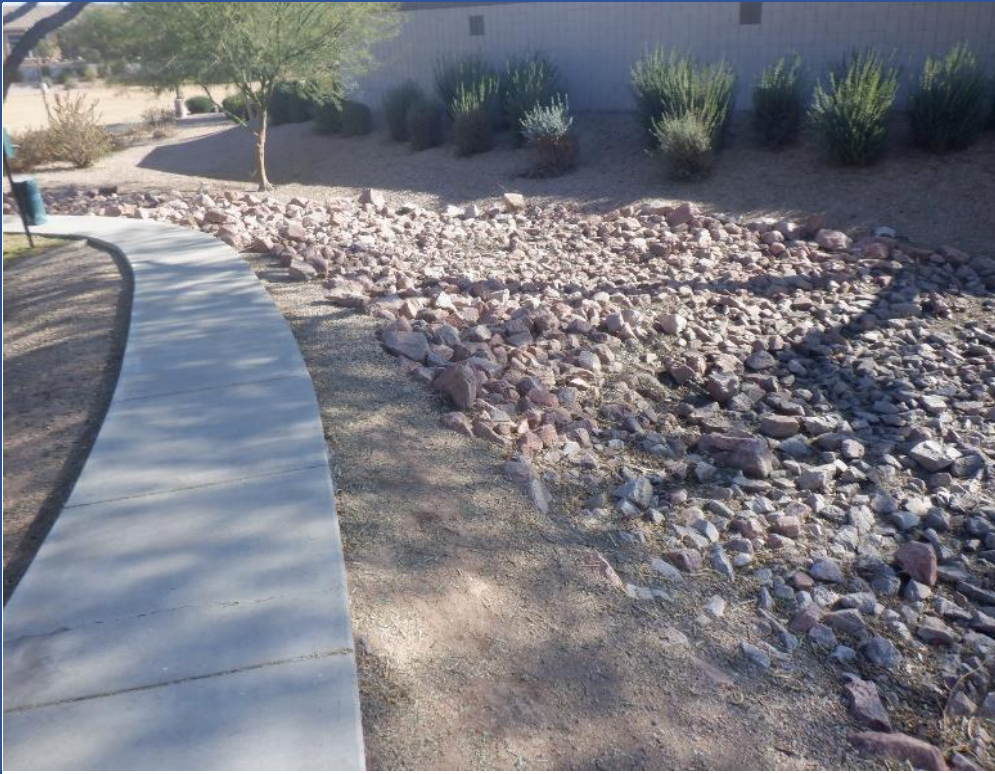
77

Overview of riprap and  
concrete sidewalk in  
Tract E

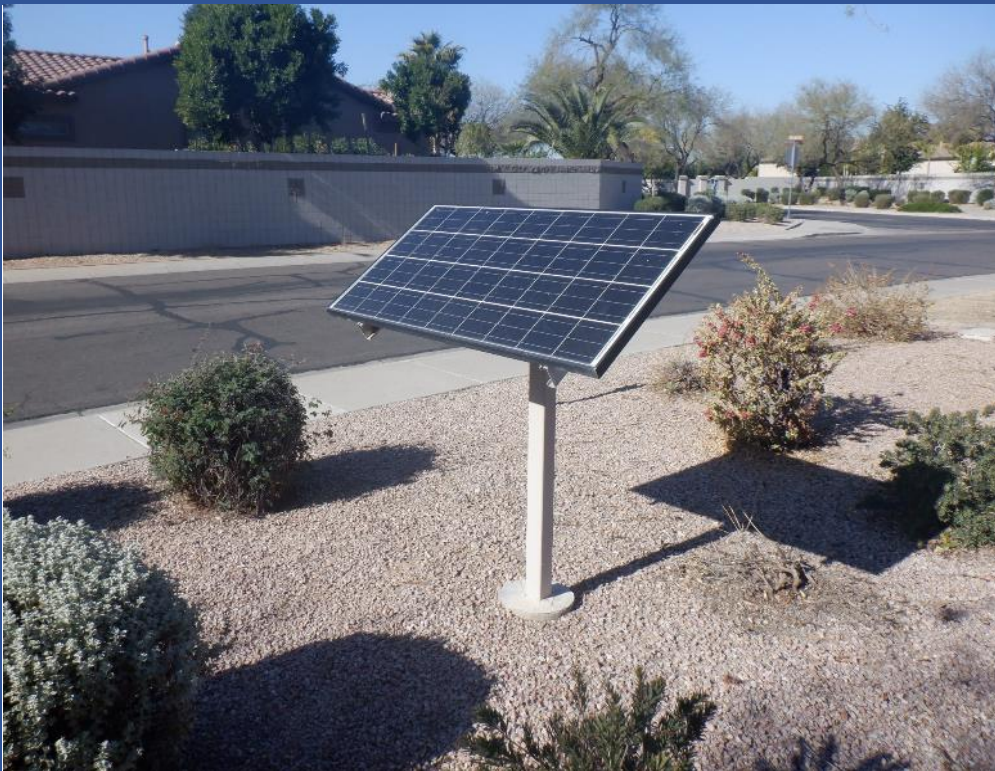
78

Solar panel in Tract E  
park

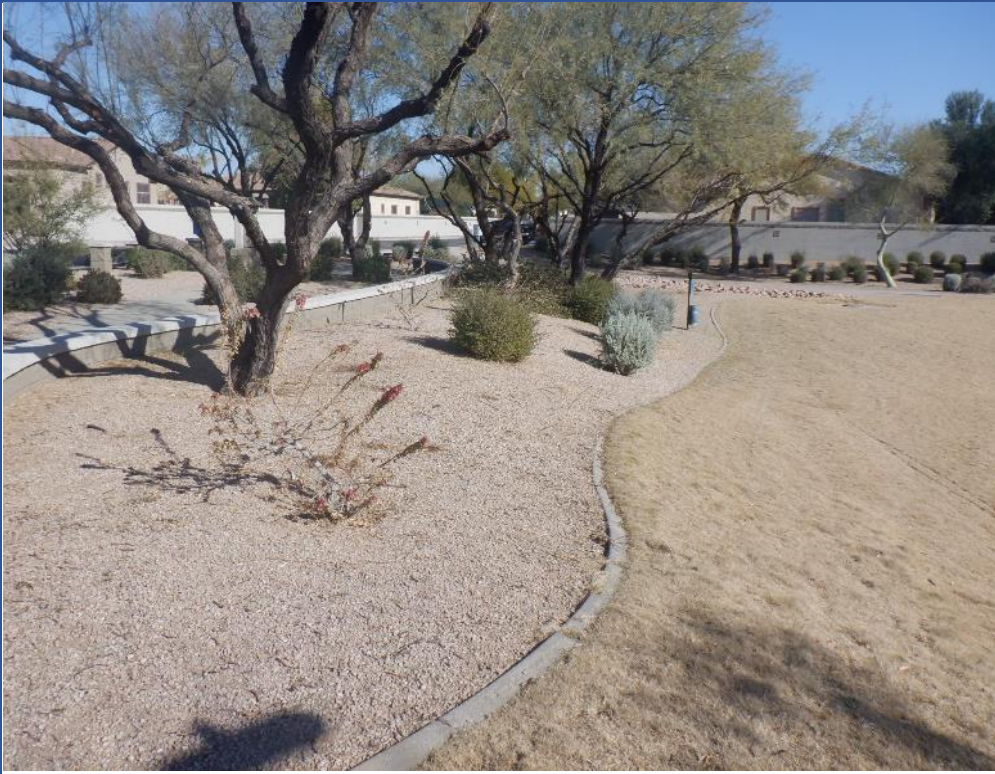
Landscape Granite,  
landscaping, and  
landscape curbing in  
Tract E

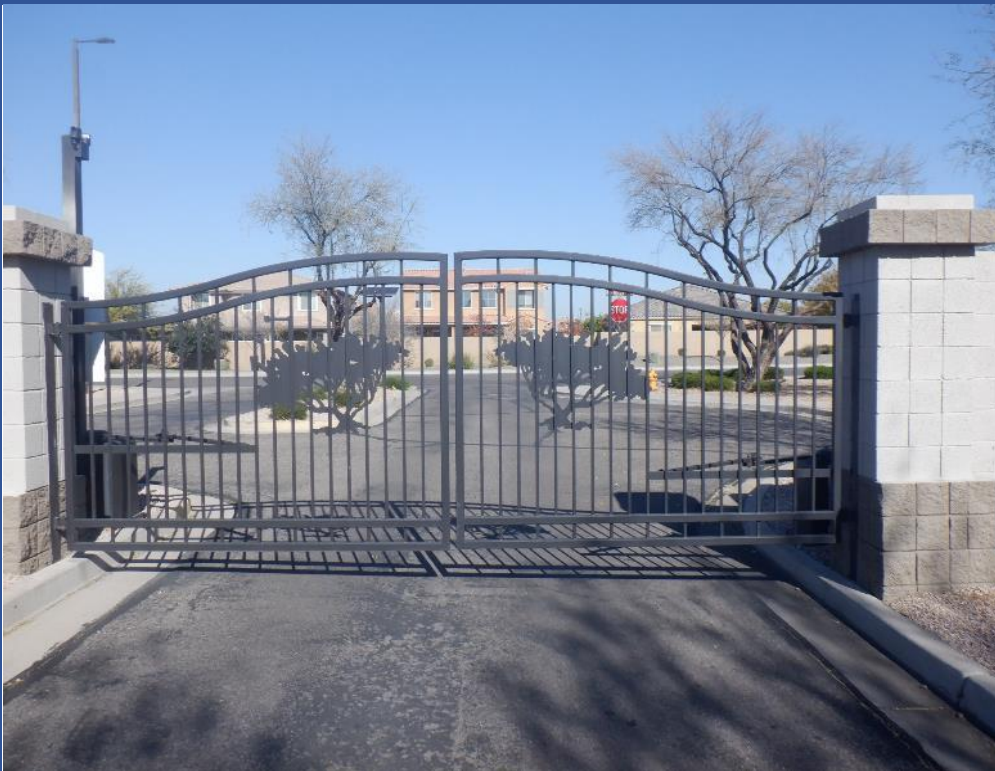
Wrought iron entrance  
gates at Wood Drive  
entrance

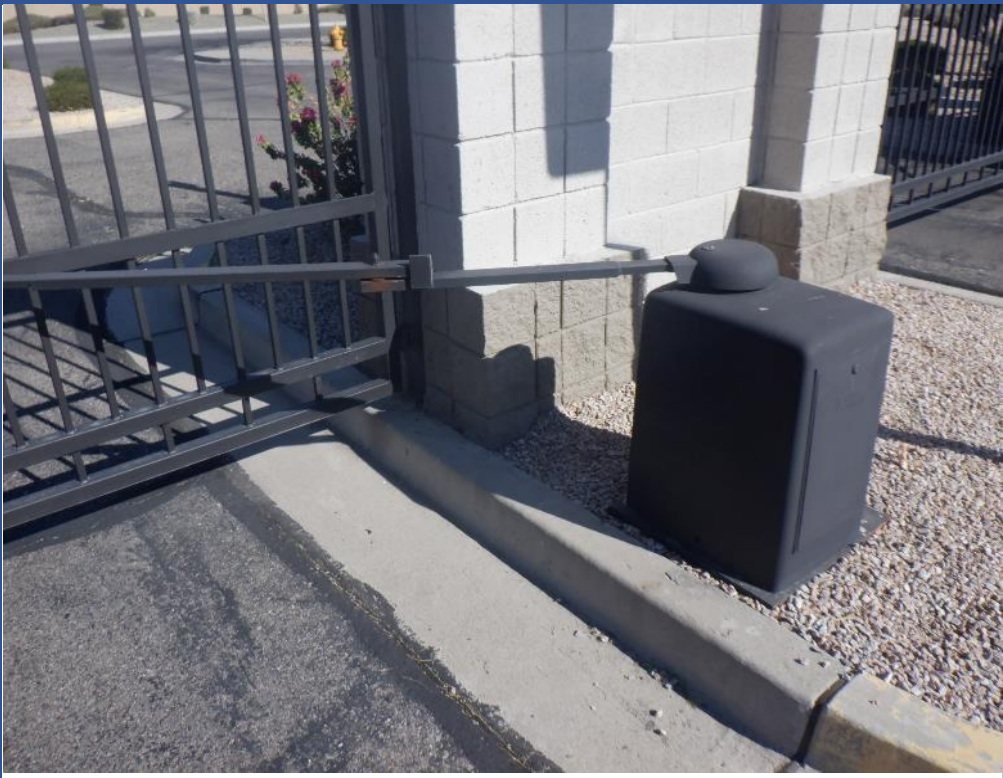
Gate operator at Wood Drive entrance

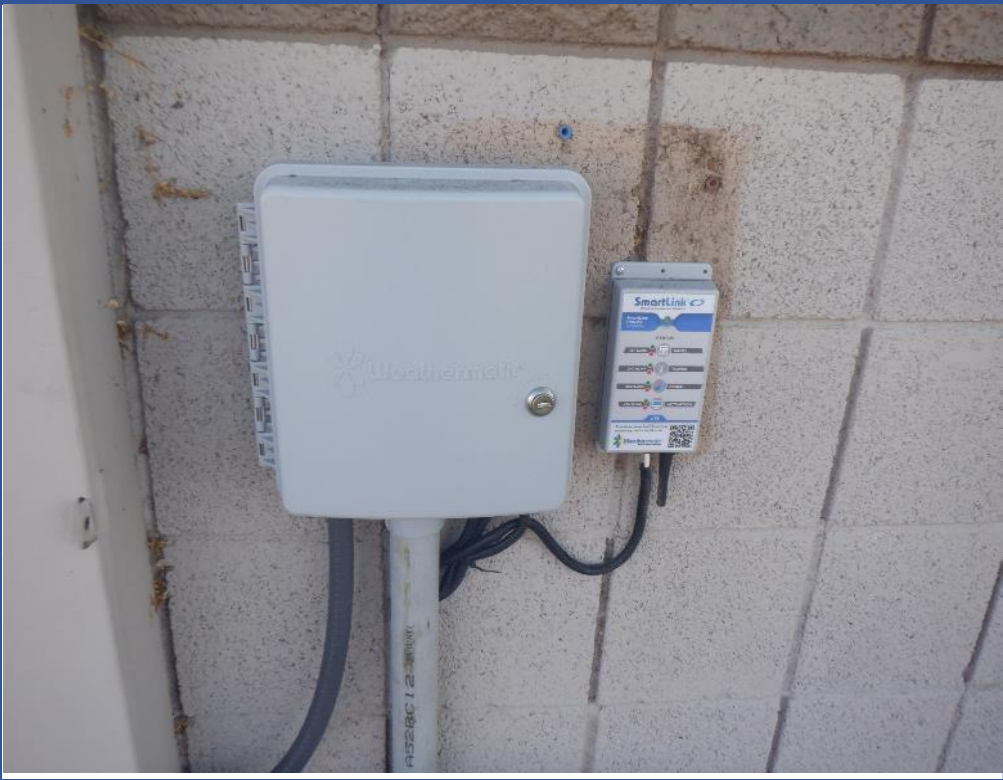
Weathermatic irrigation controller near Wood Drive entrance

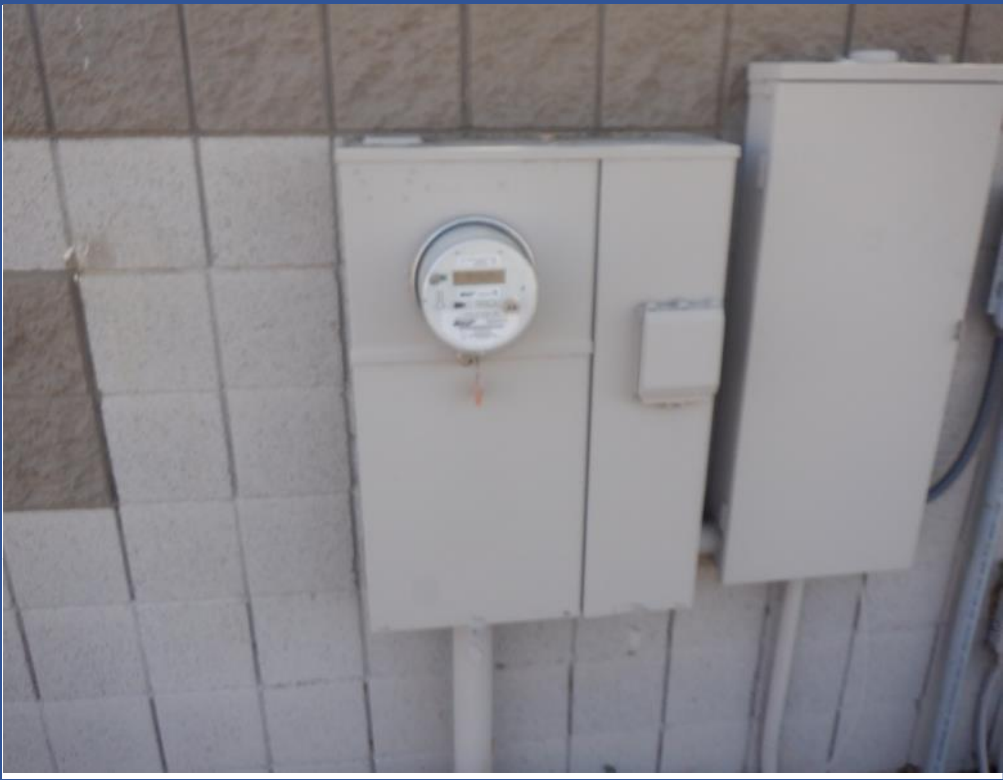
Electric control meter near Wood Drive entrance

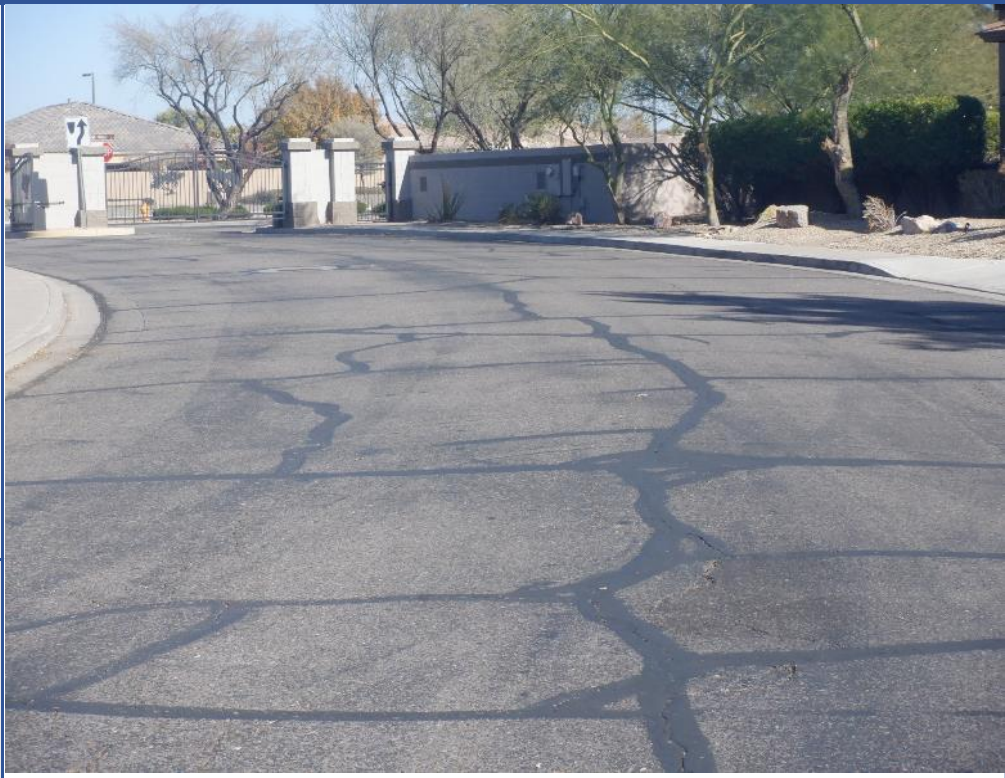
Asphalt near Cedar and Four Peaks

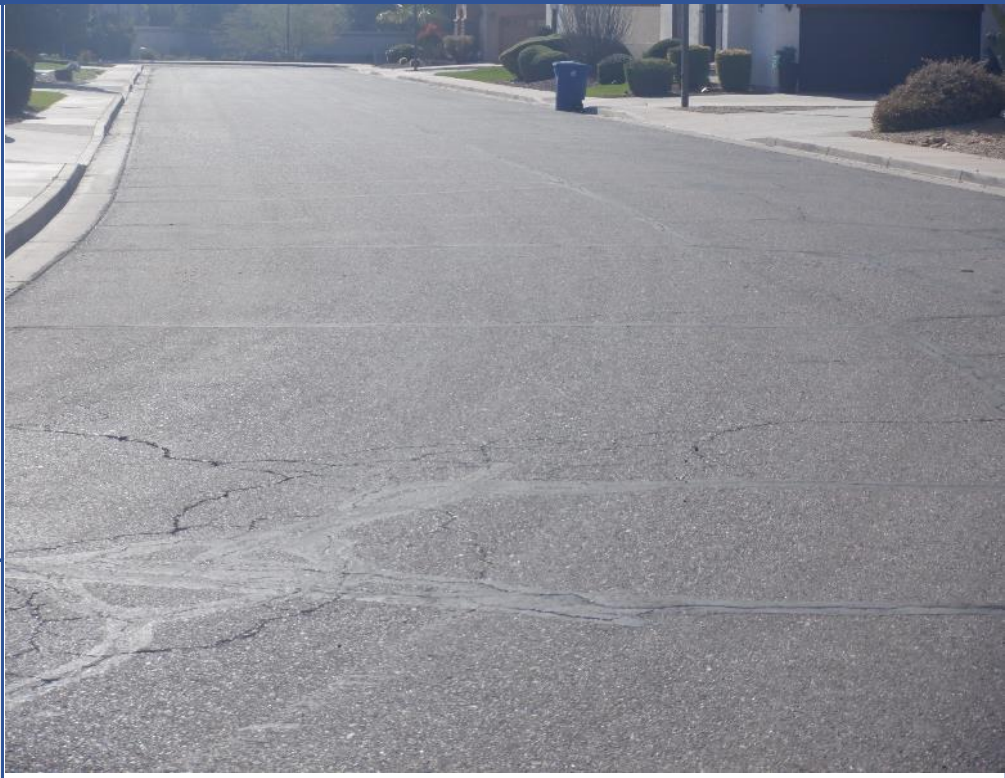
Asphalt near Cedar and Dragoon

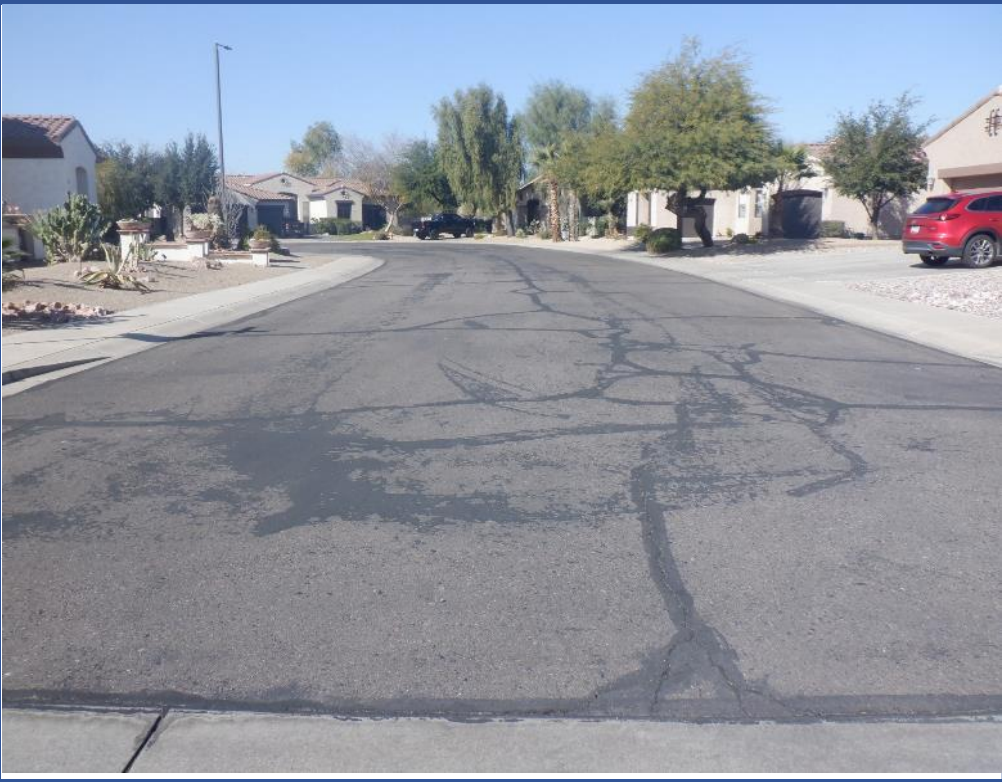
89

Asphalt near Libra and  
Mesquite Grove Way

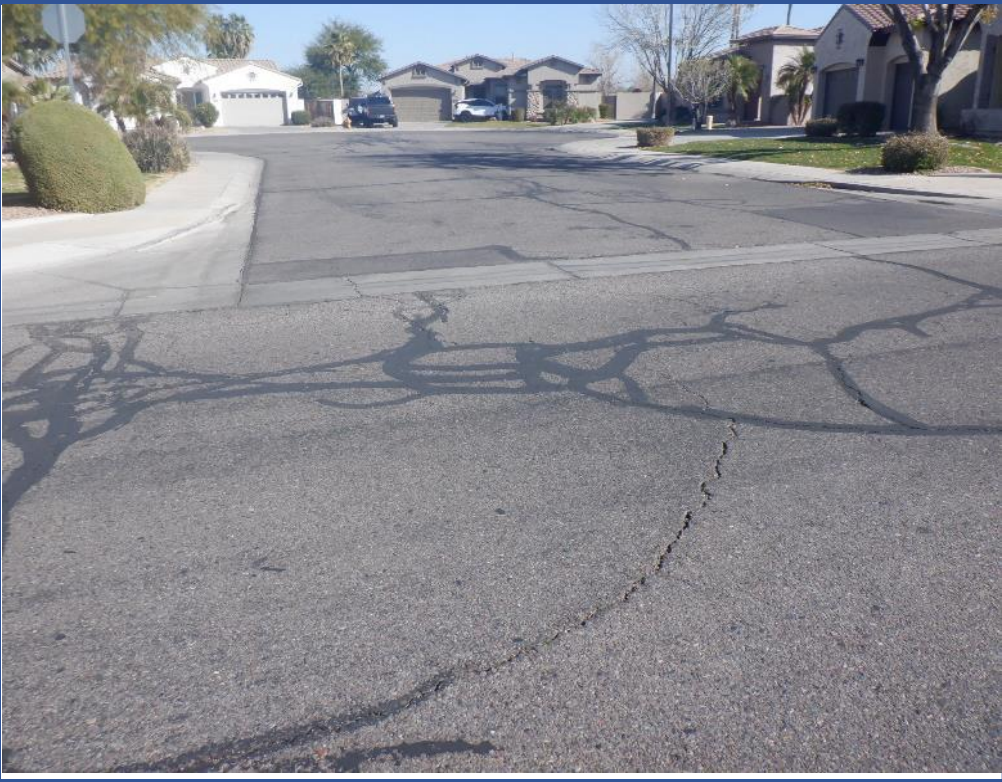
90

Asphalt near Four Peaks  
and Mesquite Grove  
Way

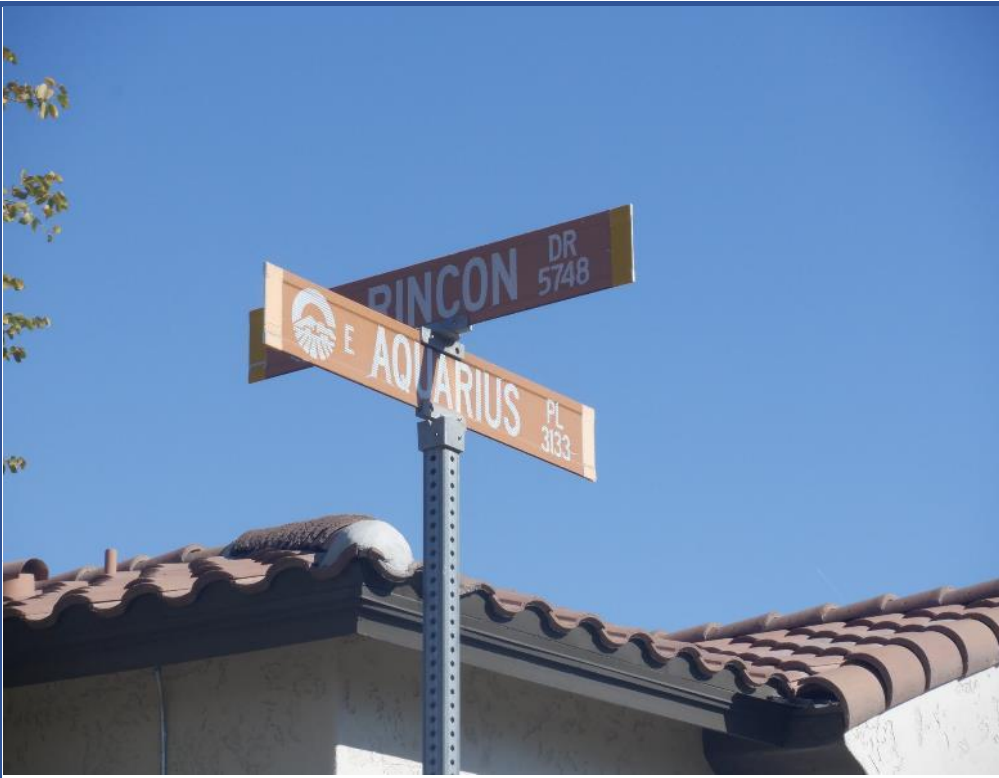
Street signs in community

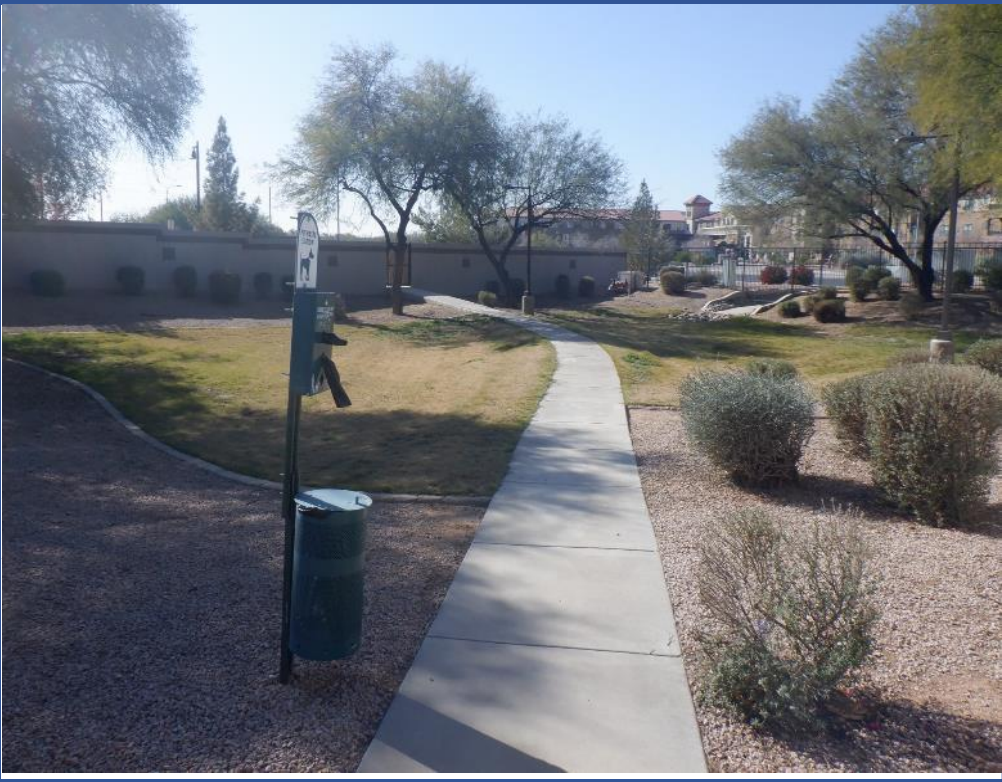
95

Tract J park overview ,  
including concrete  
sidewalk and pet station

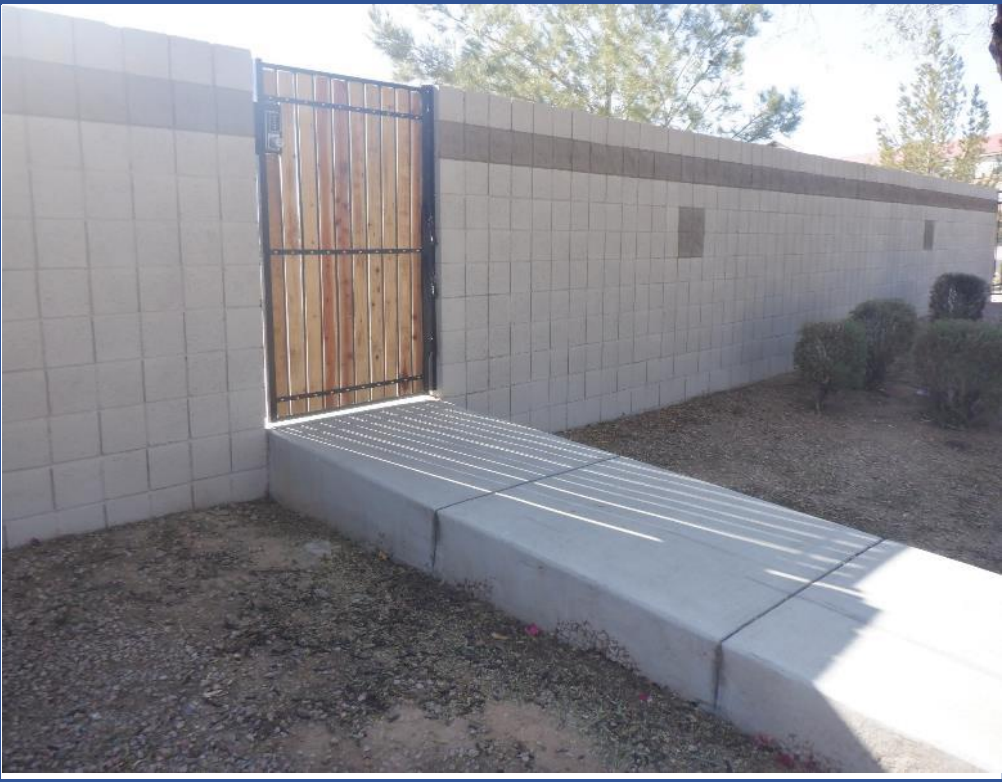
96

Tract J concrete sidewalk  
leading to exit from  
community and a  
wrought iron / wood slat  
pedestrian gate
